Mill Creek Addition

Road Inventory and Assessment Report

July 7, 2010

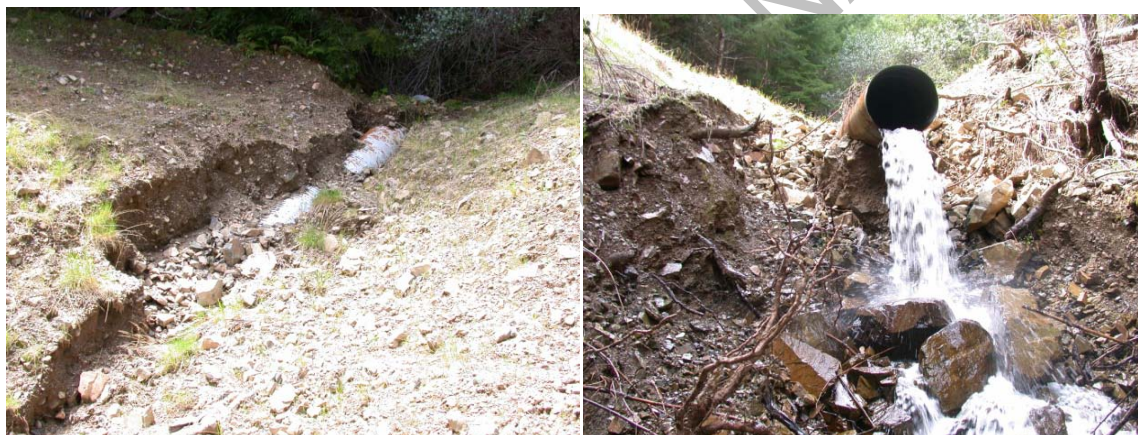
To date, these crossings continue to erode at an accelerated rate compared to the non-maintenance-free roads. Erosion occurs as chronic scour of the fill where flow overtops the fill, and as headcuts migrate upstream from the downstream end of the crossing (Figure 13).

Figure 13. Chronic erosion of stream crossing fill on a partially removed (maintenance-free) crossing.

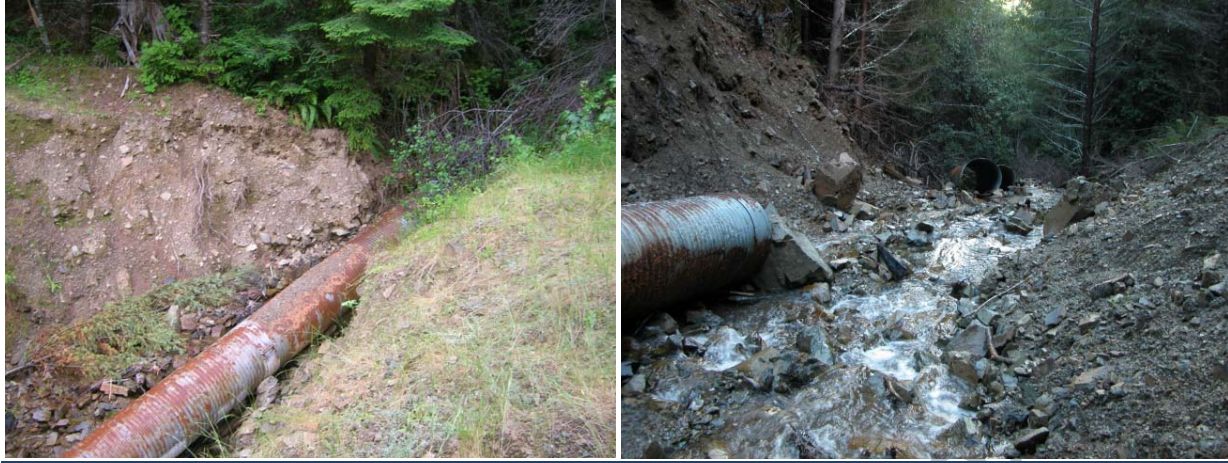
At several sites, catastrophic failure has occurred as high flow overwhelmed the culvert and scoured large volumes of fill from the sites (Figure 14). By removing the crossing fill to a level that increases the likelihood of overtopping, the crossings have proven to be far less stable than if they had been left intact. In addition, the rationale to leave the culverts in place for future re-entry was flawed; by definition, these maintenance-free roads were to remain decommissioned for several decades and by then, the culverts would have either failed or replacement would likely be required under future THP review.

Figure 14. This partially removed stream crossing has subsequently failed and delivered sediment to the stream channel because of the ineffective method used to convert the crossing to maintenance-free status.
