# Toscano Hotel Complex and Servants' Quarters Historic Structures Report

**Prepared for**  
California State Parks  
Archeology, History and Museums Division  
Sacramento, California

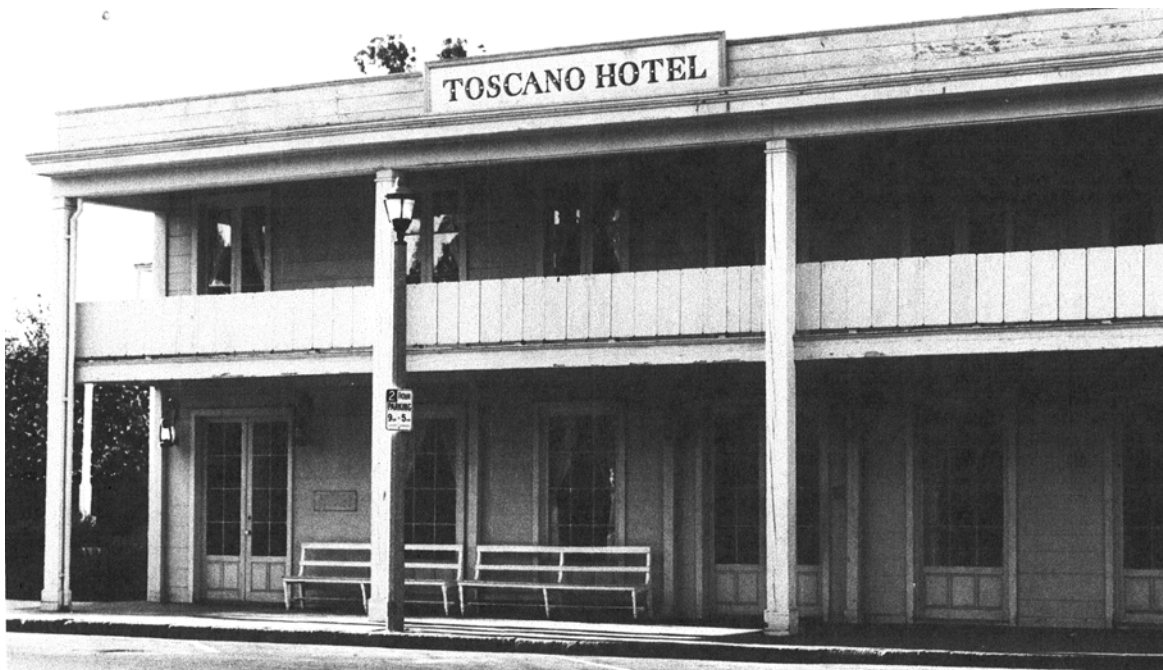
Figure 12. Toscano after 1970s (photo taken in 1981) restoration (photo courtesy of California State Parks).

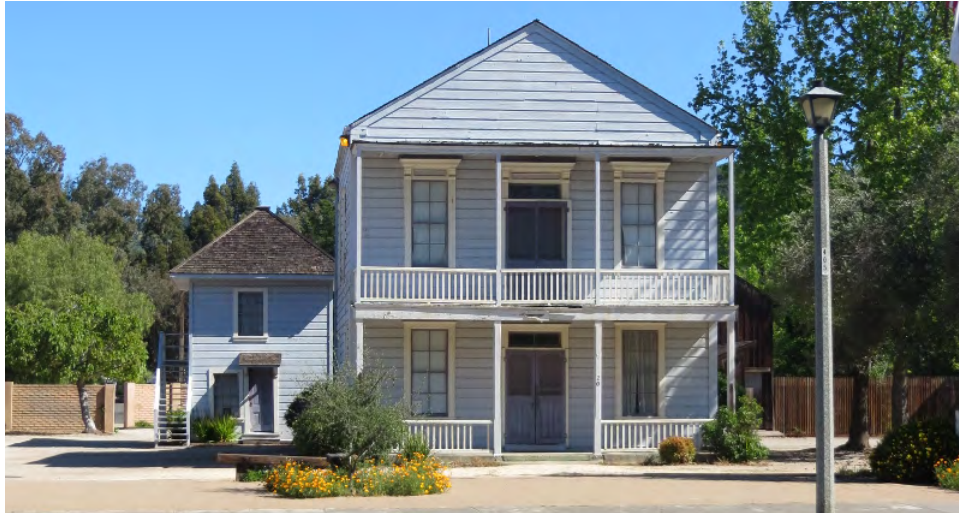
**Figure 16. The front elevations of the Hotel Annex and the Water Tower as viewed from Sonoma Plaza (photo: Garavaglia Architecture, Inc., April 2013).**

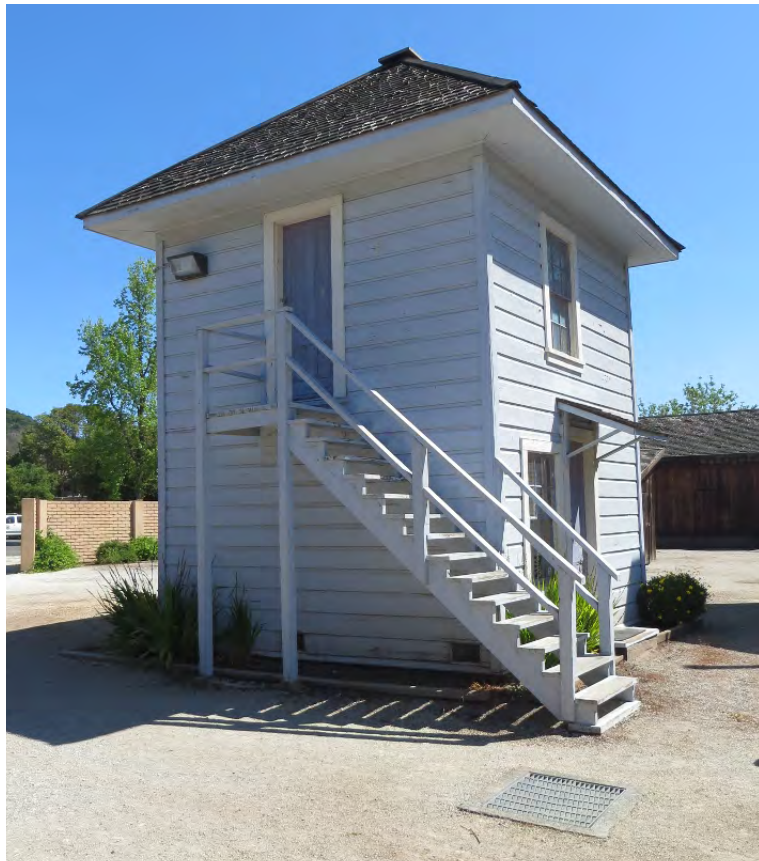
Figure 17. This image of the Water Tower shows the eastern exterior stair to the second floor. The primary first floor entrance is on the south (photo: Garavaglia Architecture, Inc., April 2013).

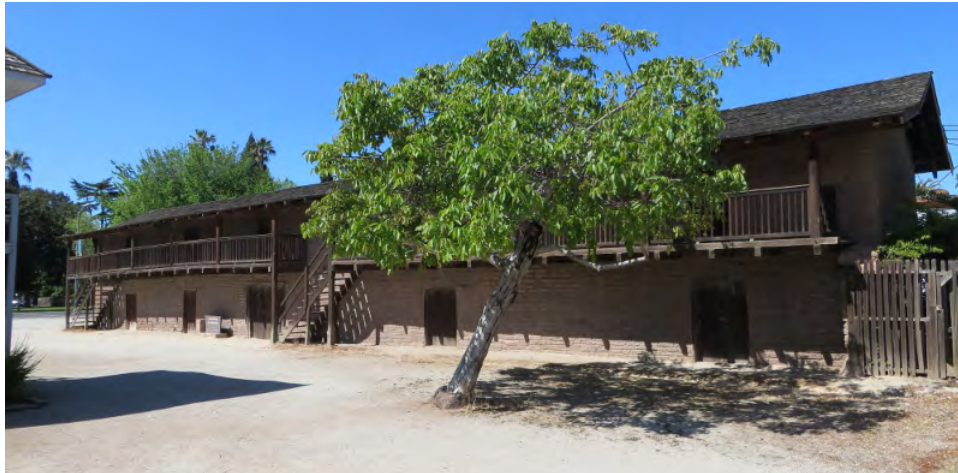
Figure 18. The east elevation of the Servants' Quarters as viewed from the rear of the park site (photo: Garavaglia Architecture, Inc., April 2013).

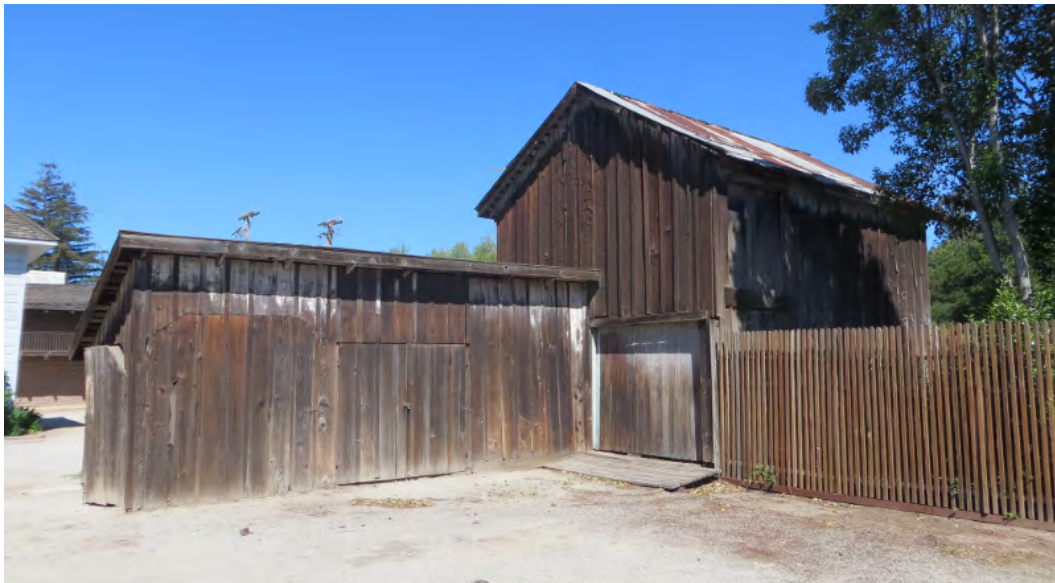
Figure 21. These barns are not original to the property but appear to date to prior to 1941. They are at the rear of the property, between the Hotel Annex and the restroom facility (photo: Garavaglia Architecture, Inc., April 2013).

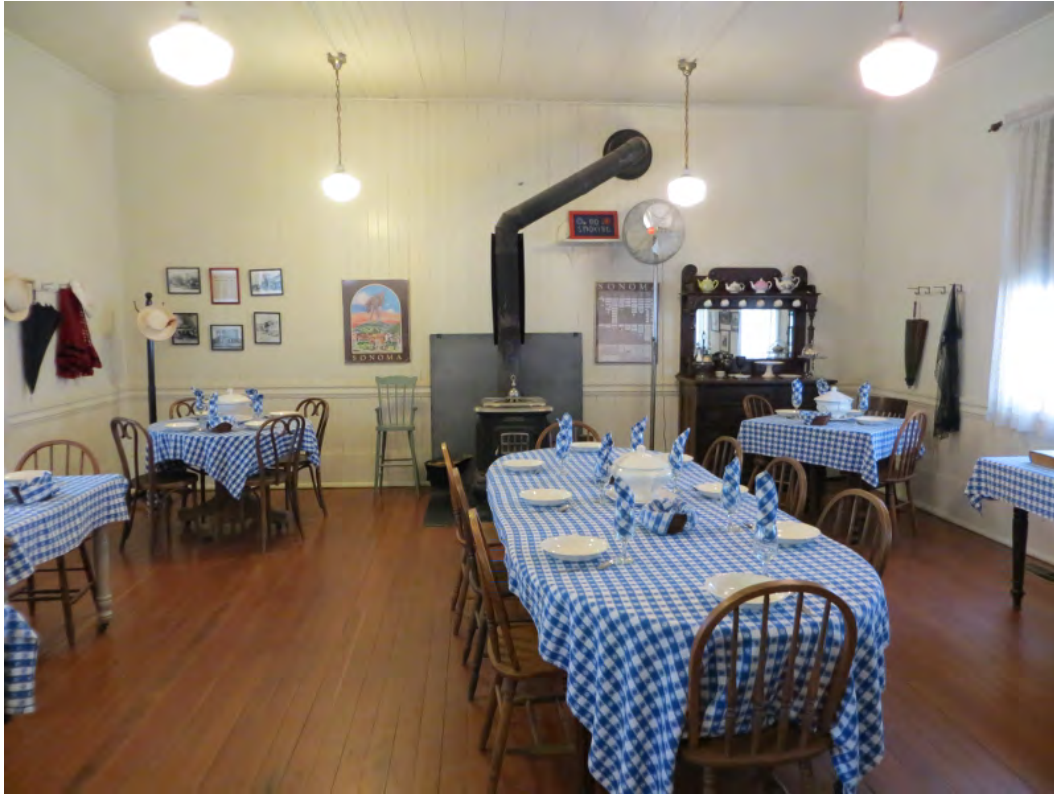
Figure 23. The Kitchen Annex is interpreted as a dining room for the hotel. The architectural finishes appear to be original, although the furnishing are not (photo: Garavaglia Architecture, Inc., April 2013).

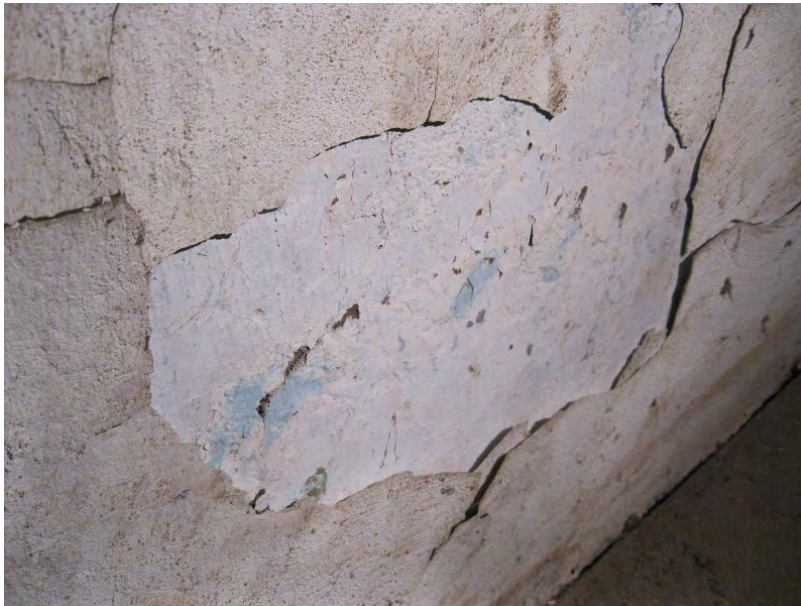
Figure 25. There are several layers of plaster and paint finishes on the second floor of the Servants' Quarters. This image shows the complicated stratigraphy found in areas of current damage.

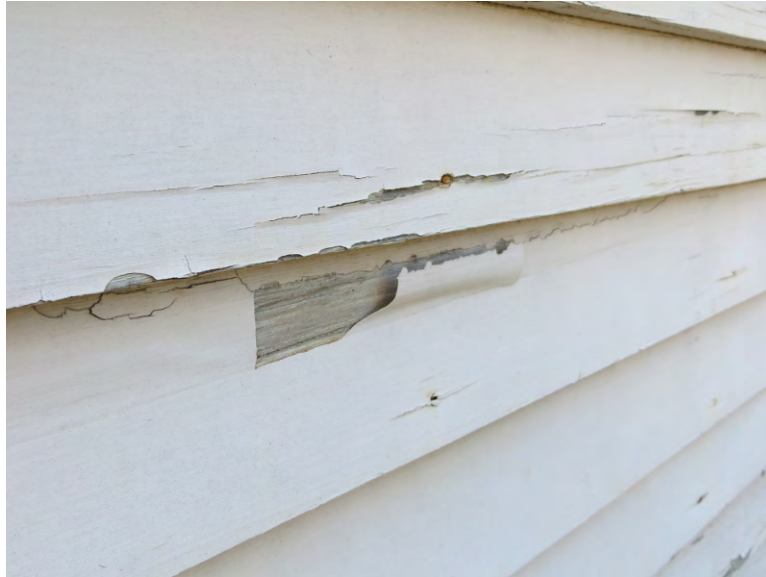
**Figure 27. Typical finish failure on the Toscano Hotel. It is worst on the west side of the building (photo: Garavaglia Architecture, Inc., April 2013).**

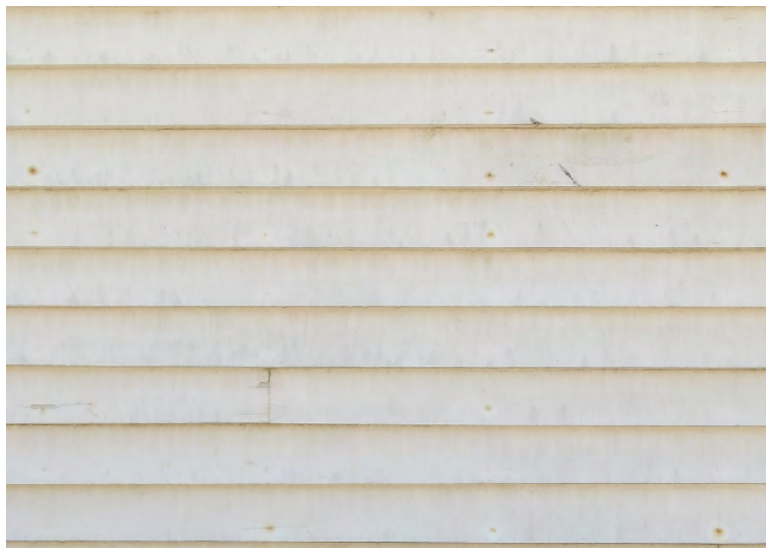
**Figure 28. Oxidized non-galvanized nail heads are staining the siding. These areas should be filled and painted to prevent further corrosion and damage (photo: Garavaglia Architecture, Inc., April 2013).**

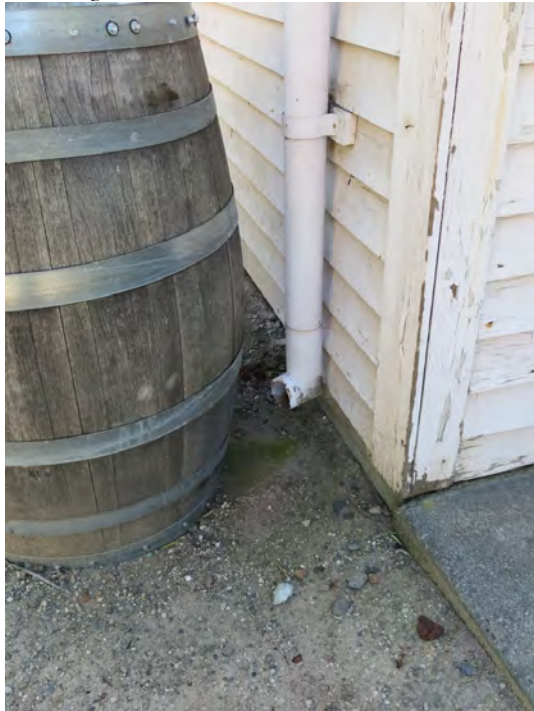
Figure 29. Downspouts on the rear elevation of the Toscano Hotel deposit rainwater at grade, directly adjacent to the building foundation. This downspout is at the northwest corner of the building (photo: Garavaglia Architecture, Inc., April 2013).

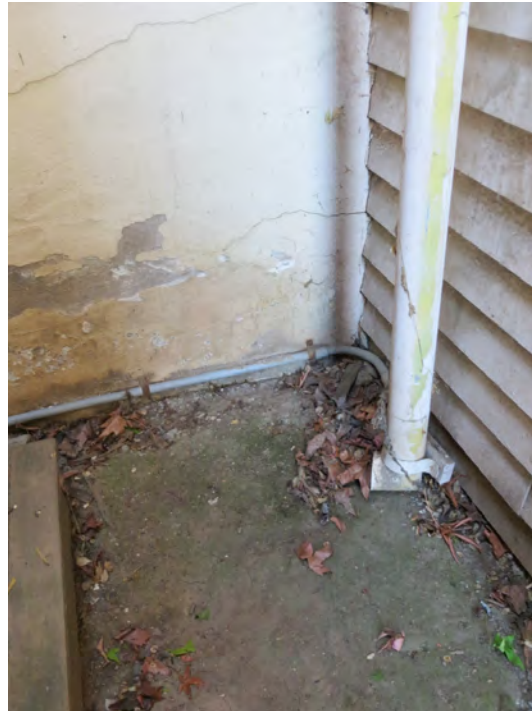
Figure 30. Downspouts on the rear elevation of the Toscano Hotel deposit rainwater at grade, directly adjacent to the building foundation. This downspout is at the northeast corner of the building (photo: Garavaglia Architecture, Inc., April 2013).

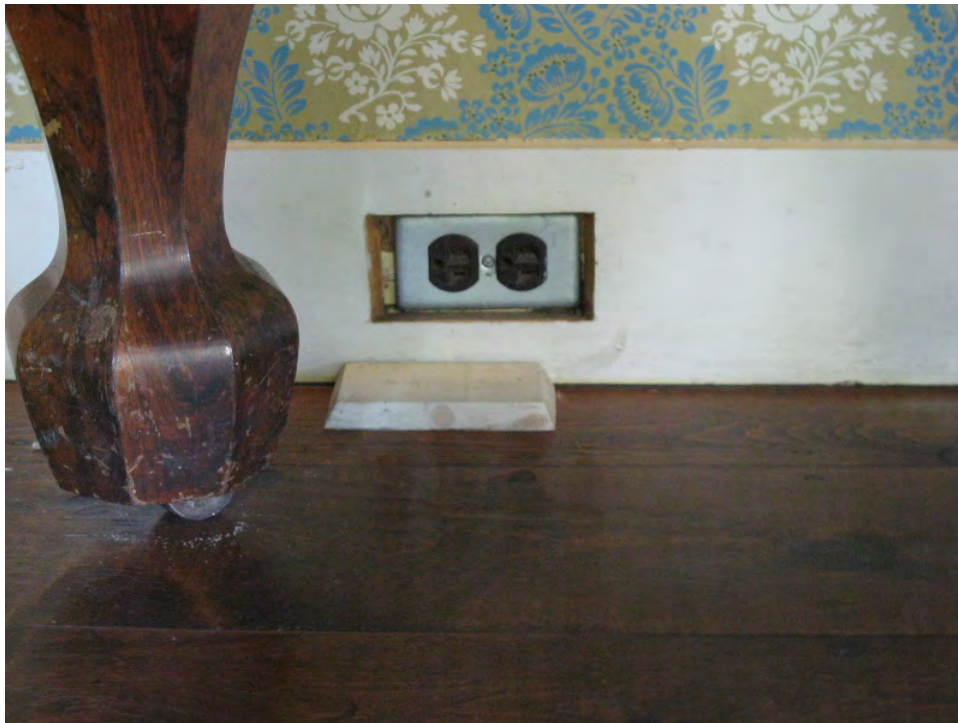
Figure 31. Modern electrical outlets are hidden behind removable panels in the Toscano Hotel (photo: Garavaglia Architecture, Inc., April 2013).

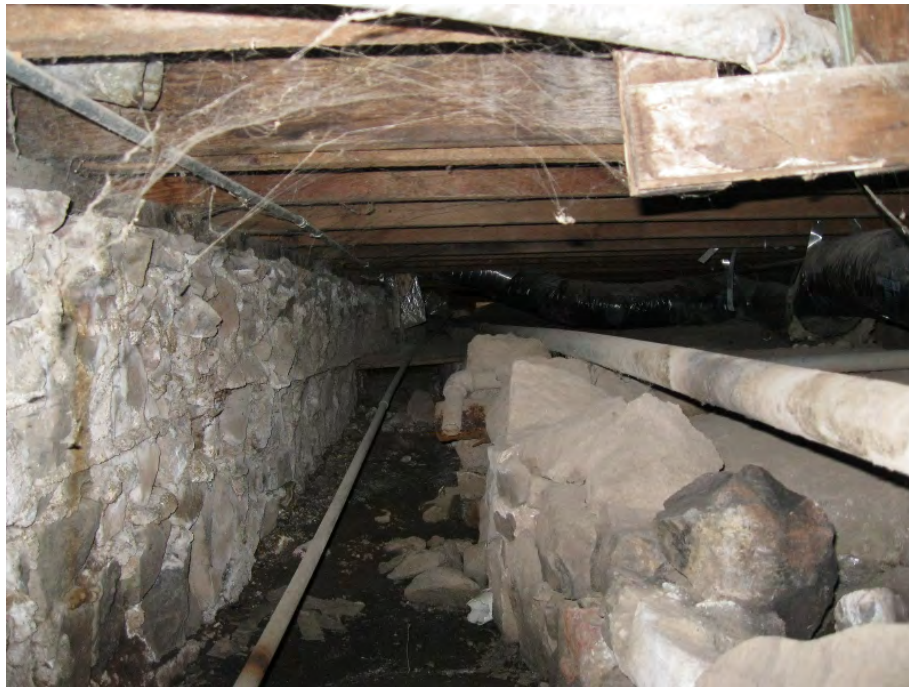
Figure 32. The Kitchen Annex has a large crawlspace and a rock foundation. A drainage pipe crosses under the building toward the street (photo: Garavaglia Architecture, Inc., April 2013).

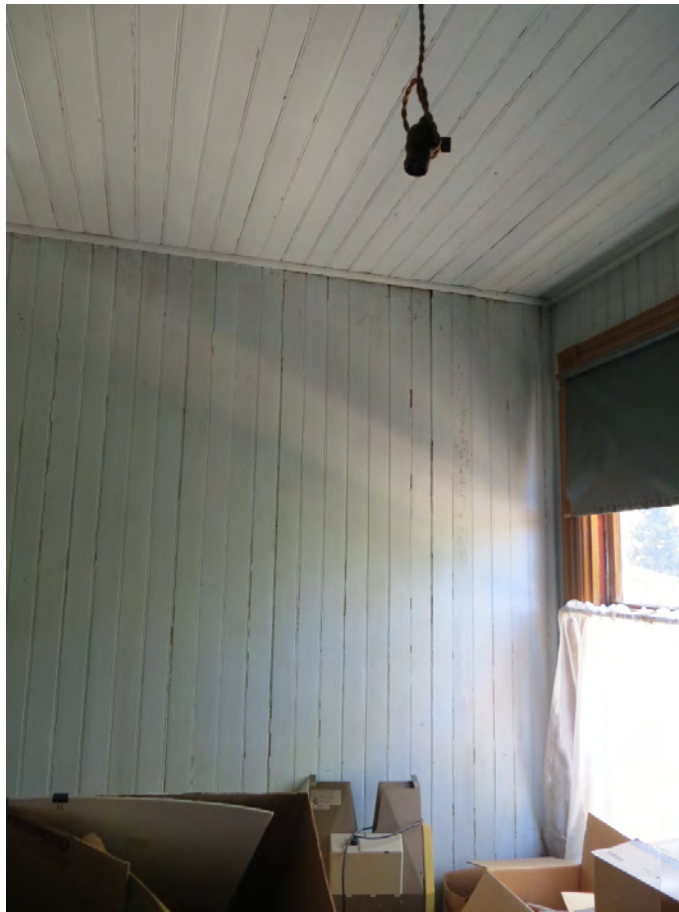
Figure 33. Leaks in the Kitchen Annex roof allow water to enter the finished rooms on the second floor. Here staining is visible where soiled water is washing down the face of the beadboard ceiling and walls (photo: Garavaglia Architecture, Inc., April 2013).

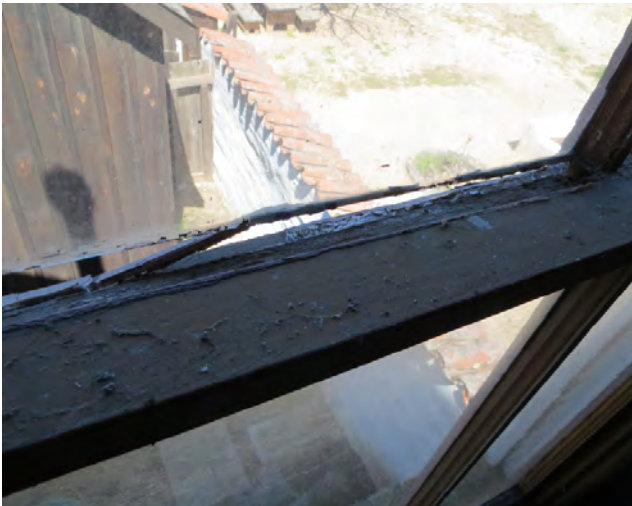
**Figure 34. Window damage is especially severe on the second floor of the Kitchen Annex. This image shows deteriorated glazing putty, missing muntin elements, and loose glass (photo: Garavaglia Architecture, Inc., April 2013).**

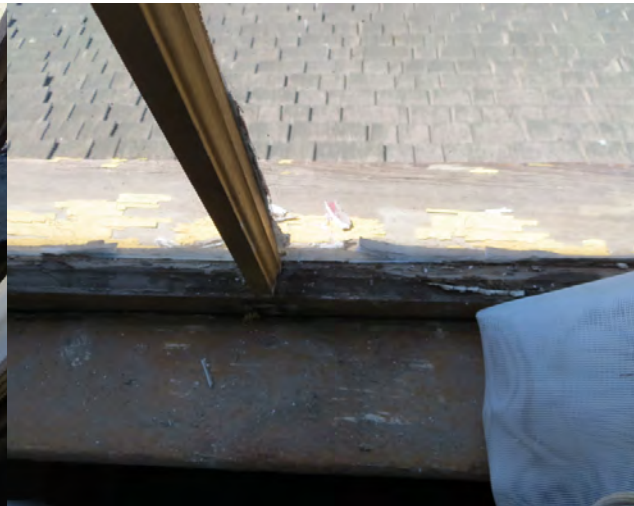
**Figure 35. Paint is weathered and no longer protects the wood substrate. This image shows the interior and exterior surfaces of a windowsill on the second floor of the Kitchen Annex (photo: Garavaglia Architecture, Inc., April 2013).**

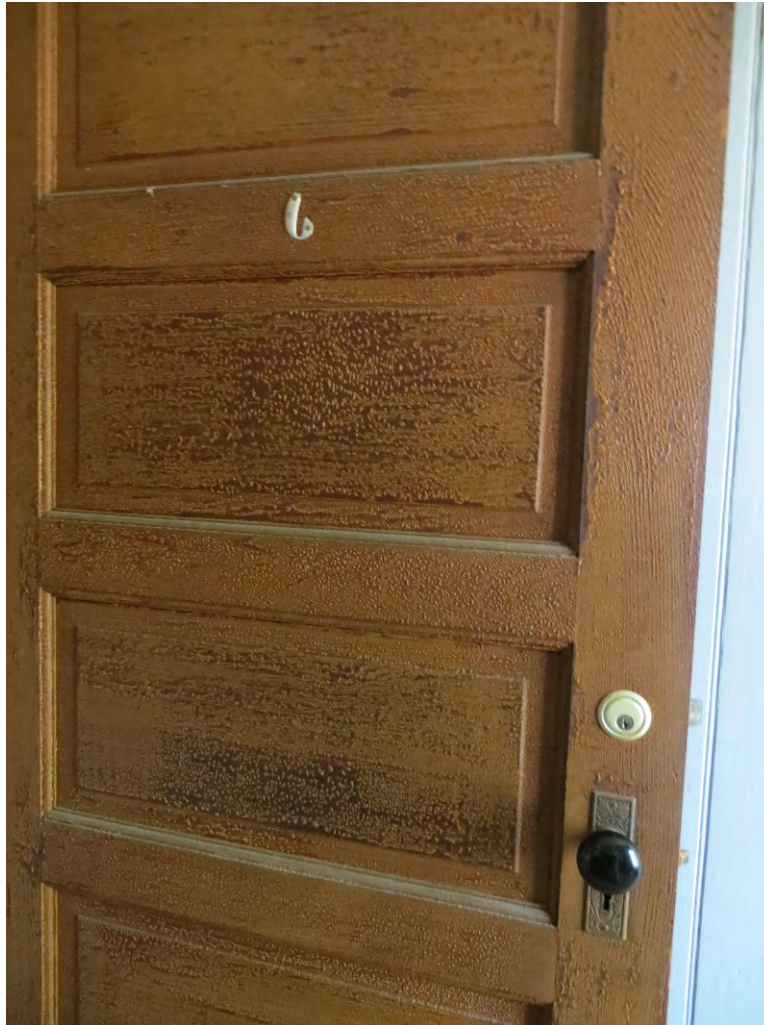
**Figure 36. The door finishes on the second floor of the Kitchen Annex are failing. The surface coating has shrunk and bubbled on the exterior face of the doors. In general, the interior faces are less damaged (photo: Garavaglia Architecture, Inc., April 2013).**

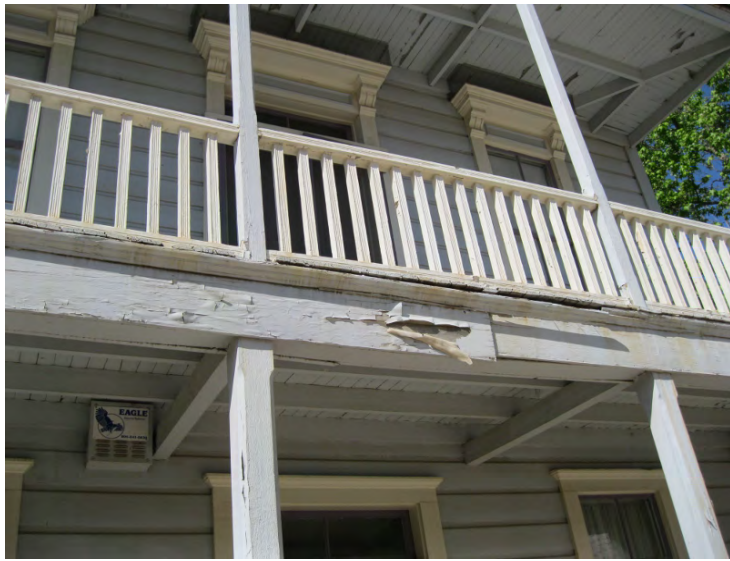
**Figure 37. Failing finishes and material deterioration are more extreme on the second floor porch of the Hotel Annex than in other locations on the building. Here paint is failing, floorboards are warping, and the railing is loose and poorly attached (photo: Garavaglia Architecture, Inc., April 2013).**

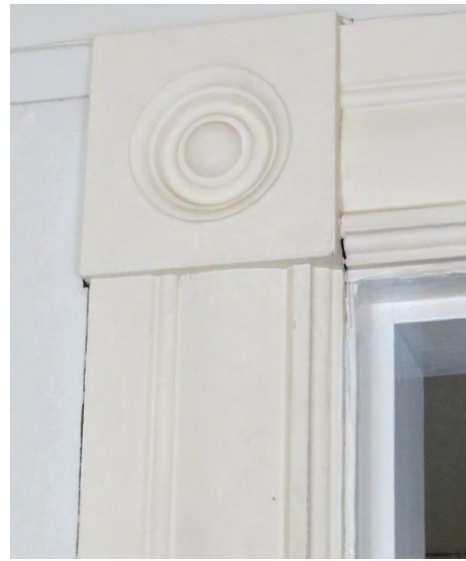
**Figure 38. Contemporary finishes have been applied over original finishes throughout the Hotel Annex. Here, 1/4" fiberboard has been installed over the original plaster walls. As a result, the original bulls-eye trim is flush with the wall surface (photo: Garavaglia Architecture, Inc., April 2013).**

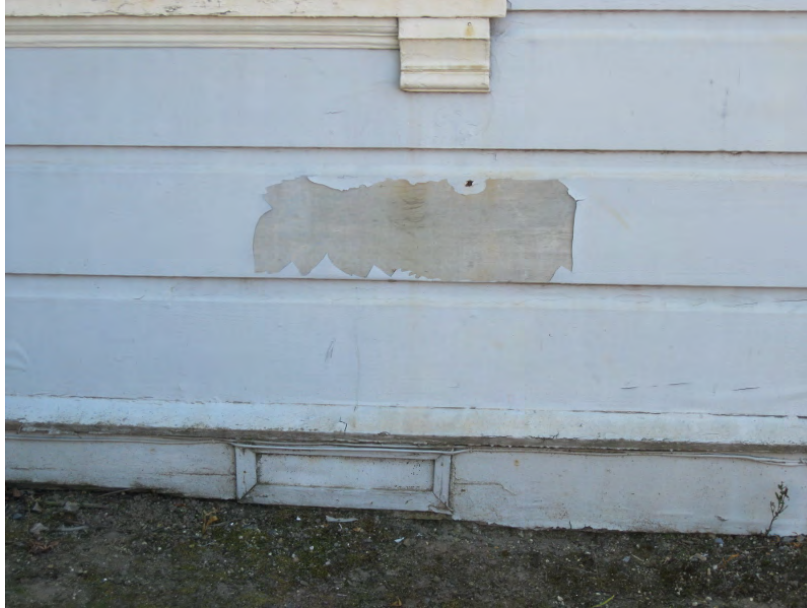
**Figure 39. Paint finishes are failing on the Hotel Annex. An earlier, similar shade of blue is visible beneath the more recent latex paint (photo: Garavaglia Architecture, Inc., April 2013).**

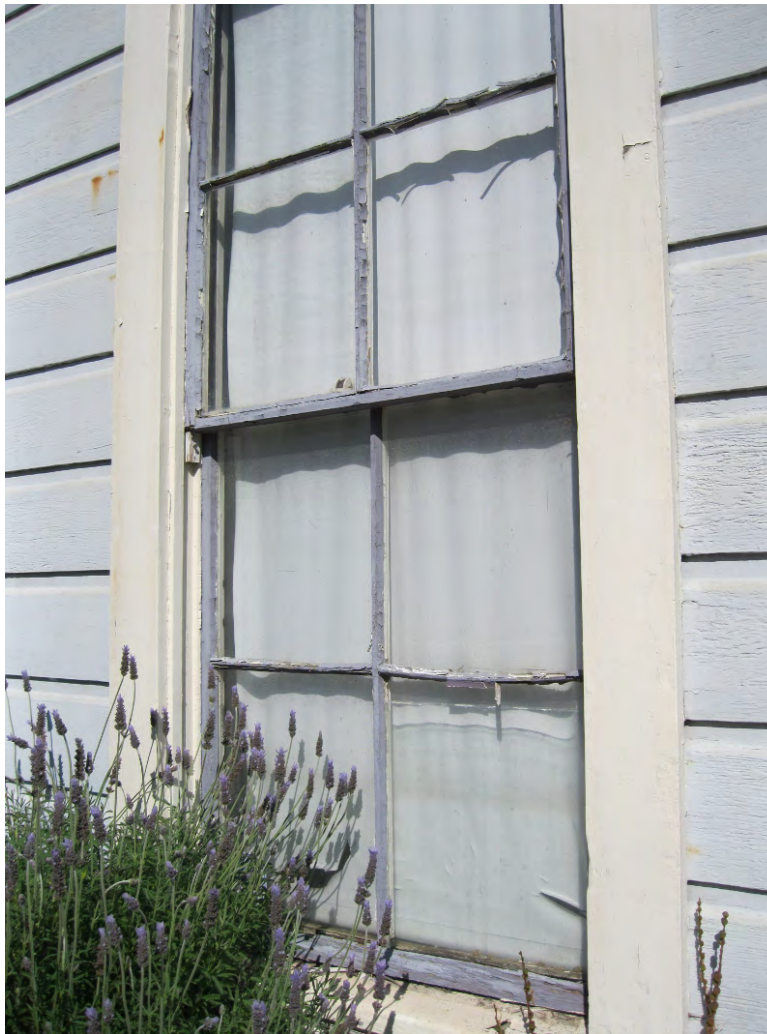
Figure 40. Windows on the west elevation of the Hotel Annex all exhibit dry and cracked glazing putty, failing paint finishes, and warping sash elements. The muntins are very thin, making them more susceptible to weathering than more contemporary designs (photo: Garavaglia Architecture, Inc., April 2013).

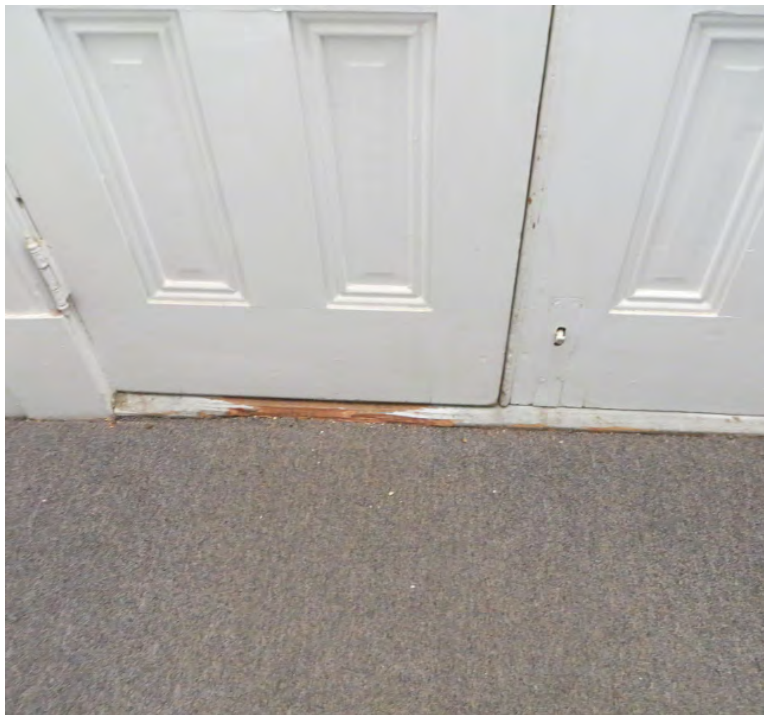
Figure 41. The front door of the Hotel Annex has a worn and damaged threshold. Otherwise, this assembly appears to be in good condition with several elements of original hardware still in place (both photos: Garavaglia Architecture, Inc., April 2013).

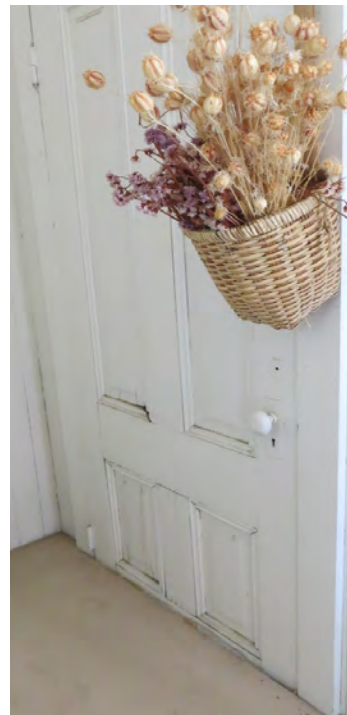
Figure 42. The east bathroom on the second floor of the Hotel Annex has been converted from part of a former bedroom. Here an original exterior door has been fixed shut and the floor raised to accommodate pipes to the fixtures.

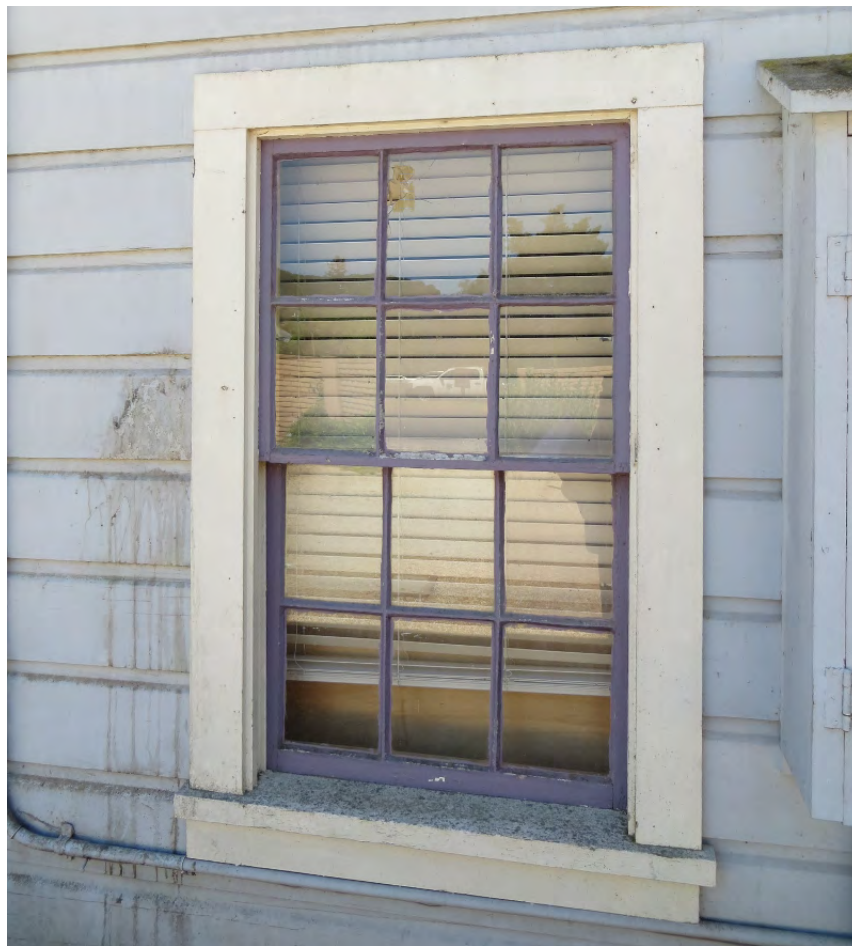
Figure 43. The first floor window on the Tank House faces north. It is fairly protected from harsh sun and winds, but still shows signs of paint failure and cracked putty (photo: Garavaglia Architecture, Inc., April 2013).

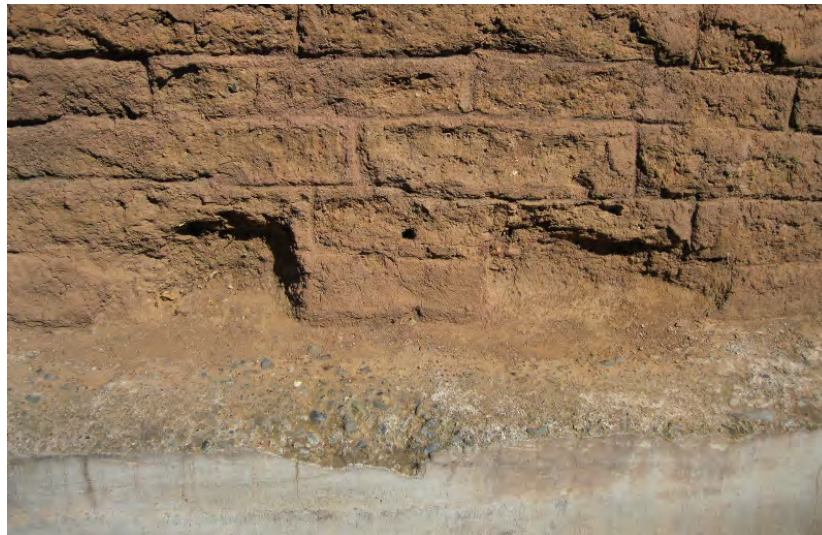
**Figure 44.** The concrete curb on the west side of the Servants' Quarters may be trapping moisture and forcing it to migrate further up the wall. As it evaporates, it can spall the fragile adobe surface (photo: Garavaglia Architecture, Inc., April 2013).

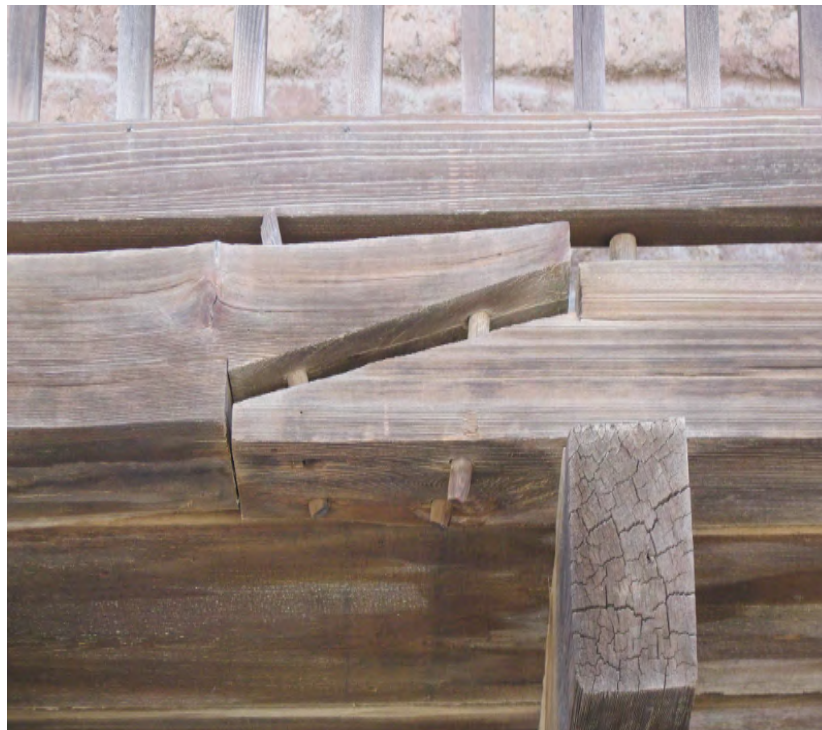
Figure 45. The exterior hallway on the east elevation of the Servants' Quarters is a contemporary version of an original feature. It was rebuilt using a combination of modern and traditional techniques. Here, an area of wood dowel pinning is starting to loosen and requires immediate attention (photo: Garavaglia Architecture, Inc., April 2013).

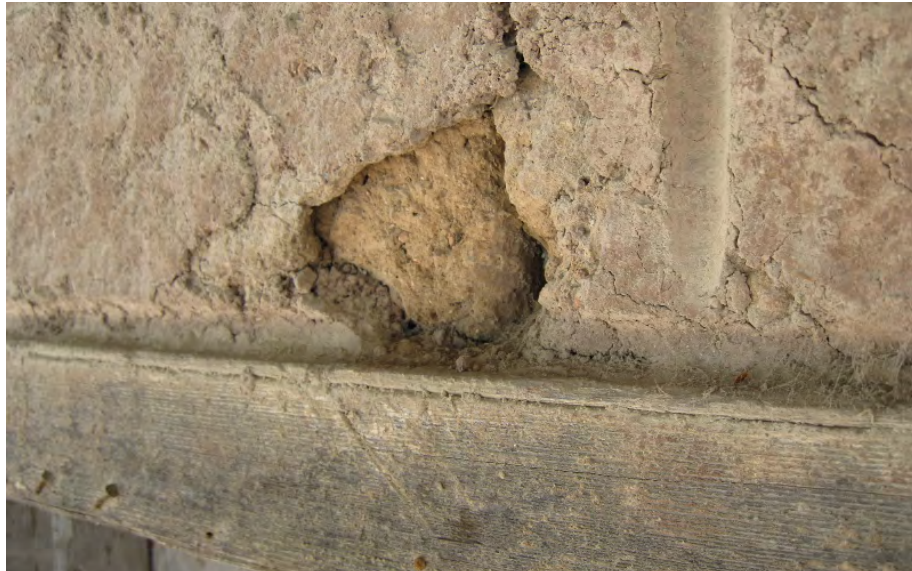
Figure 46. At an unknown time in the past, a decision was made to apply an adobe parge coat to the Servants' Quarters. This coat was then scored to resemble large adobe bricks. Now the layer is failing, sometimes spalling off in large sections to expose the original adobe beneath (photo: Garavaglia Architecture, Inc., April 2013).

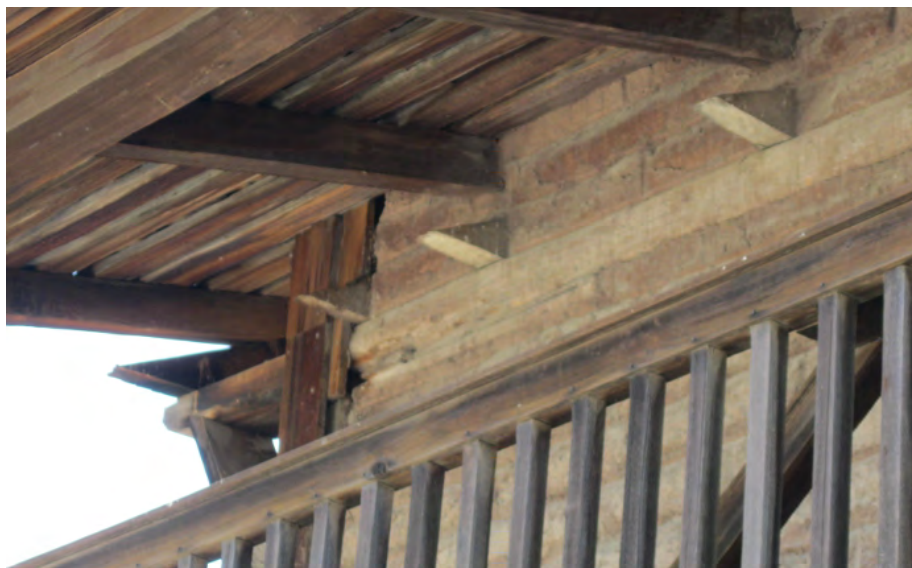
Figure 47. Birds are nesting in the south wall of the Servants' Quarters. Here a double layer of wood siding is filled with adobe and straw. The birds are getting into this interstitial space at the southwest corner (shown) (photo: Garavaglia Architecture, Inc., April 2013).

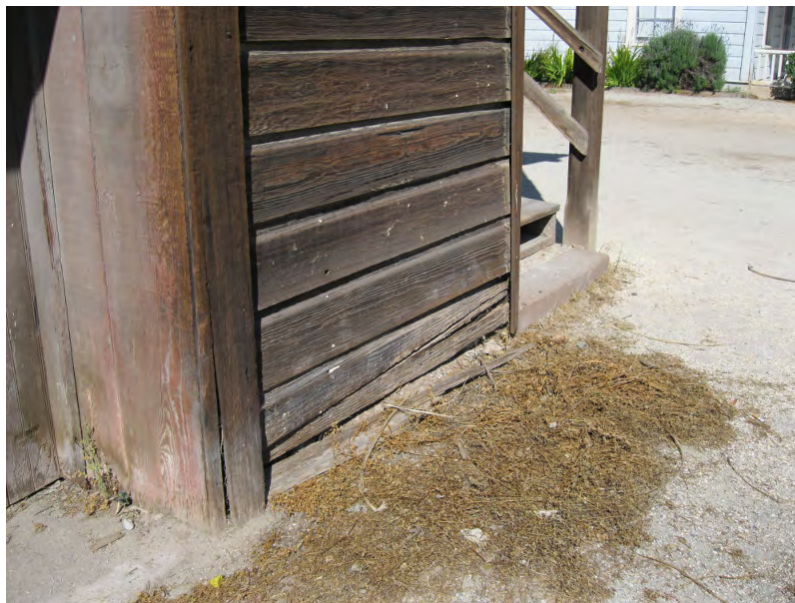
Figure 48. As the birds are nesting, they are pushing building materials out through gaps in the wood boards. Here straw from the adobe insulating fill has been deposited at the base of the wall (photo: Garavaglia Architecture, Inc., April 2013).

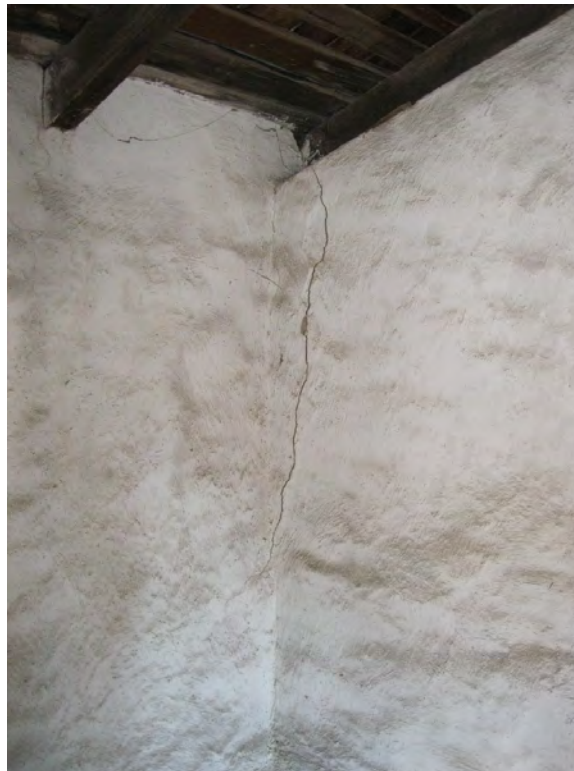
Figure 53. This is an example of the types of corner cracks found on the second floor of the Servants' Quarters.

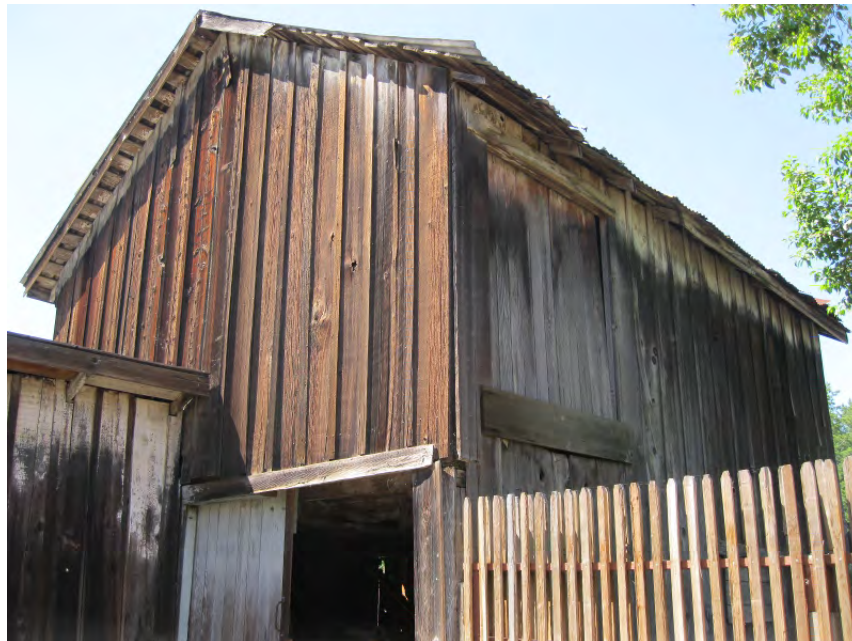
**Figure 54. The barn was once whitewashed. Traces of the finish are visible on the protected areas immediately under the eaves.**

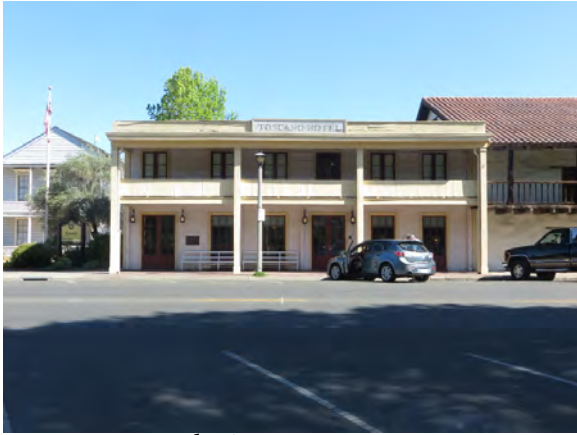
Figure A1. South elevation.

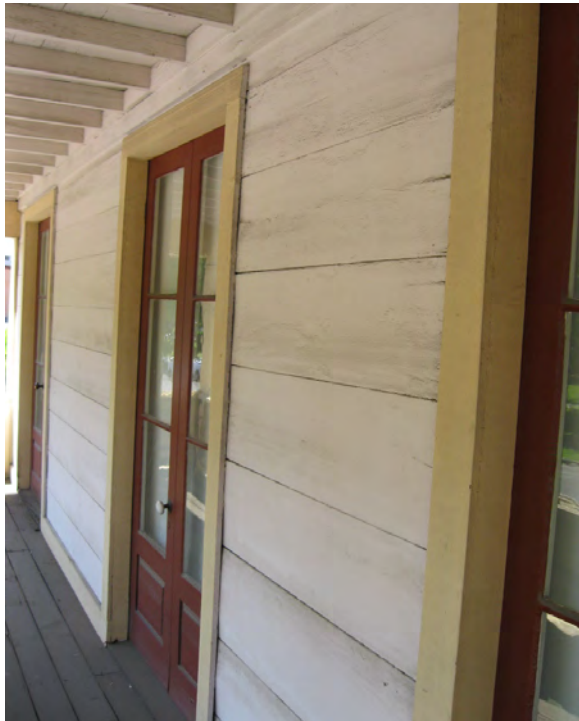
Figure A8. The siding under the porch on the second floor appears to be original. Note the large width of the siding boards.

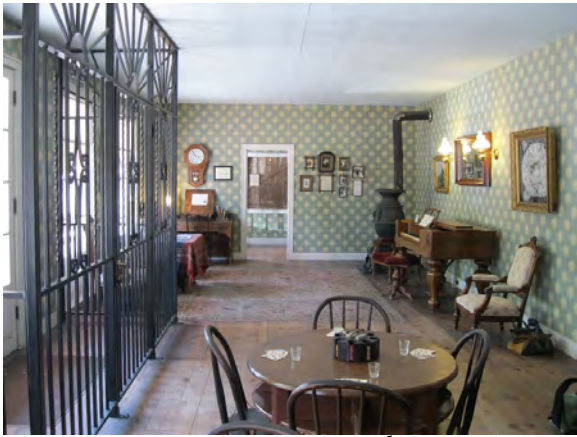
Figure A9. Bar and restaurant exhibit, looking west.

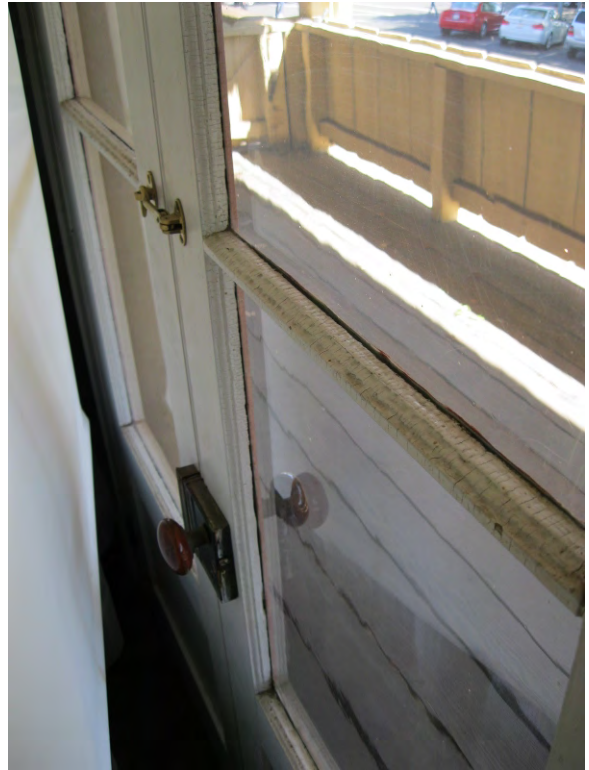
Figure A21. Wavy glass and early hardware are found on the second floor hallway doors to the balcony.

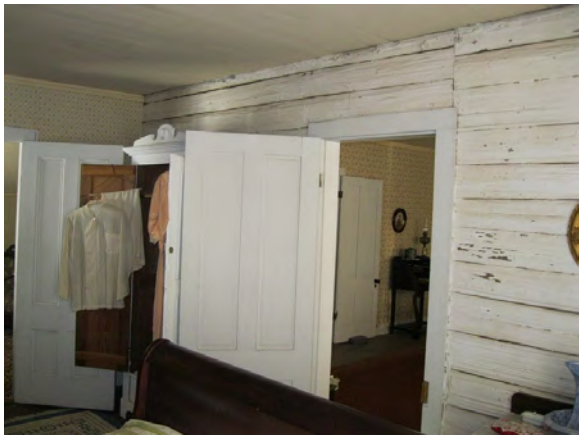
Figure A22. The southwest room has one wall of horizontal boards exposed, demonstrating the rough construction of the partitions.

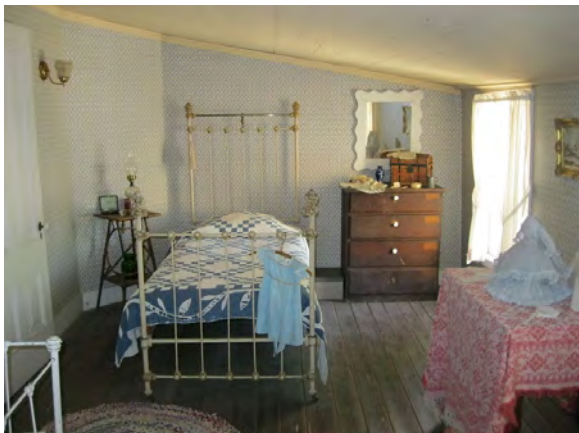
Figure A23. A bedroom in the rear, shed addition on the second floor.

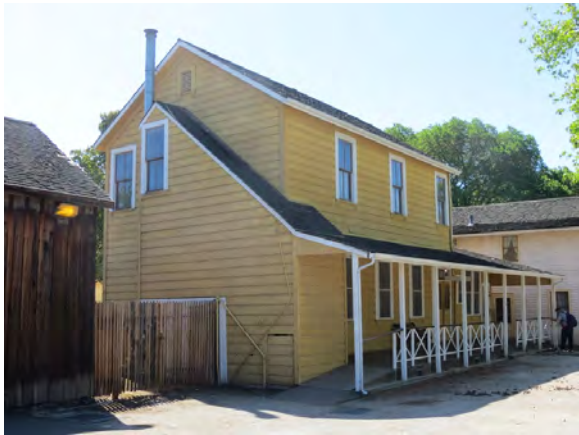
Figure A24. North and west elevations. The Toscano Hotel is visible in the background at the far right.

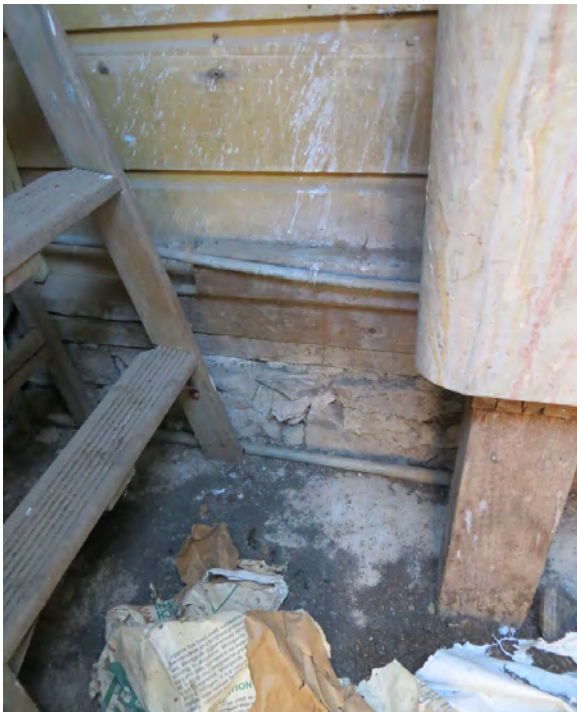
Figure A30. Detail of the stone foundation, as viewed from a utility shed on the north elevation.

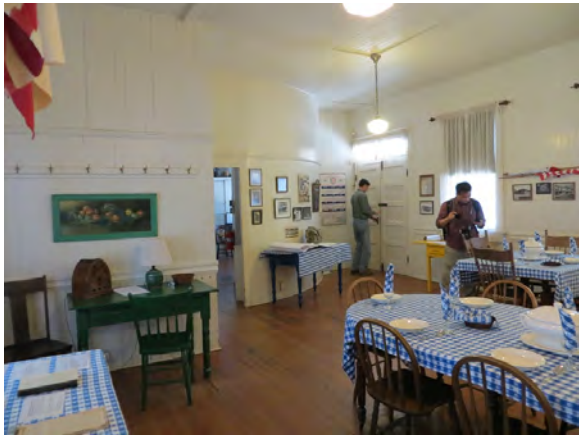
Figure A31. Dining room interpretive space, looking southwest

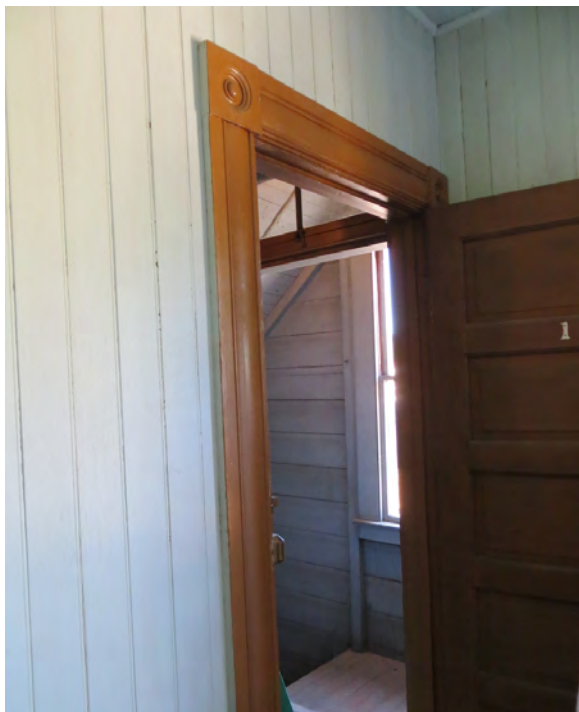
Figure A38. Second floor rooms as bulls-eye molding and 5-panel doors, like those found in the Hotel Annex.

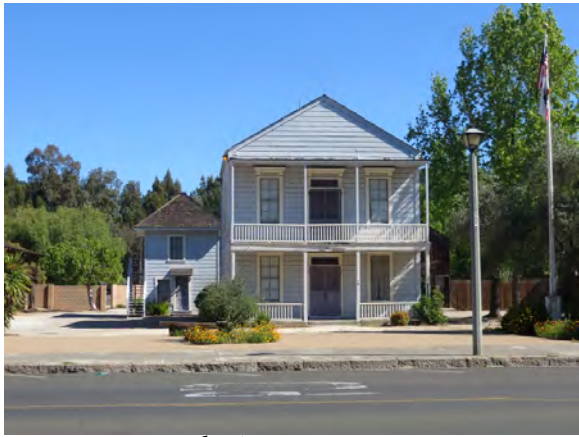
Figure A39. South elevation.

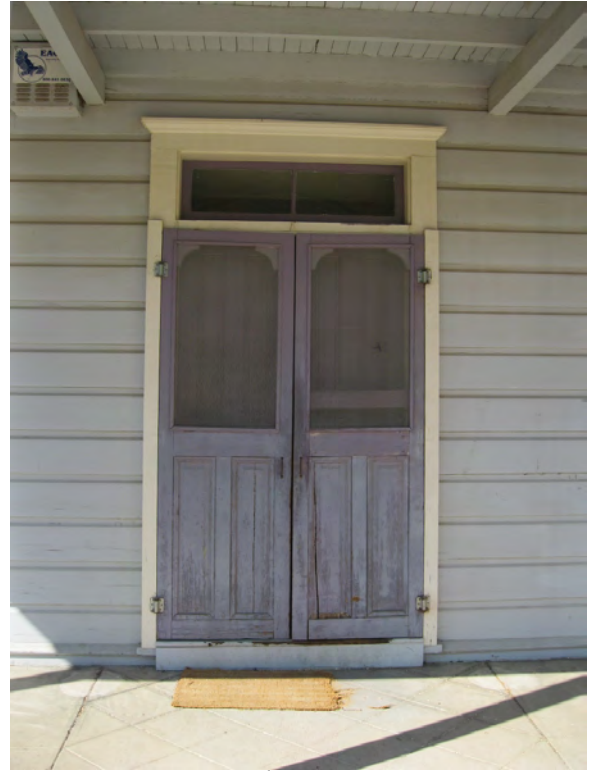
Figure A45. Detail of the front screen doors.  
There is damage to the eastern door.

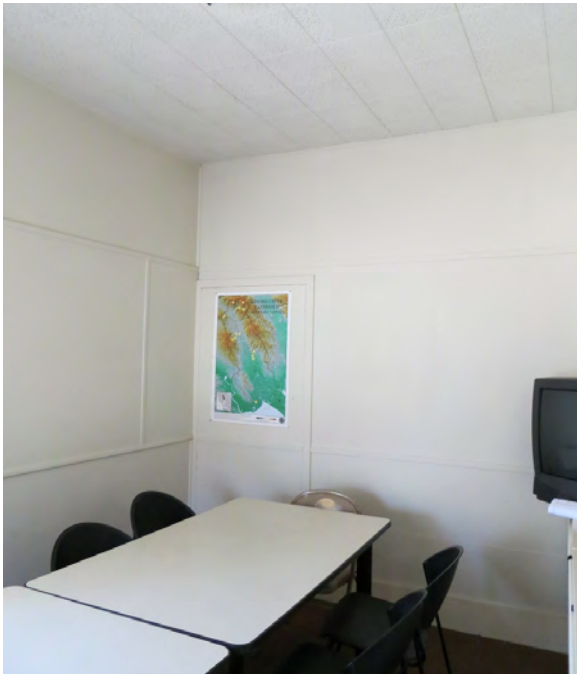
Figure A46. Typical room with contemporary finishes.
