# Toscano Hotel Complex and Servants' Quarters Historic Structures Report

**Prepared for**  
California State Parks  
Archeology, History and Museums Division  
Sacramento, California

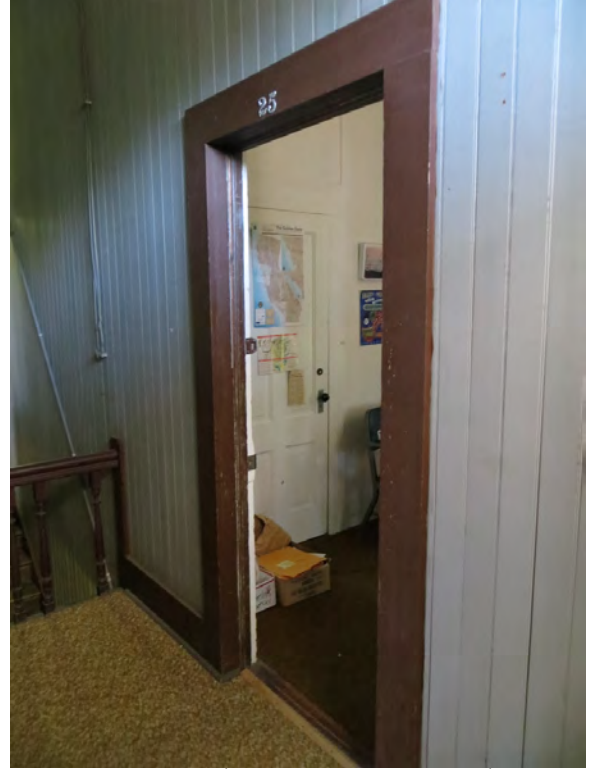
Figure A55. Note the simplified trim on the second floor. Original room numbers are still present.

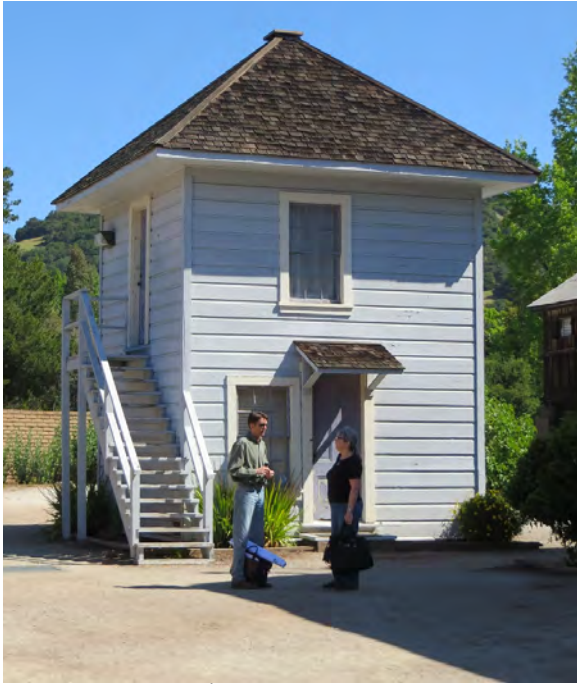
Figure A56. South elevation.

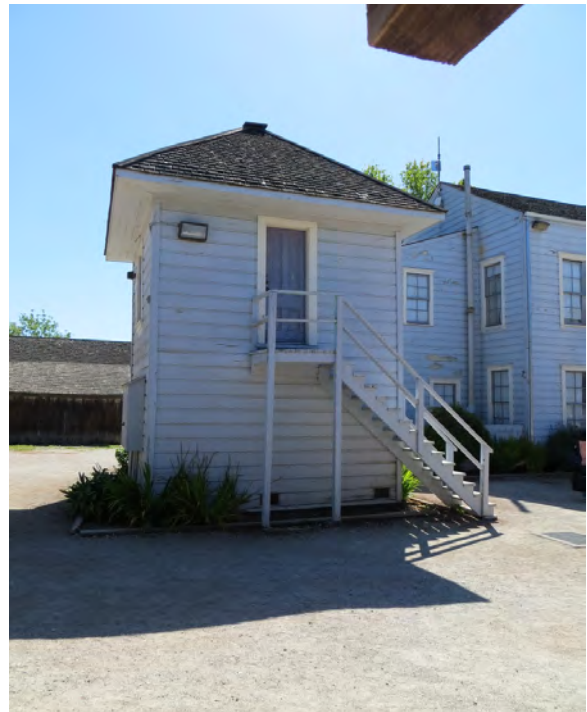
Figure A59. West elevation with exterior stair

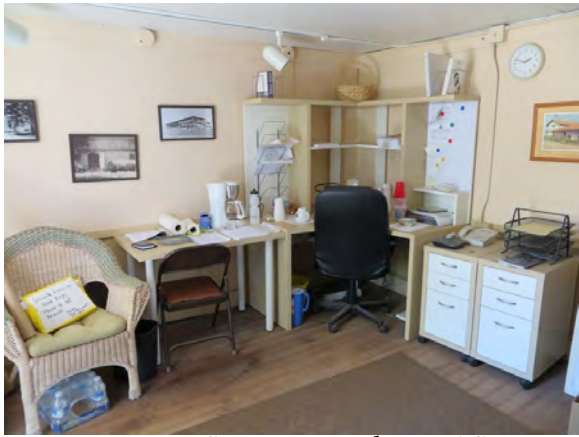
Figure A60. First floor room with wood floors, beadboard wainscot and ceiling, and fiberboard walls.

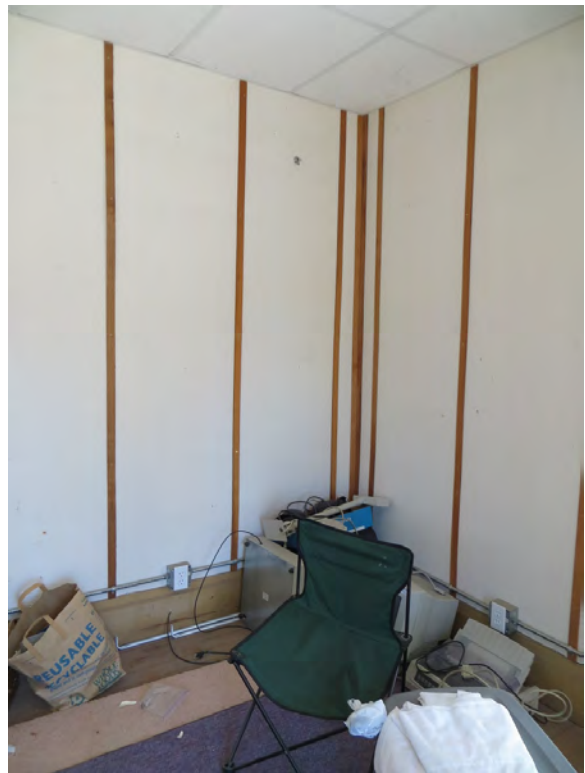
Figure A63. There are no uses currently in the second floor room of the Tank House

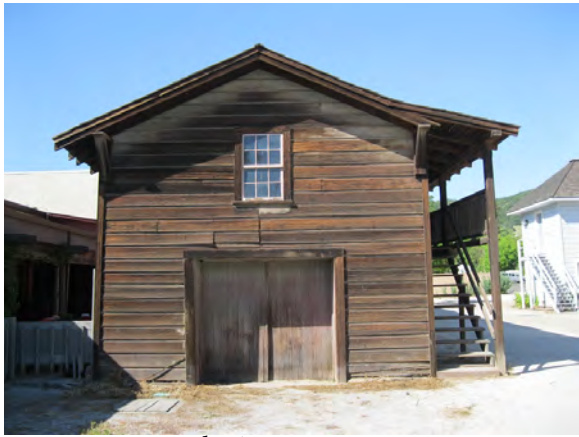
Figure A64. South elevation.

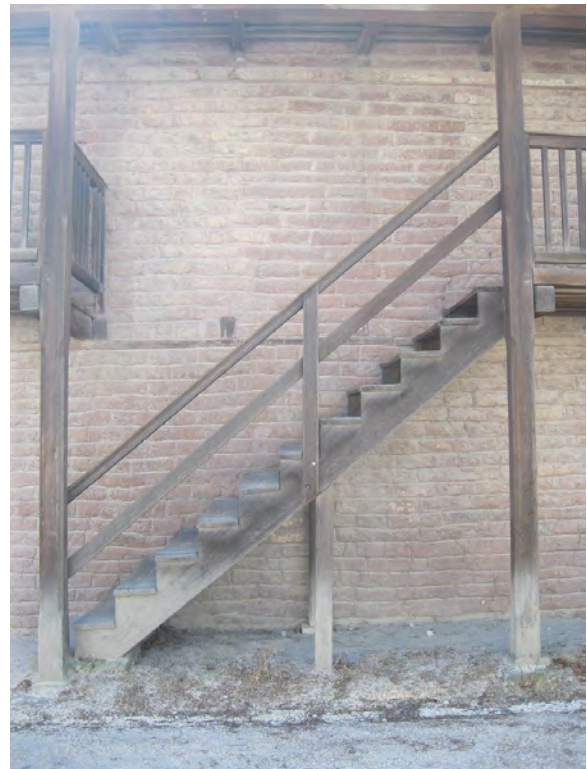
Figure A73. Detail of one of two stairs to the second floor balcony. Note the staining on the columns from water backsplashing

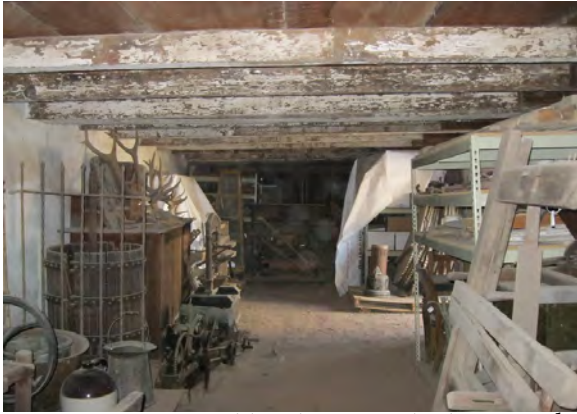
Figure A74. Ground level storage, looking north.

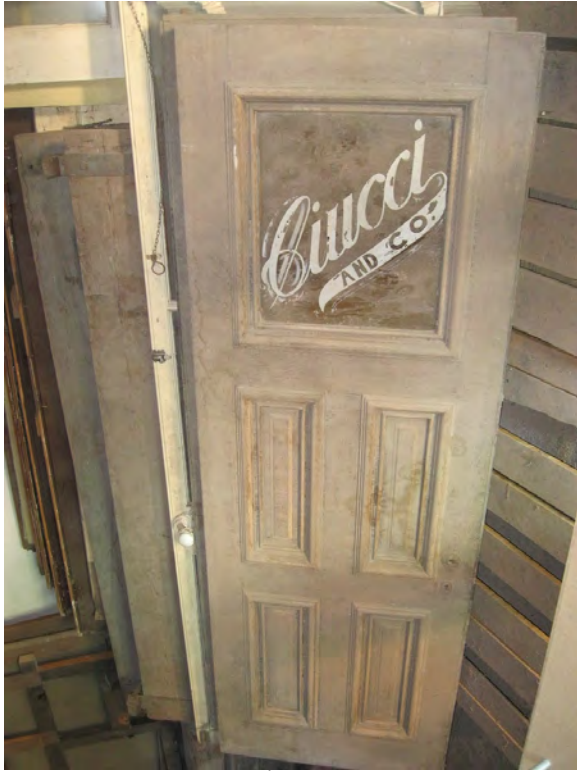
Figure A84. Detail of the former front doors on the Toscano Hotel. They are in storage in the Servants' Quarters.

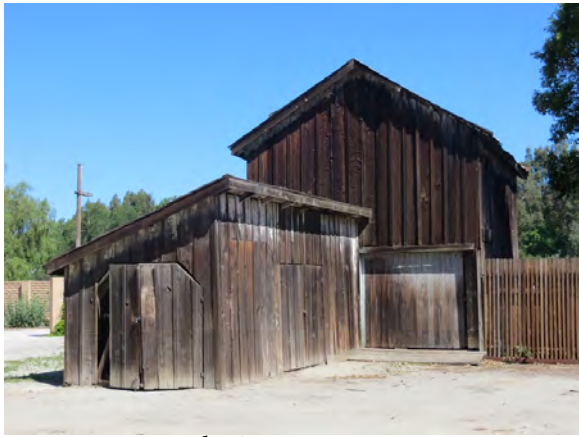
Figure A85. South elevation.

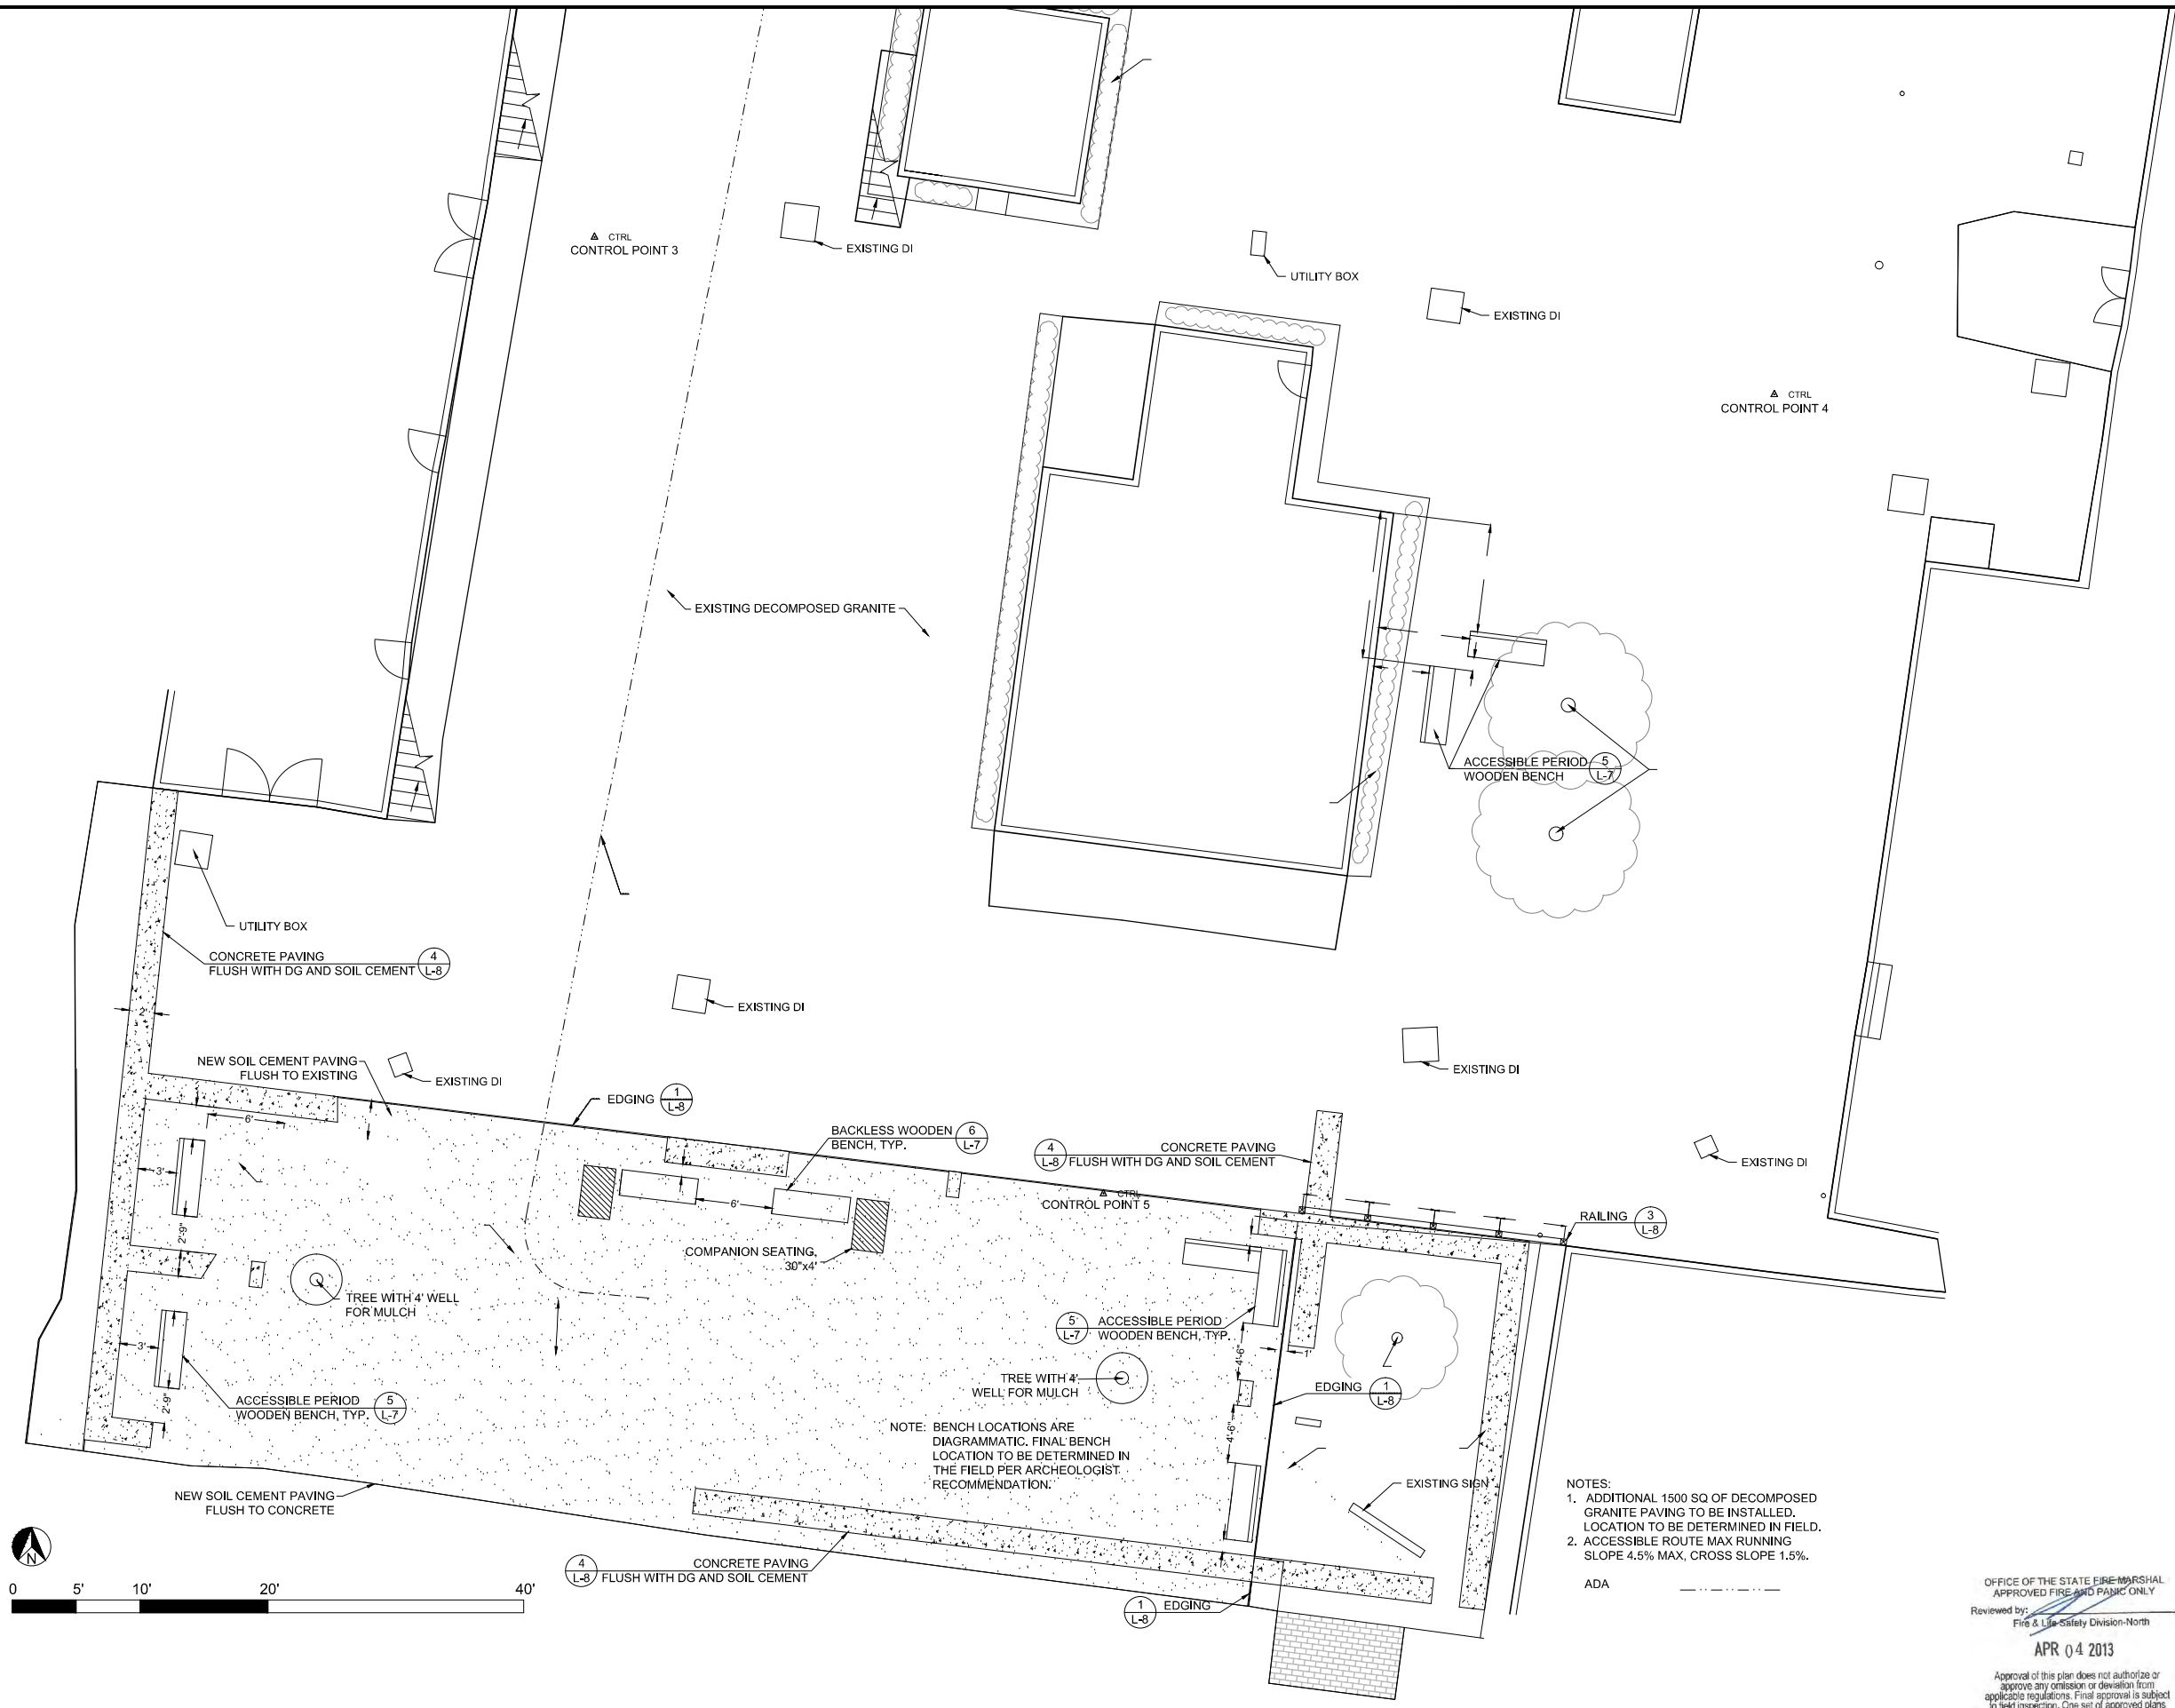
NOTE: BENCH LOCATIONS ARE DIAGRAMMATIC. FINAL BENCH LOCATION TO BE DETERMINED IN THE FIELD PER ARCHEOLOGIST RECOMMENDATION.
