Año Nuevo Island Light Station

*Documentation of the Light Station Complex
Año Nuevo Island,
Año Nuevo State Reserve, San Mateo County, California*

June 2005

Matt C. Bischoff
Historian II
California State Parks
Northern Service Center
Sacramento, CA

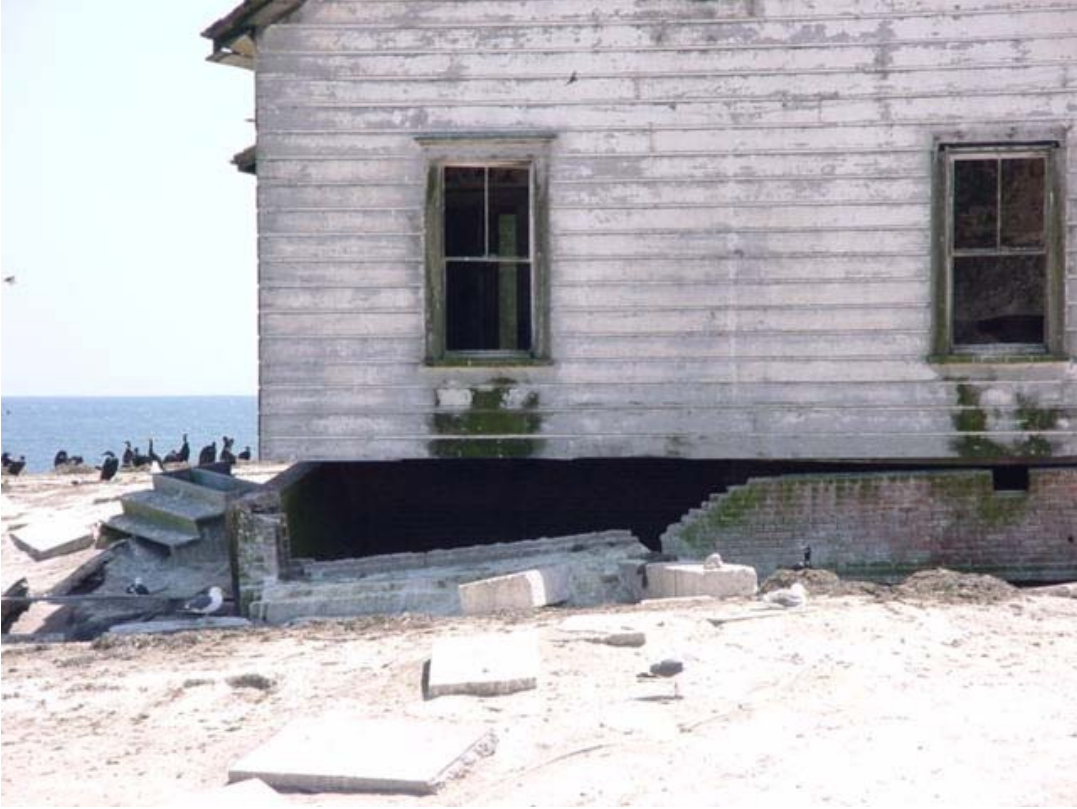
Figure 43. Keeper's dwelling, original portion, showing brick foundation and deterioration to north corner, 2005.

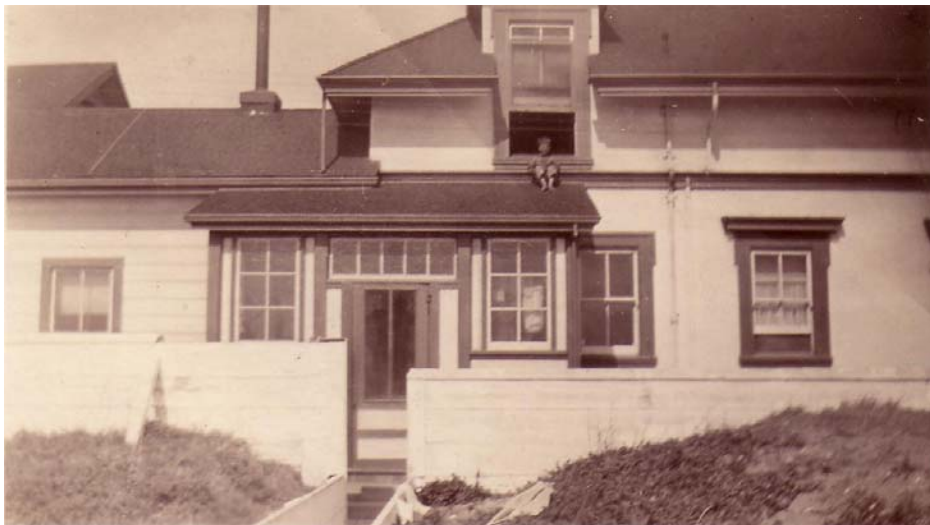
Figure 45. Rear (west) of keeper's dwelling (1906 addition), showing separation between original building (on left), and addition on right, 1926. Jack Chambers photograph, California State Parks.

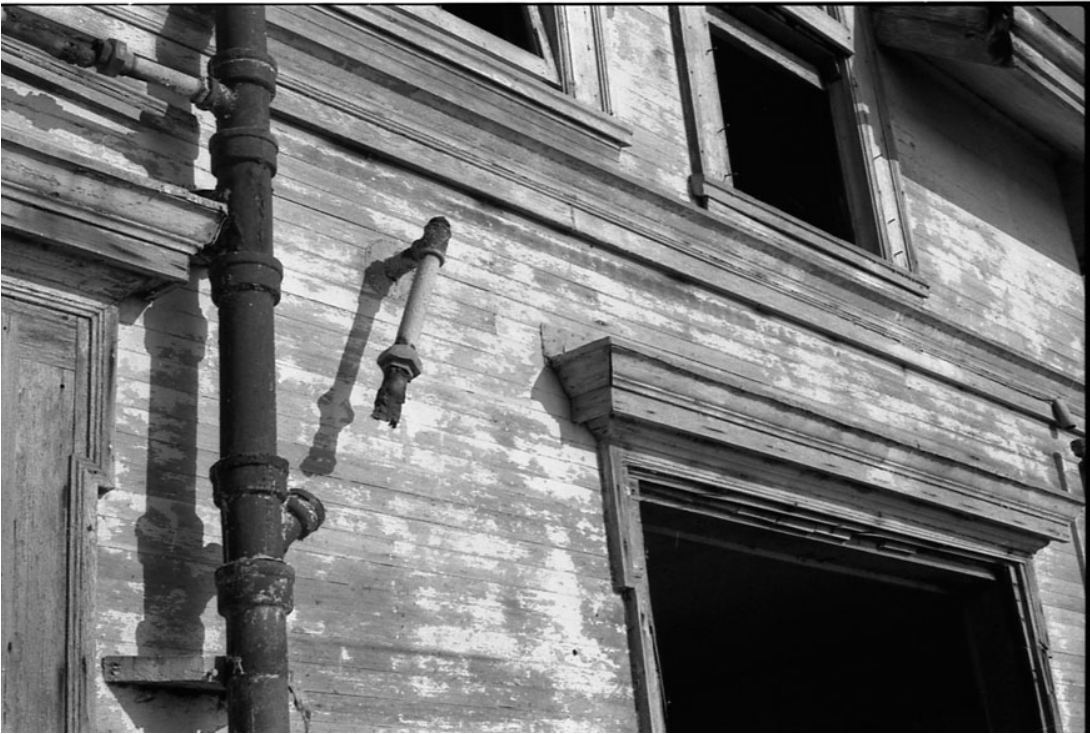
Figure 49. Exterior of west wall, keeper's dwelling (1906 addition), showing broken iron pipes, window frames, and molding, 1982. Catalog #24736, California State Parks, Archaeology Laboratory, West Sacramento.

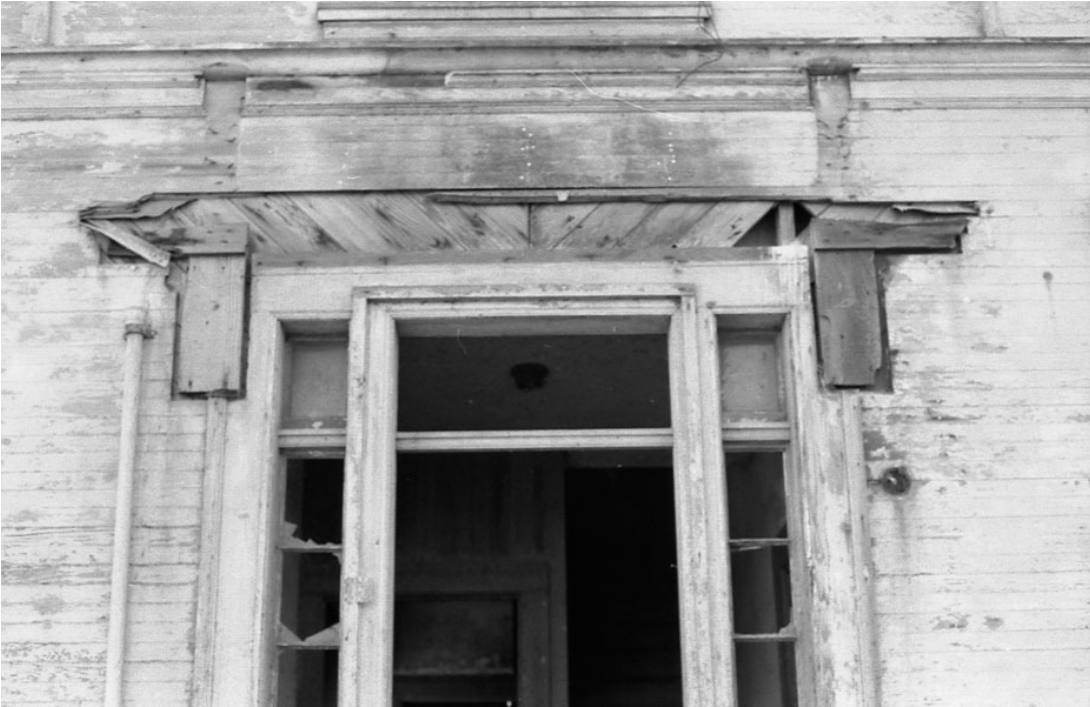
Figure 50. Front (east) entrance to keeper's dwelling (1906 addition), 1982. Note scar from portico and boarded transom. Catalog #24740, California State Parks, Archaeology Laboratory, West Sacramento.

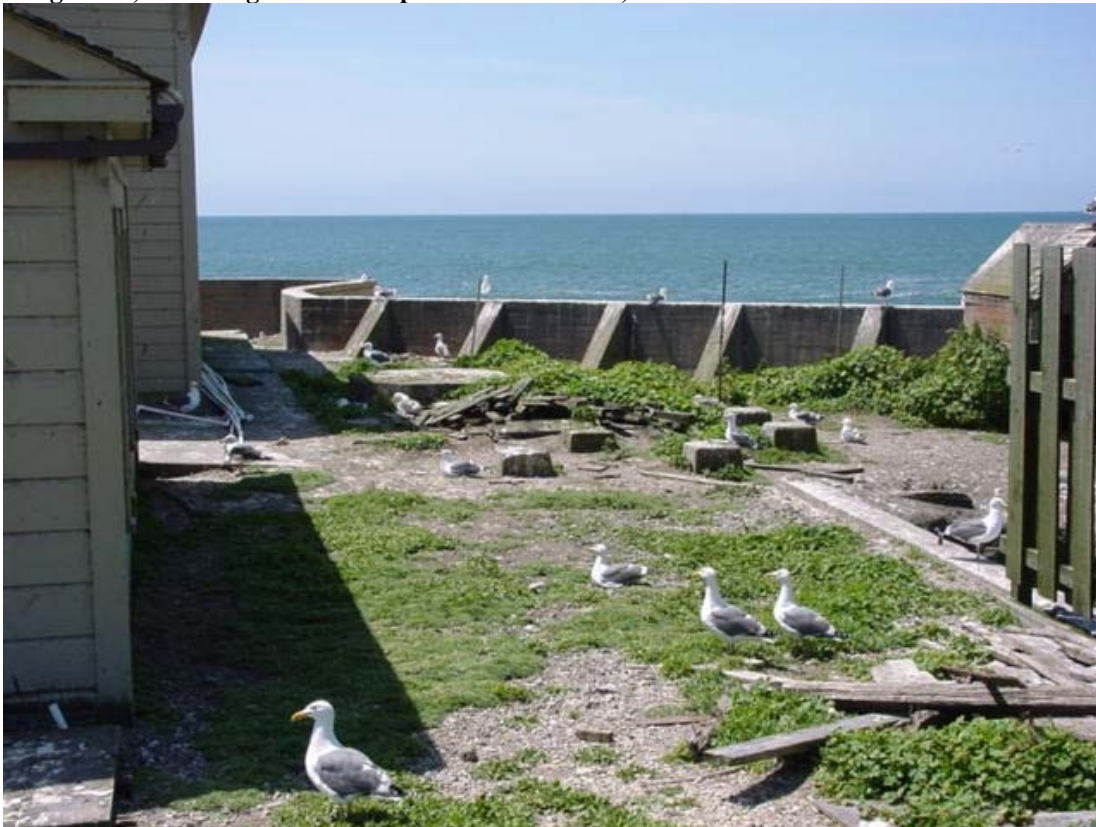
Figure 87. Foundation for water tank adjacent to fog signal building, 2005. Concrete retaining wall is visible at rear.

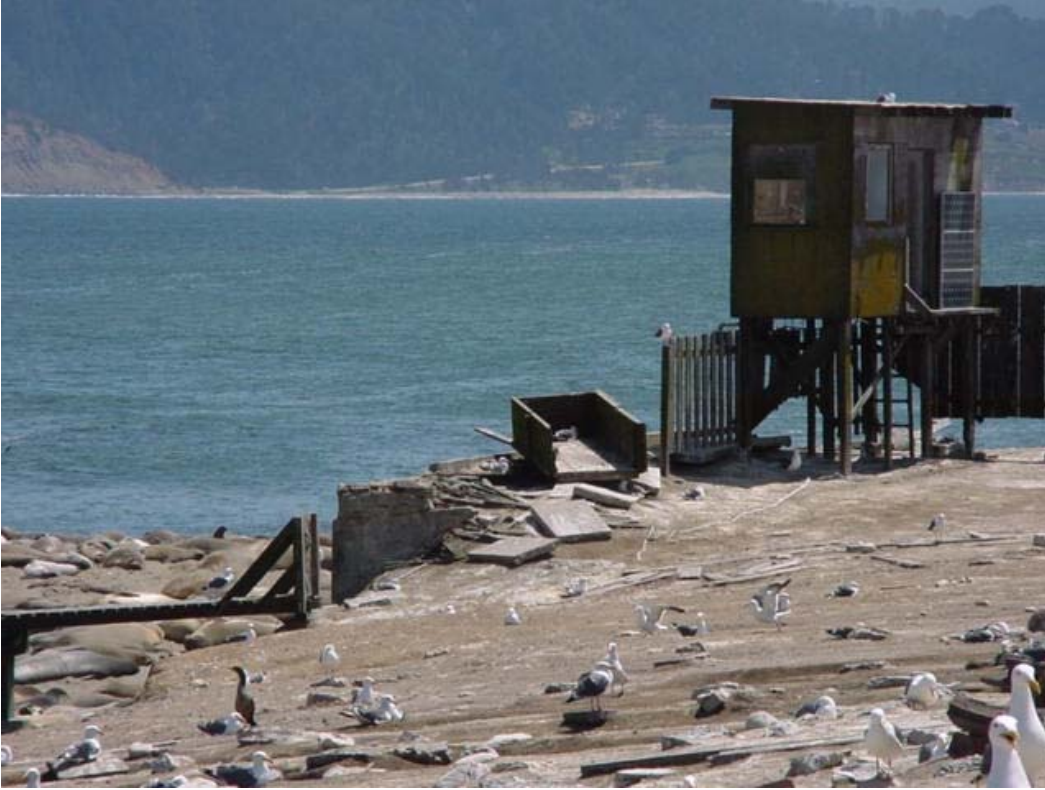
Figure 95. Foundation of boathouse to left of modern blind, 2005. Pier is visible at left.

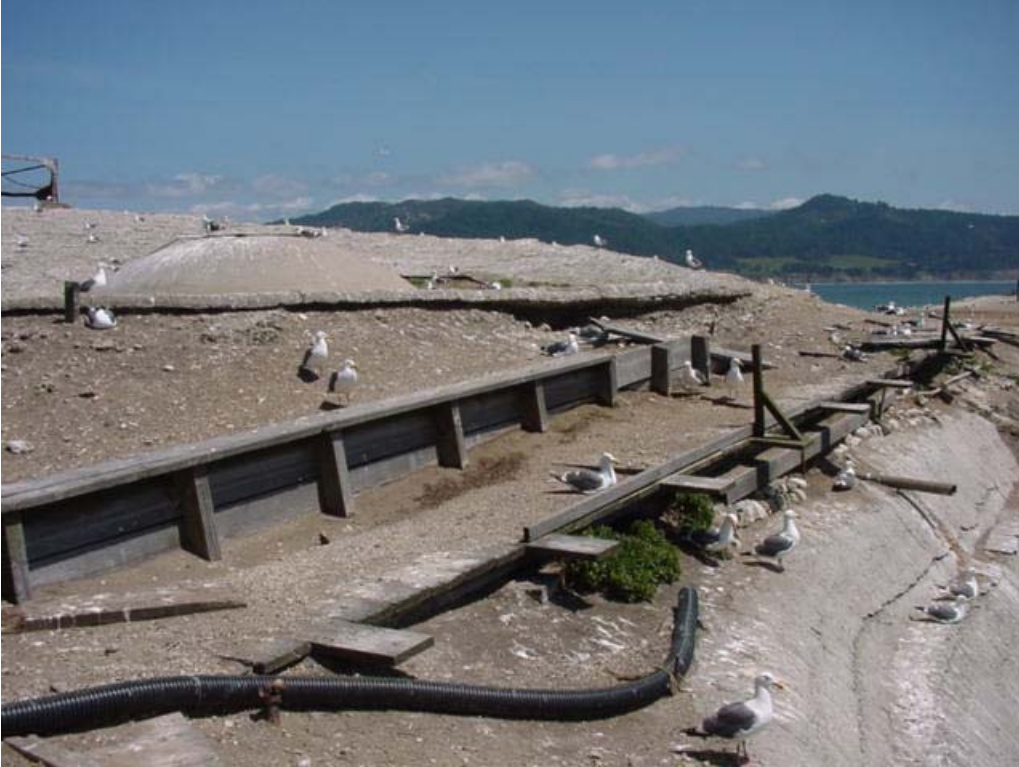
Figure 103. Remains of wood walkway connecting keeper's dwelling with fog signal building, 2005.

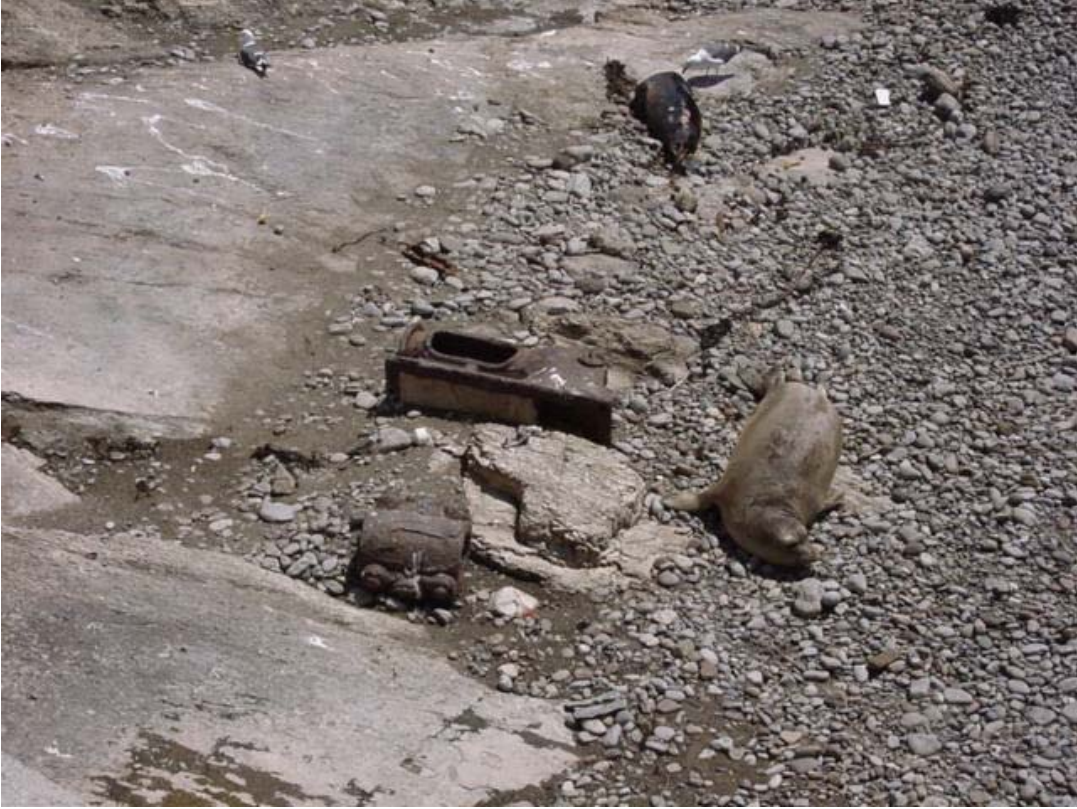
Figure 109. Various iron refuse on beach on southwest portion of island, 2005.
