**Subject** : Pilarcitos Bridge Structural Condition Assessment  
Half Moon Bay State Beach

# **HALF MOON BAY STATE BEACH PILARCITOS BRIDGE**

## **STRUCTURAL CONDITION ASSESSMENT FINAL REPORT**

Subject: Half Moon Bay State Beach – Pilarcitos Bridge Structural Assessment

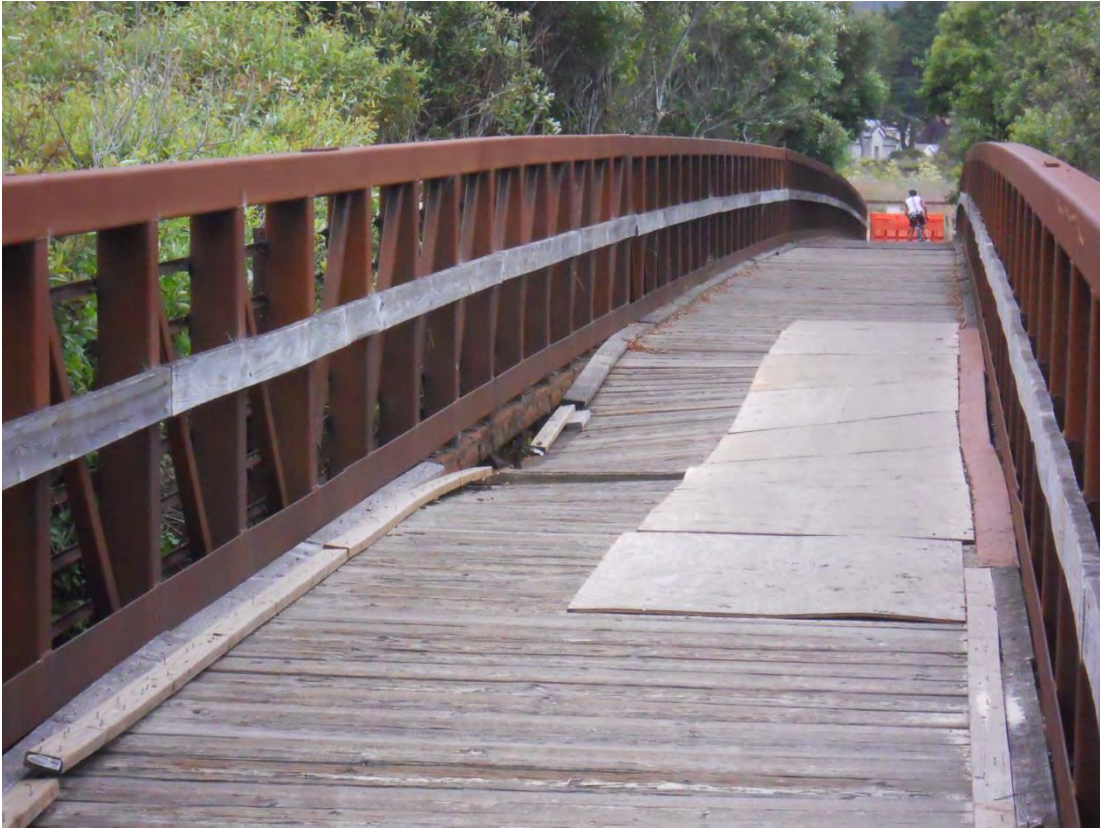
*Floor Beams:* Floor beams at west end bays 1 through 7 were 100% corroded and detached at the north truss. Other beams were still attached at the truss but had end corrosion 75% to 95%.

Collapsing Portion of Deck – Span 1 (Note Public Use)

1. Bridges should be replaced with new pre-manufactured bridge elements.
2. Safety measures should be taken to protect the public from using the spans. We suggest the immediate removal of floor deck members from the abutments at each end to at least 30 to 40 feet onto each of the end spans. The remaining elevated deck should be barricaded/ fenced at that point to keep the public from climbing onto the bridge deck.
3. Bridge materials should be selected to take into consideration the proximity to the ocean in regard to salt exposure. FRP is a likely choice for the coastal environment. Self-weathering steel would only be considered if the steel wall thickness was increased on all members to provide an acceptable life expectancy of the structure. A corrosion expert should be consulted if this approach is considered.

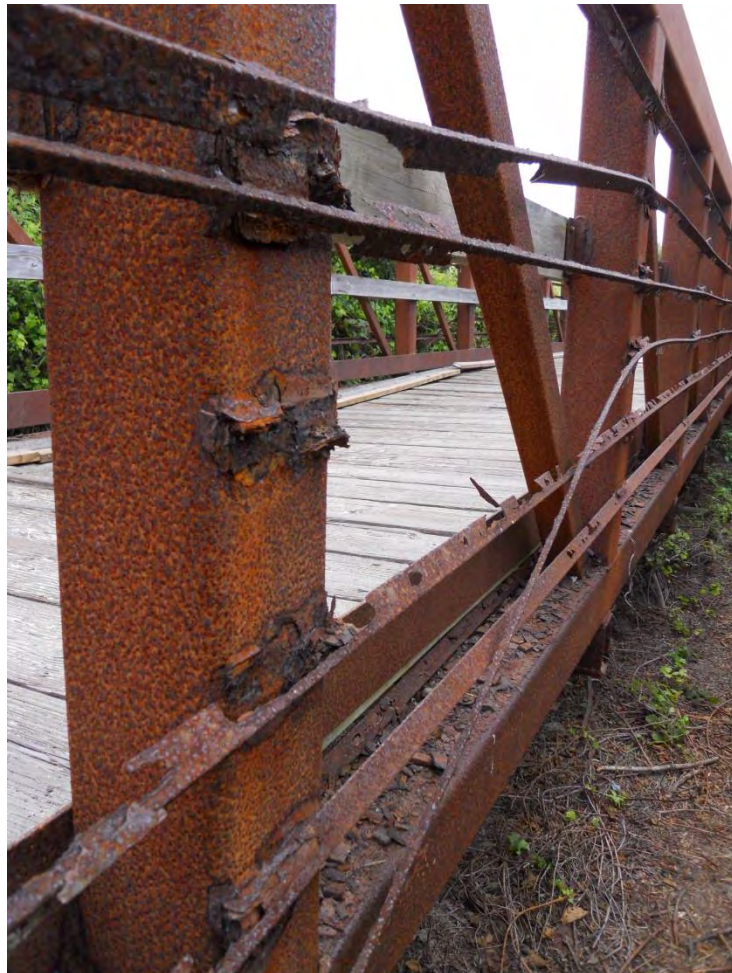
*Guard rail Angles:* Guard rail angles were 100% corroded at the west half of the span and around 50% to 75% at the remainder.

Typical Corrosion at Guardrail Runners

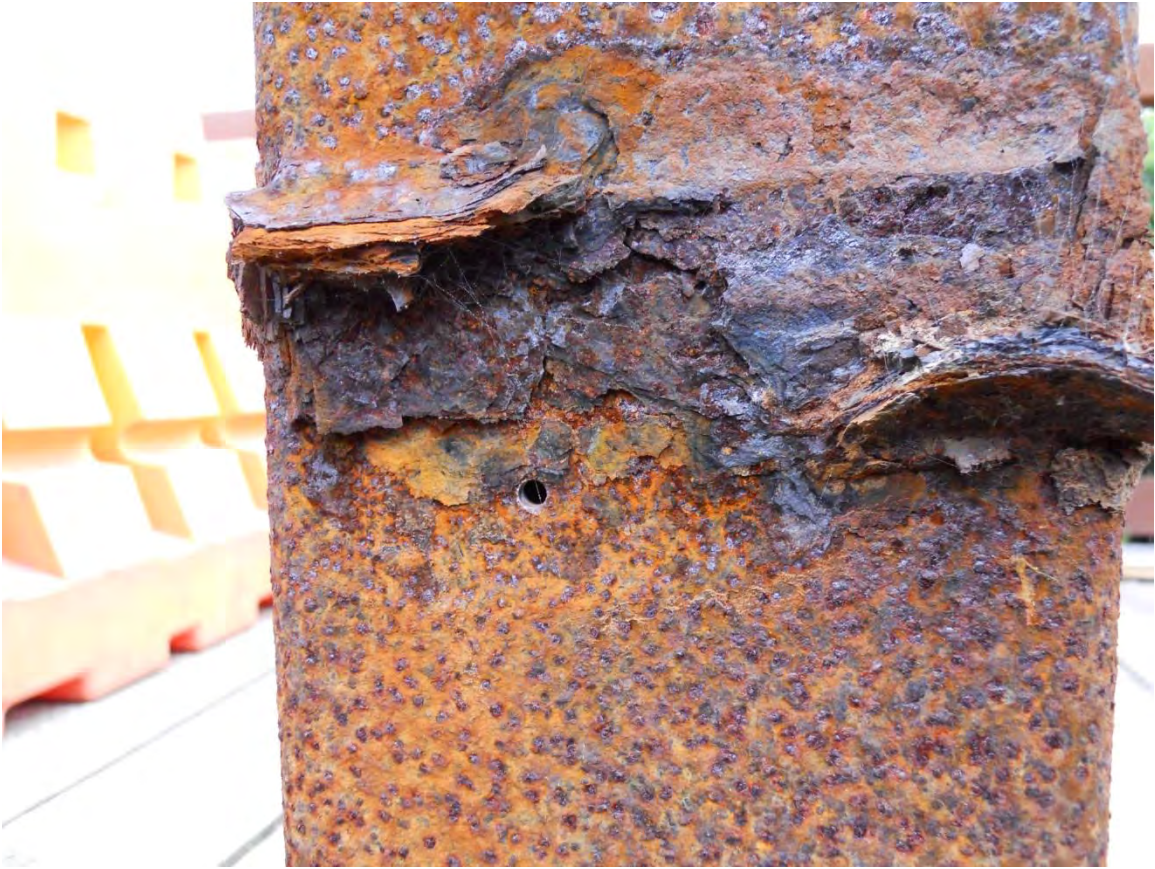
*Truss Vertical Posts:* We drilled posts at Panels 3S, 1N and 2N. We noted air pressure relief in drilling at panel 3S where corrosion was 10%. Corrosion was up to 50% primarily at the attachment points of the guard rail angles.

Truss Vertical – Span 1, Panel 3  
[25% Loss of Section at Drilled Holes]

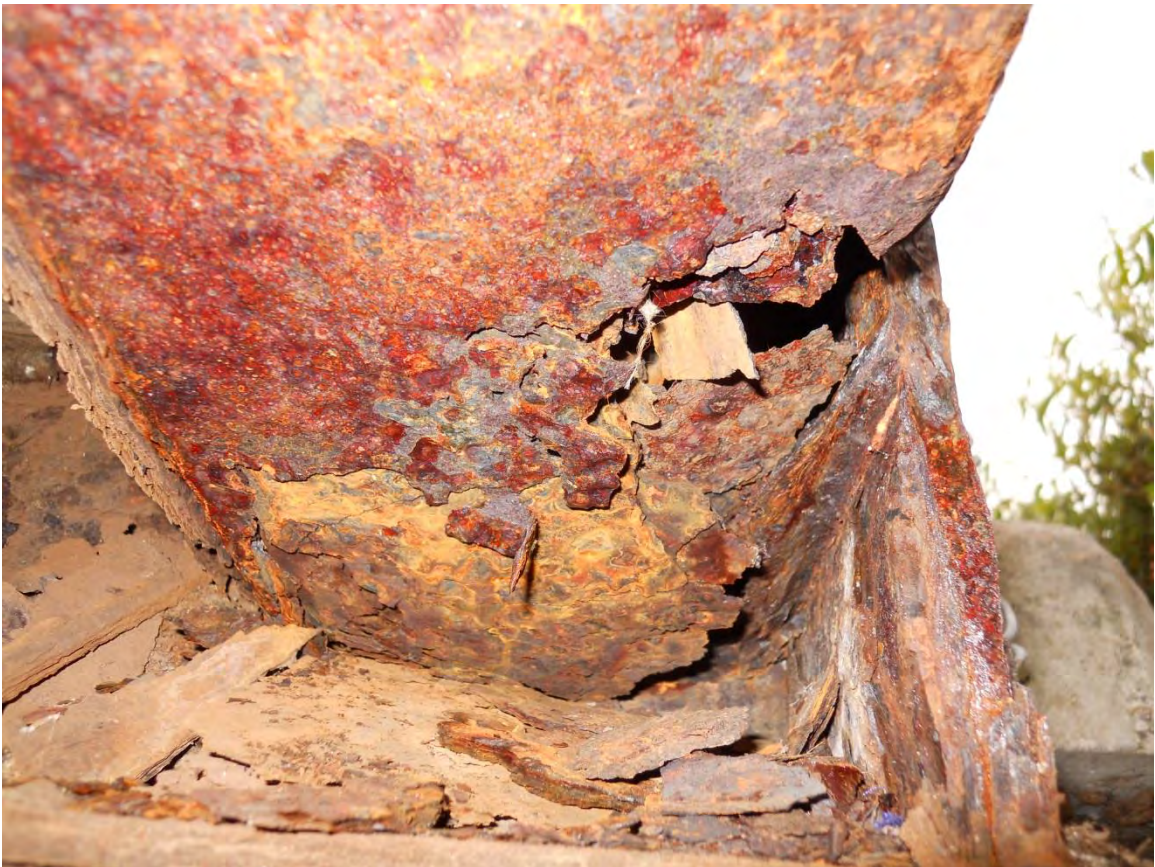
*Abutment No. 1:* Steel galvanized beams and post were visible on the north side only. Members and connections appeared to be in good condition. The lower beam was partially buried in soil. Truss connection plates to galvanized plates were in poor condition with up to 50% corrosion in a 5/8 inch thick base plate.

Bottom Chord Section Loss – Abutment 1

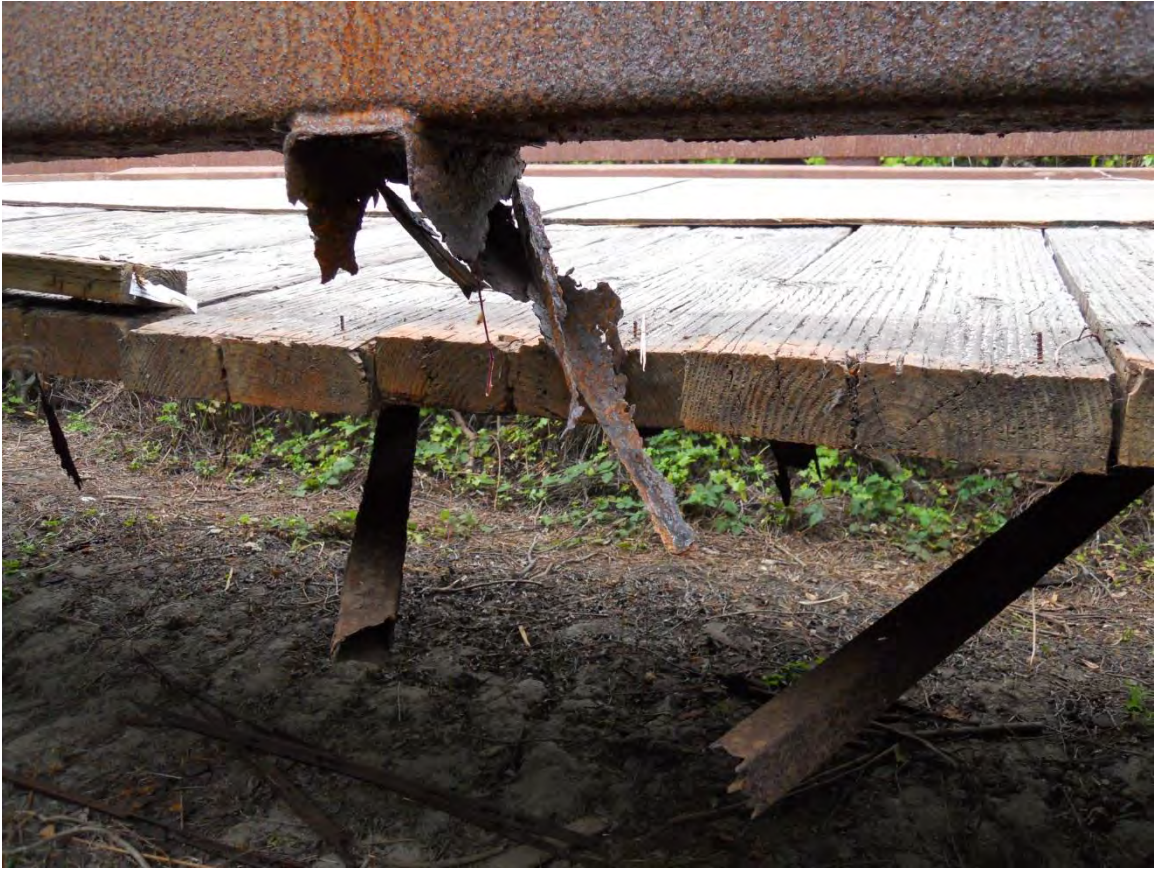
Collapsed Deck – Span 1

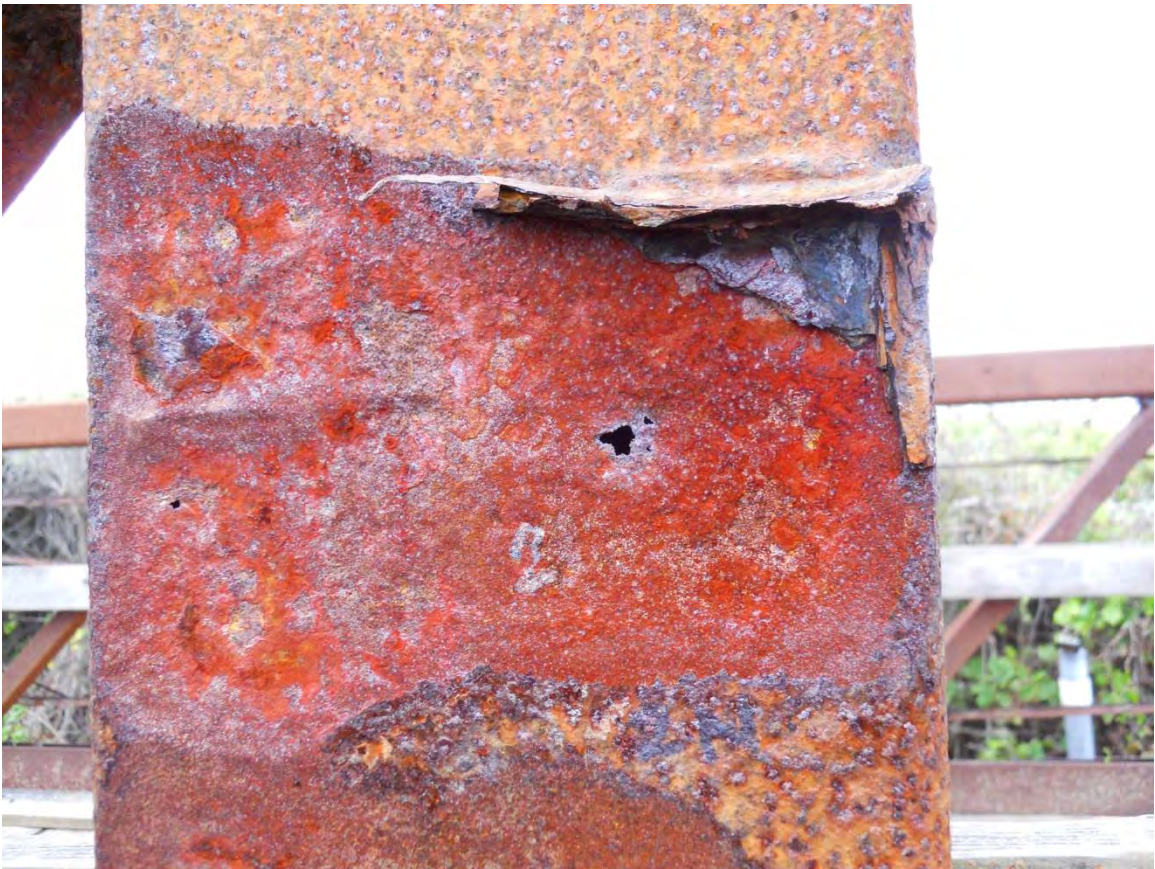
Truss Vertical at Guardrail Attachment  
[Section Compromised]

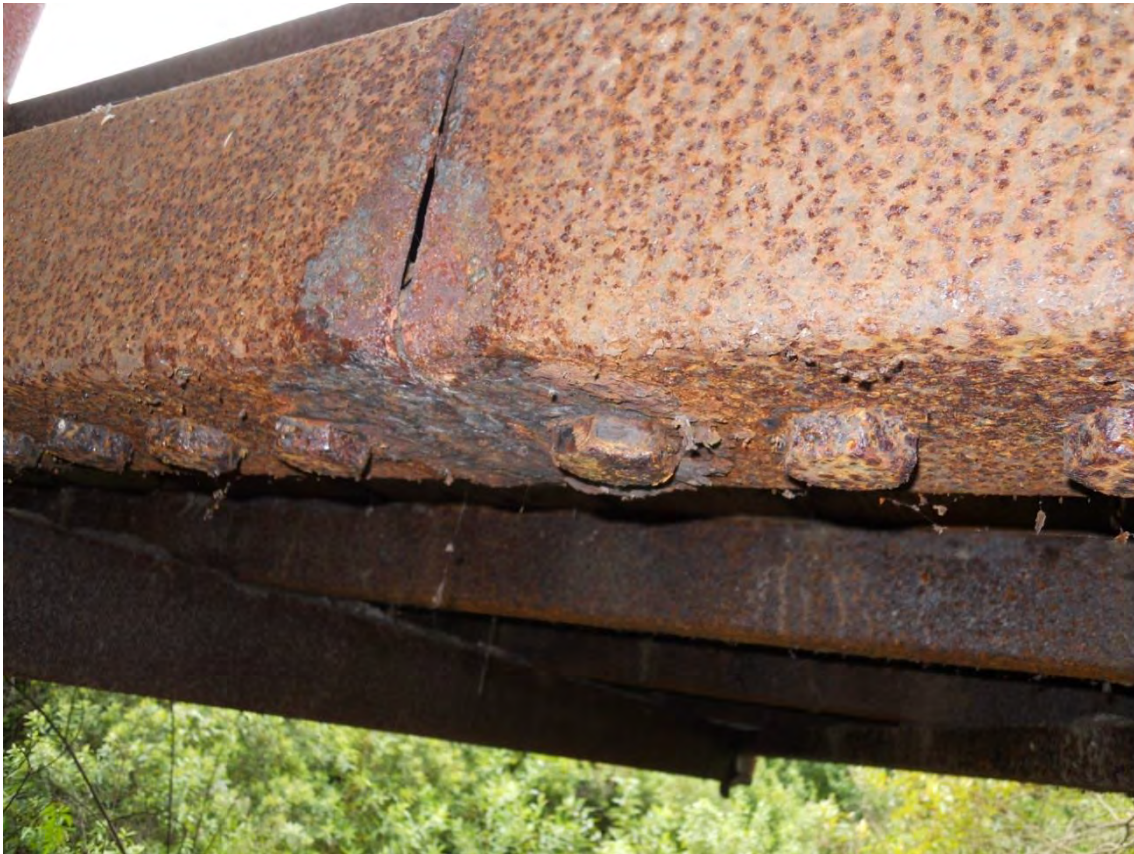
This bridge section had similar issues to Span No. 1. Panels 1 to 2 indicated moderate corrosion at the bottom chord. Floor beams, stringers and bracing had corrosion from 50% to 75% again more severe to the north side of the bridge. The end diagonal had severe corrosion at the end connection to the bottom chord at Panel 1. The diagonal bolted splice at Panel 10 was corroded 100% at the bolted plate with severe flaking at the bottom chord connection.

Bottom Chord Corrosion at Midspan Splice – Span 2  
[50% Section Loss]

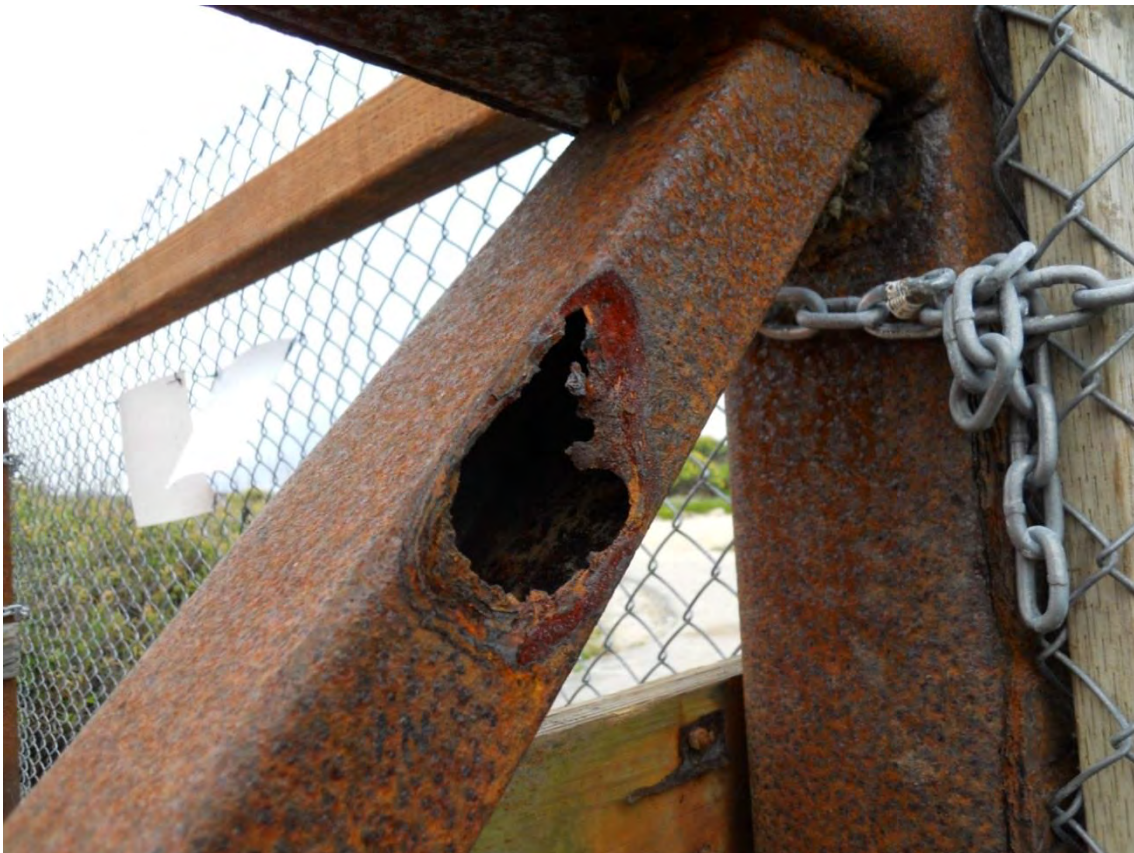
*Truss Diagonals:* We drilled the diagonal at Panel 3S and 1N. Section reduction was 20%. Connections at the top chord appeared adequate. Connections at the bottom chord were corroded severely.

Truss End Diagonal Corrosion Hole – Span 1  
[50% Loss of Section]

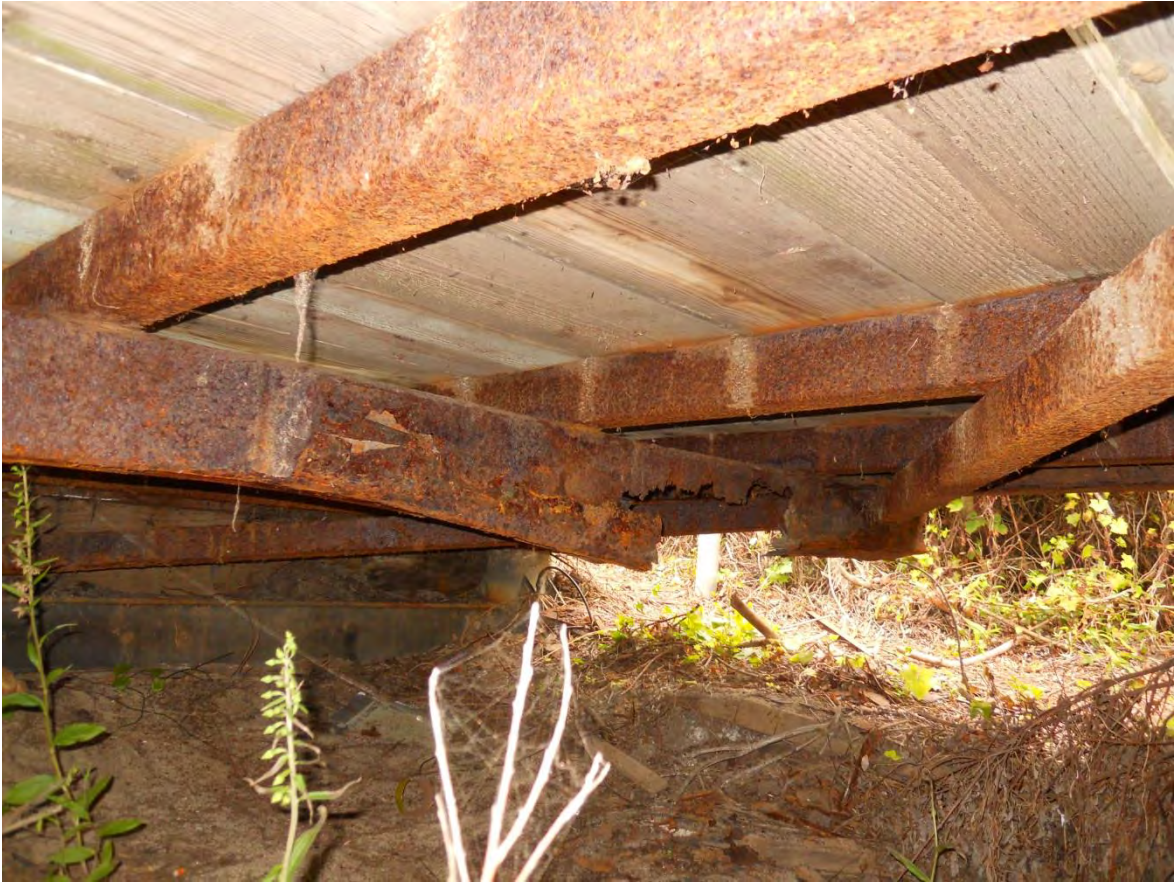
Floor Beam Corrosion Failure – Span 1, Panel 2

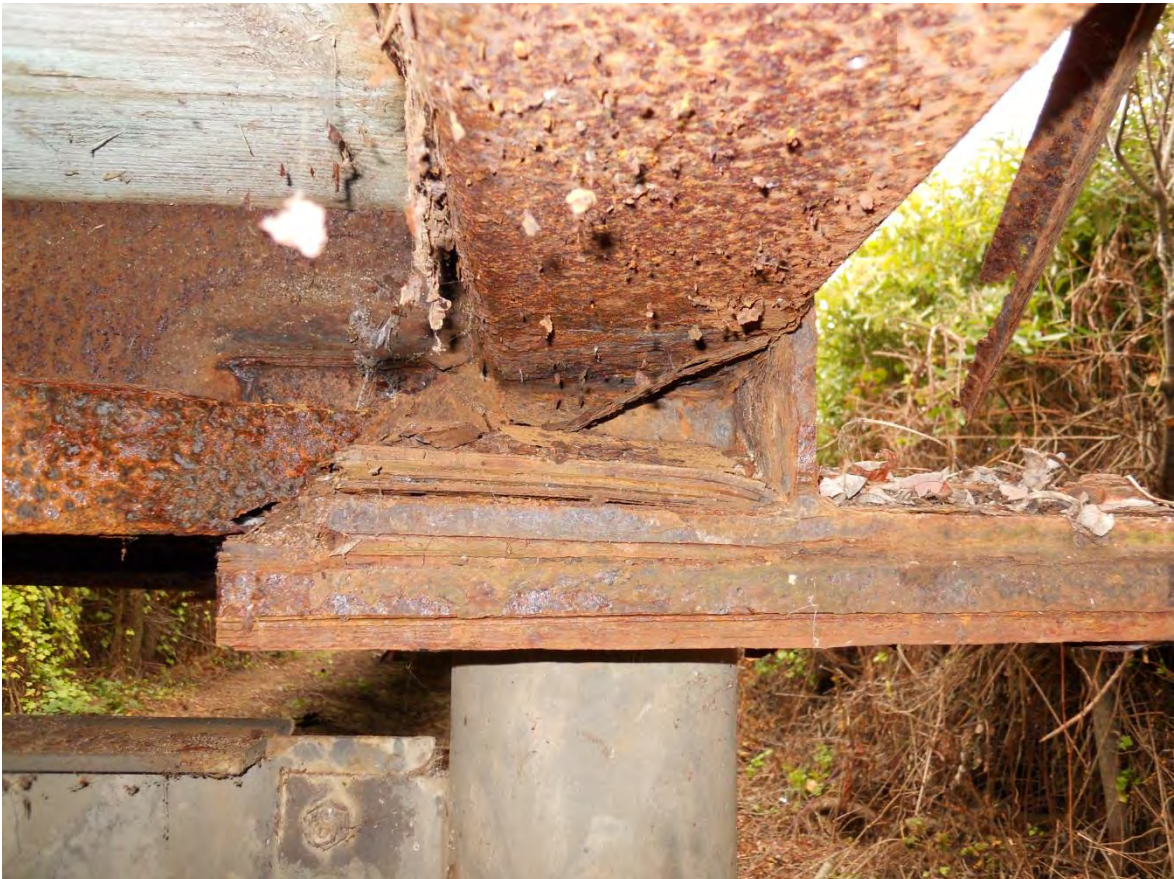
*Interior Pier No. 2:* Galvanized beams and bracing appeared to be in good condition. The pier was located close to the top of the slope at the creek embankment. Corrosion was noted on the galvanized plate at the attachment to the 1 inch bridge bearing plate. Bridge bearing plates were corroded up to 50% on the inside faces.

Bearing Plate Corrosion – Pier 2

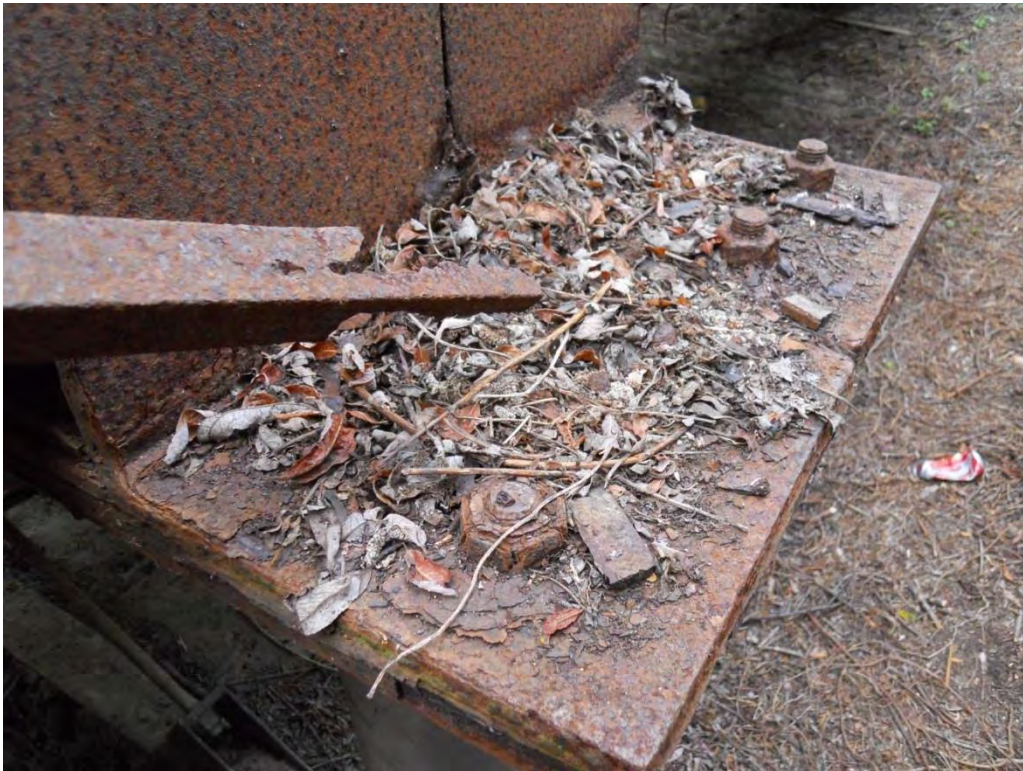
Bearing Plate Corrosion – Pier 3

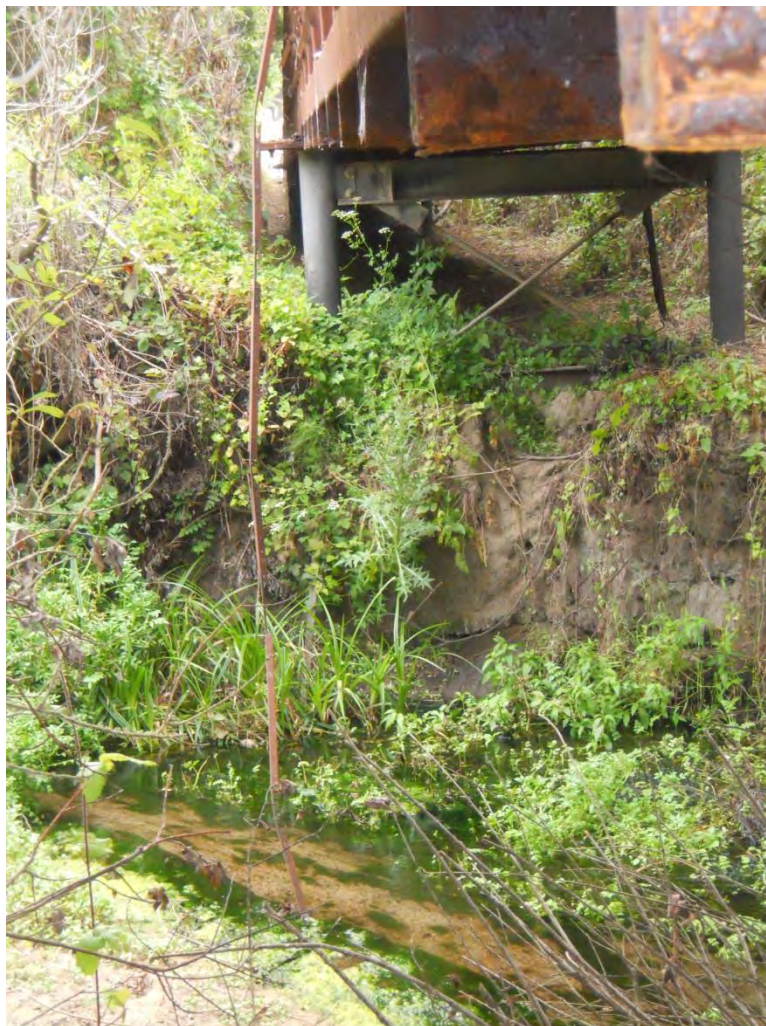
*Interior Pier No. 3:* The stream bed has scoured into the embankment at the north pier post exposing the diagonal tieback rod in the stream bed. The soil face appeared to be within 2'-0" of the vertical face of the 10-foot plus embankment

Stream Scour – Pier 3

7. Scour counter-measures will need to be investigated and designed at Pier No. 3 and possibly Pier No. 2.
8. Further study of abutments and foundations is recommended and is beyond the scope of this report. A geotechnical engineer will be necessary to confirm load capacity and to expose buried members for evaluation and design information.

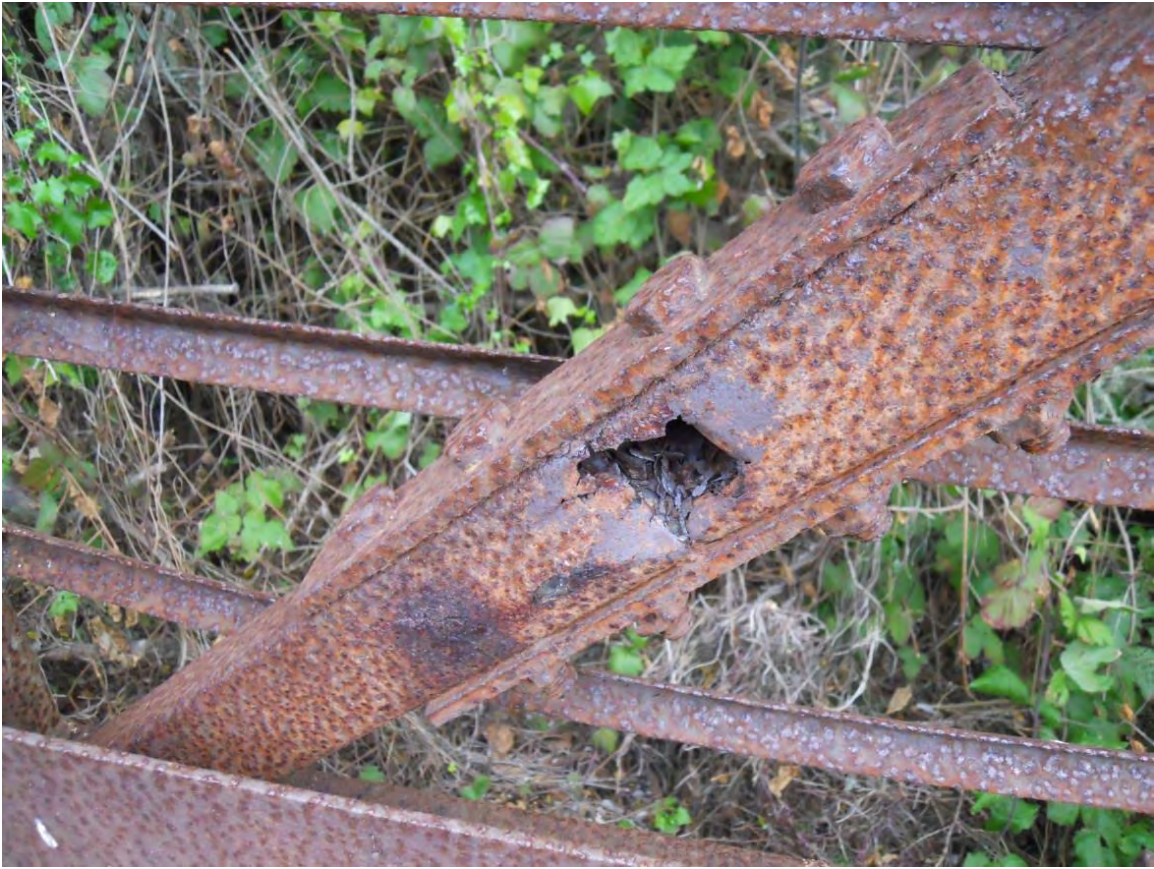
Truss Midspan Diagonal Splice – Span 3

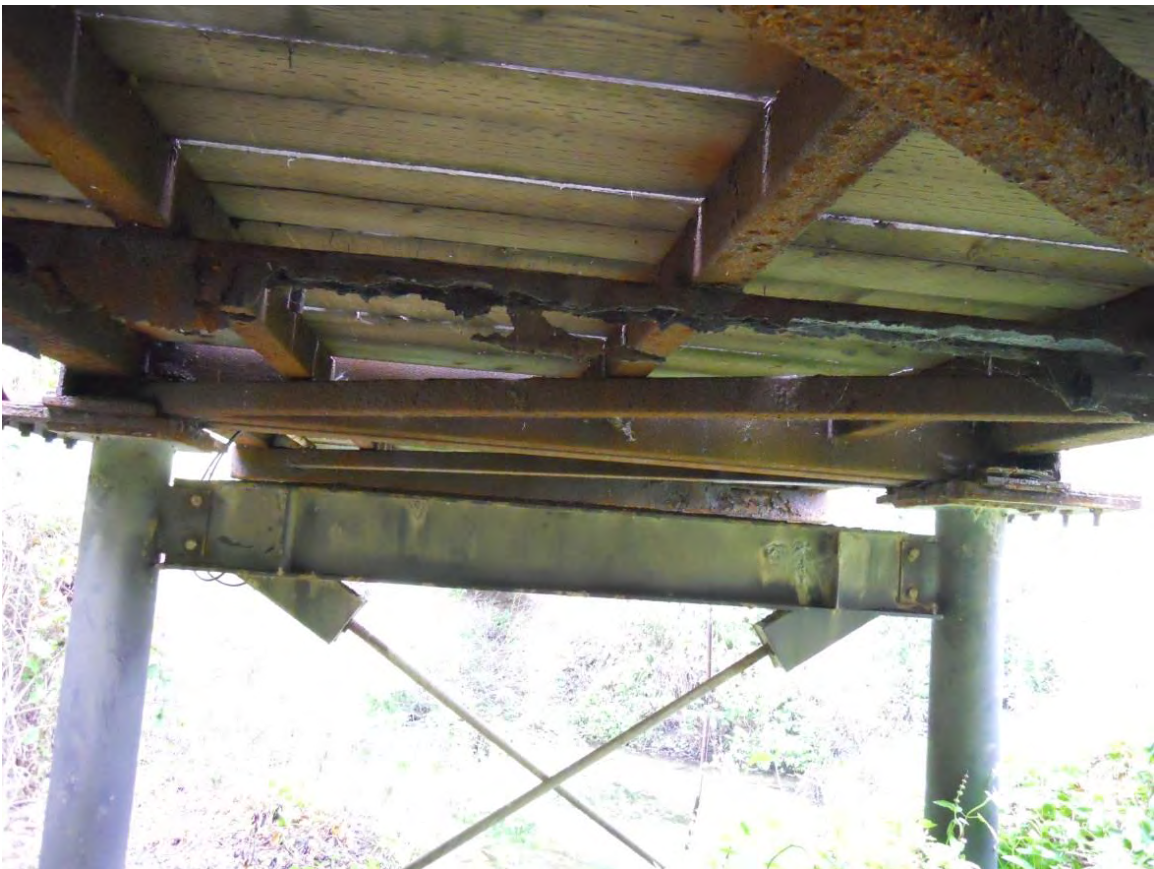
Floor Beam Corrosion – Pier 3  
[100% Loss of Section]

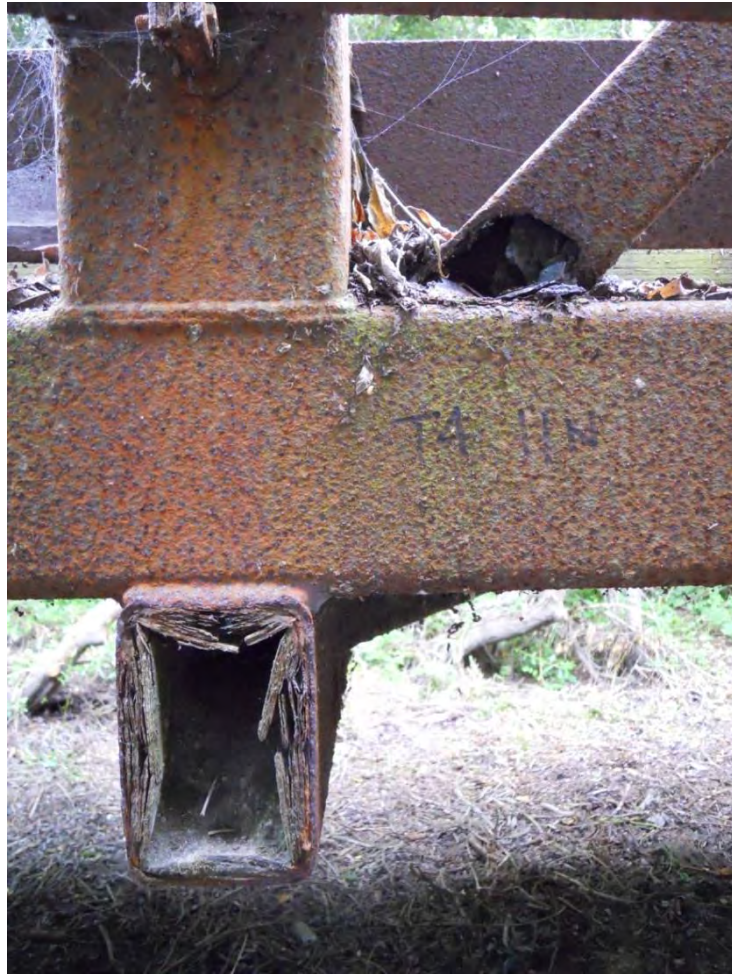
These bridge sections have similar issues to other spans. Mud debris was noted in open ended floor beams. Span No. 4 had 75% corrosion to floor beams. Debris on the bottom chord has caused severe corrosion of the truss connections behind the toe kick plate.

Typical Floor Beam and Brace Connection Corrosion – Span 4  
[75% Loss of Section]

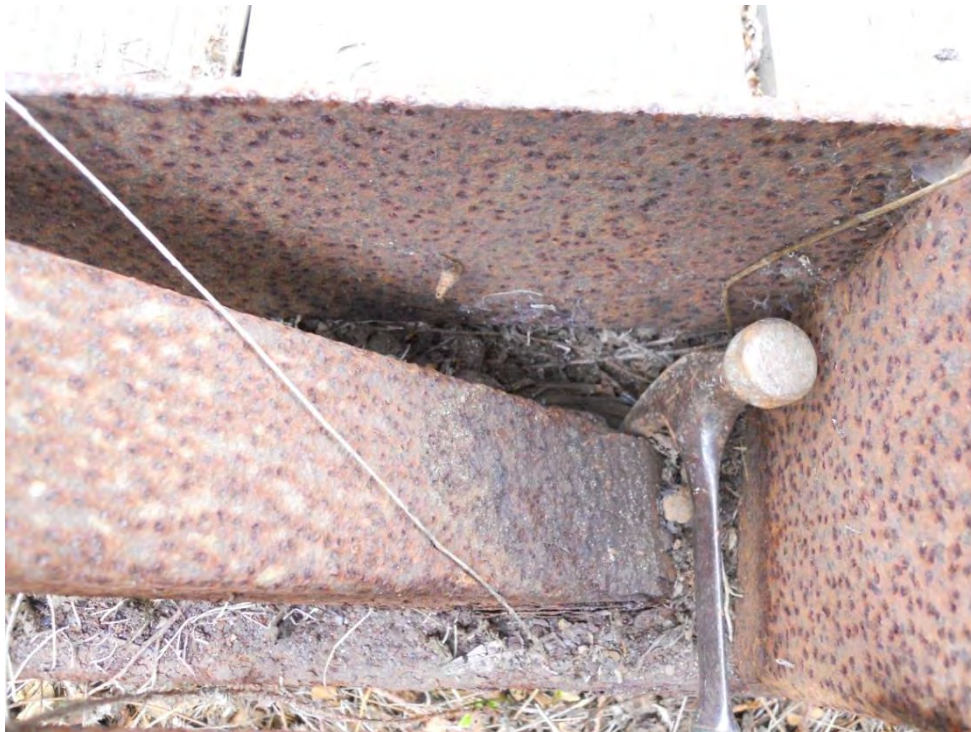
Truss Diagonal Section Loss at Connection  
to Bottom Chord at Deck Kick Plate – Span 4
