National Register of Historic Places Registration Form

| 1. Name of Property Historic name: <u>Kelso Historic District (Bounda</u> | DRAFI DRAFI |
| Other names/site number: <u>Kelso Depot, Restaura</u> Name of related multiple property listing: N/A (Enter "N/A" if property is not part of a multiple p | nt and Employees Hotel Historic District |

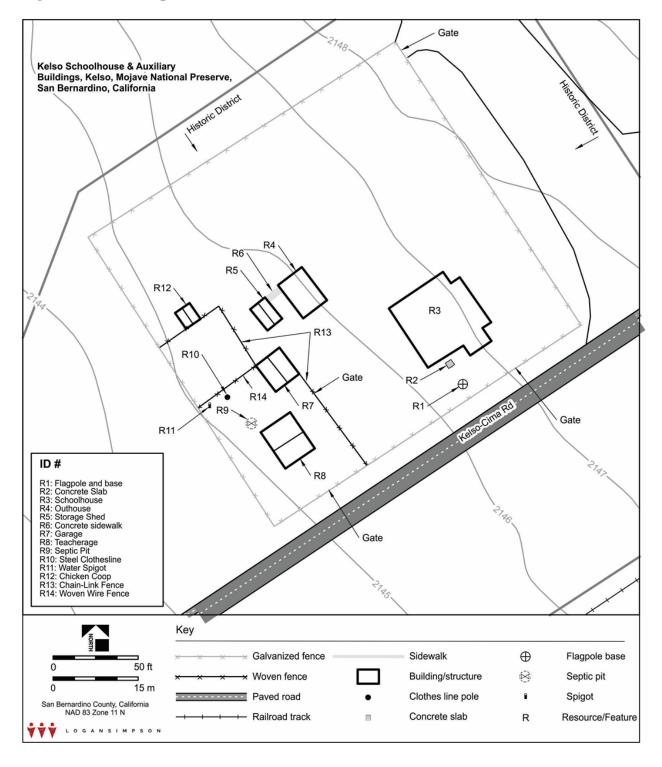
Figure 3. Sketch Map

Identification number in parentheses refers to location indicator on Figure 3 Sketch Map.

Eight ancillary features associated with the property are largely utilitarian (**Photographs 13-19**). Features are listed in the table and their locations are indicated on the Sketch Map (**Figure 3**).

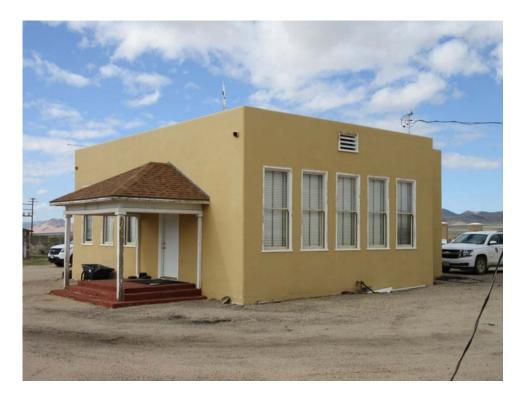
Completed in 1925, the Kelso Schoolhouse is a single-story, 1,332 sq. ft., frame building with boxy massing, resting on a post-and-beam foundation, capped by a low-pitched roof surrounded by a tall, flat parapet (**Photograph 1**). The walls are sheathed in smooth-finish concrete stucco, and single-hung sliding sash windows are present on all elevations. Windows are constructed of wood, and rest within wood frames, on integrated sills flush with exterior walls. The parapet is punctuated with wood-framed attic vents on the (roughly) north and south elevations, and galvanized steel drainage pipes are present on the corners of the remaining elevations.

The building's overall condition is good. Some signs of deterioration are present, as are signs of alterations and repairs. Paint around windows, on vents, and on porch steps is peeling; wood frames are warping; and some spalling of stucco near the foundation is visible. In 2010, conversion of the schoolhouse to a ranger station resulted in the application of new stucco and exterior paint; installation of new wood window frames and new roof sheathing; replacement of exterior wood doors with solid core steel doors; and installation of an HVAC system, satellite dish, swamp cooler, carpeting, interior molding, and ceiling fans. Many of the 2010 alterations are in need of repair (e.g., windows and painted elements) or replacement. Colored stucco should be replaced with white paint per original appearance, and interior moldings and carpet should be removed.

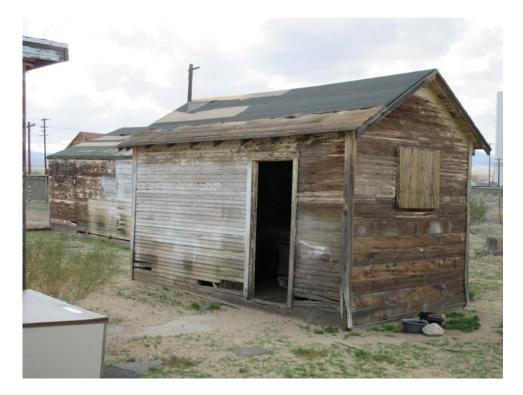
Photo 4

The storage shed is a small, 161 sq. ft. frame building with shiplap siding, a side-gable roof sheathed with tarpaper, and exposed rafter ends supported by a post-and-beam foundation covered by a wood floor (**Photograph 4**). The building includes a single window on the west elevation, covered with plywood. The shed has only one entry that faces towards the schoolhouse, but the door is missing. The interior features open shelves and the remains of miscellaneous building materials. Although the building was stabilized in 2004, noticeable deterioration is evident including missing tarpaper sheathing, missing shiplap near the foundation, and the lack of a protective covering across the entry. The date of construction is unknown. Based on construction materials, the shed dates to the period of significance.

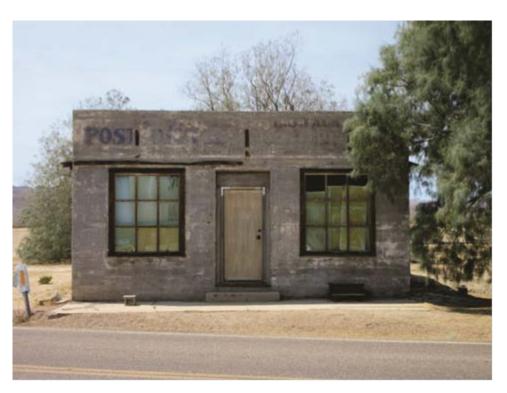
Photo 6

The old Kelso Post Office and store, roughly square in plan, was constructed of cast-in-place concrete, formed using horizontal boards (**Photograph 6**). The building has a shallow gable roof concealed behind a false front on the primary elevation, which faces the road to the south. The primary elevation is symmetrical, with a central door flanked by large, fixed nine-light wood sash (**Photograph 7**). The entrance threshold is two steps above grade. The door opening appears to have been closed down at both jambs and at the head to accommodate a new door smaller than the original. Wood nailers have been embedded in the concrete, horizontally across the west half of the elevation, just above the window head, and vertically at three points across the width of the false front. Remnants of painted signage remain on the concrete of the false front including lettering for the post office.

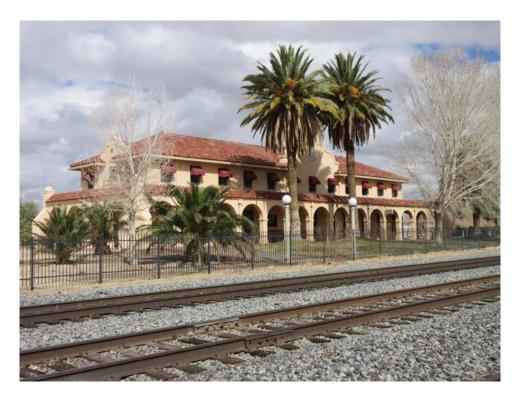
Photo 20

The Kelso Depot, although somewhat modified during its later years of operation, retains a high degree of integrity. Principal exterior and interior character-defining details and spaces are extant. On the exterior, these features include: overall building mass; tri-color Mission tile roof; espadana parapets; Union Pacific herald in south espadana; arcade with molded bases and capitals on pillars and buttressed ends; original double-hung and casement window sash; entry; downspouts, collector boxes and decorative straps; brick walks; and electroliers. In the interior, these features include: lobby, lunch room, lodging rooms, billiard room, and reading room; heavily-textured plaster wall and ceiling finishes; panel-and-batten wainscot; cigar case and check-in counter; lunch counter and stools; stair cases, newel posts, and balustrades; and lockers.
