National Register of Historic Places Registration Form

Historic name: <u>Mount San Jacinto State Park Historic District</u>

Street & number: 25905	Highway 243			
City or town: <u>Idyllwild</u>		County:	Riverside	
Not For Publication: N/A	Vicinity:	X

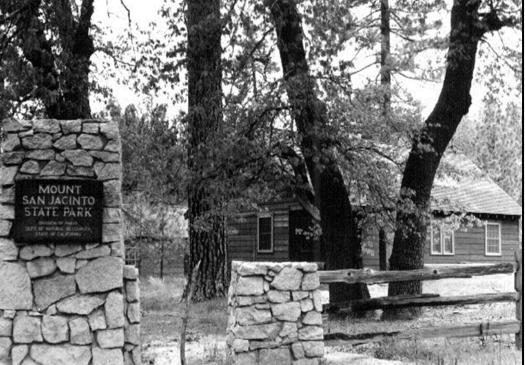
Photograph # HP2

Looking North at Stone Masonry Column, Pier, and Residence #1 (right)

Constructed around 1936, this approximately 8-foot-long by 3-foot-wide structure consists of twin opposing cement-mortared dressed stone rubble truncated battened piers set on a cement-mortared dressed stone rubble rectangular slab. The piers support a built-in wood plank. Combined, the approximately 3-foot-tall structure acts as a rustic bench as well as the base for two 20-foot-tall cylindrical galvanized steel flagpoles.¹¹

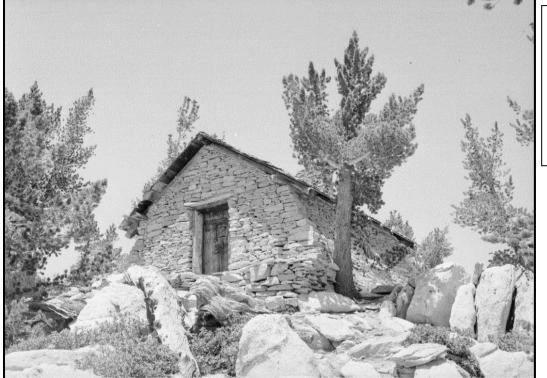
Photograph # HP8

Looking Northwest at San Jacinto Peak Shelter
