### **National Register of Historic Places Registration Form**

1. Name of Property
historic name Hansen Bridge DRAFT
other names/site number Pearl Street Bridge, Downie River Bridge, Scott's Bridge, Bailey's Bridge, May's Bridge

The Hansen Bridge, built in 1935 across the Downie River, is a rare surviving example of a *single lane* low side-panel steel Pratt pony truss bridge that was once common throughout California. While 80 feet long but just 12 feet and 4 inches wide and still carrying contemporary automobile traffic, this bridge is a striking example of a structure now fast disappearing from the American landscape.

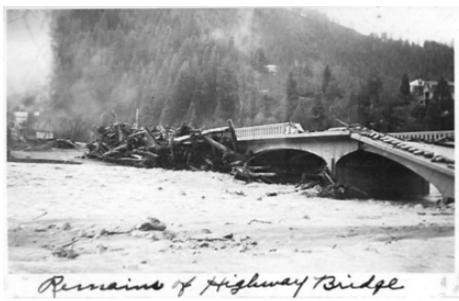
Figure 2. Historic photo of damaged highway bridge, 1937

collected on the piers and blocked the passage of water through the arches. The temporary dam brought the water level high enough to send the river through the streets of Downieville, lifting homes from their foundations and sending them floating downstream. The highway bridge could not withstand the pressure of the water and debris for long, and collapsed after approximately 30 minutes. The catastrophic break-through of water and debris caused more damage to the buildings of Downieville, and utterly destroyed the two wooden bridges downstream from the highway bridge, the Jersey and Durgan Bridges.

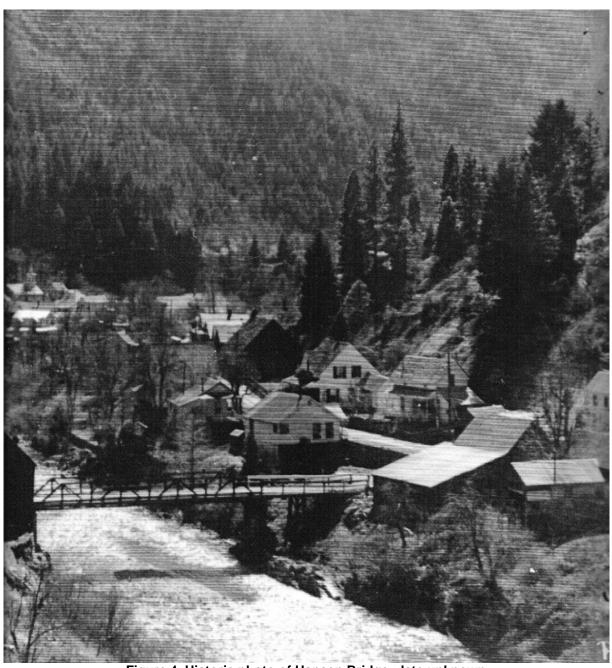
Figure 4. Historic photo of Hansen Bridge, date unknown

The Hansen Bridge is a Pratt pony truss steel bridge 80 feet long and 12 feet 4 inches wide, running east-west across the Downie River. The bridge trusses are constructed of steel I-beams secured by riveted steel plates. Steel guardrails extend beyond the edges of the pony truss on either side of the bridge, with a rolled sheet metal safety railing below the steel guardrails. The roadway deck is supported on wooden stringers running the entire length of the bridge, topped with corrugated metal and an asphalt road surface. The bridge is supported by two concrete pilings on each end, resting on concrete footings, with wooden boards between each piling. The boards on the western side appear to have partially collapsed but are still present. Steel struts from the canyon wall to the bridge are located on the eastern side of the bridge behind the pilings. A water pipe runs along the northern edge of the bridge. The remains of a granite retaining wall, possibly from an earlier bridge, are present on the northern side of the western bridge abutment.
