Potential Significance to Water Resources & Drainage Structure Condition Index

NOTHGATE TO SUMMIT

Mount Diablo State Park Road and Trail Management Plan

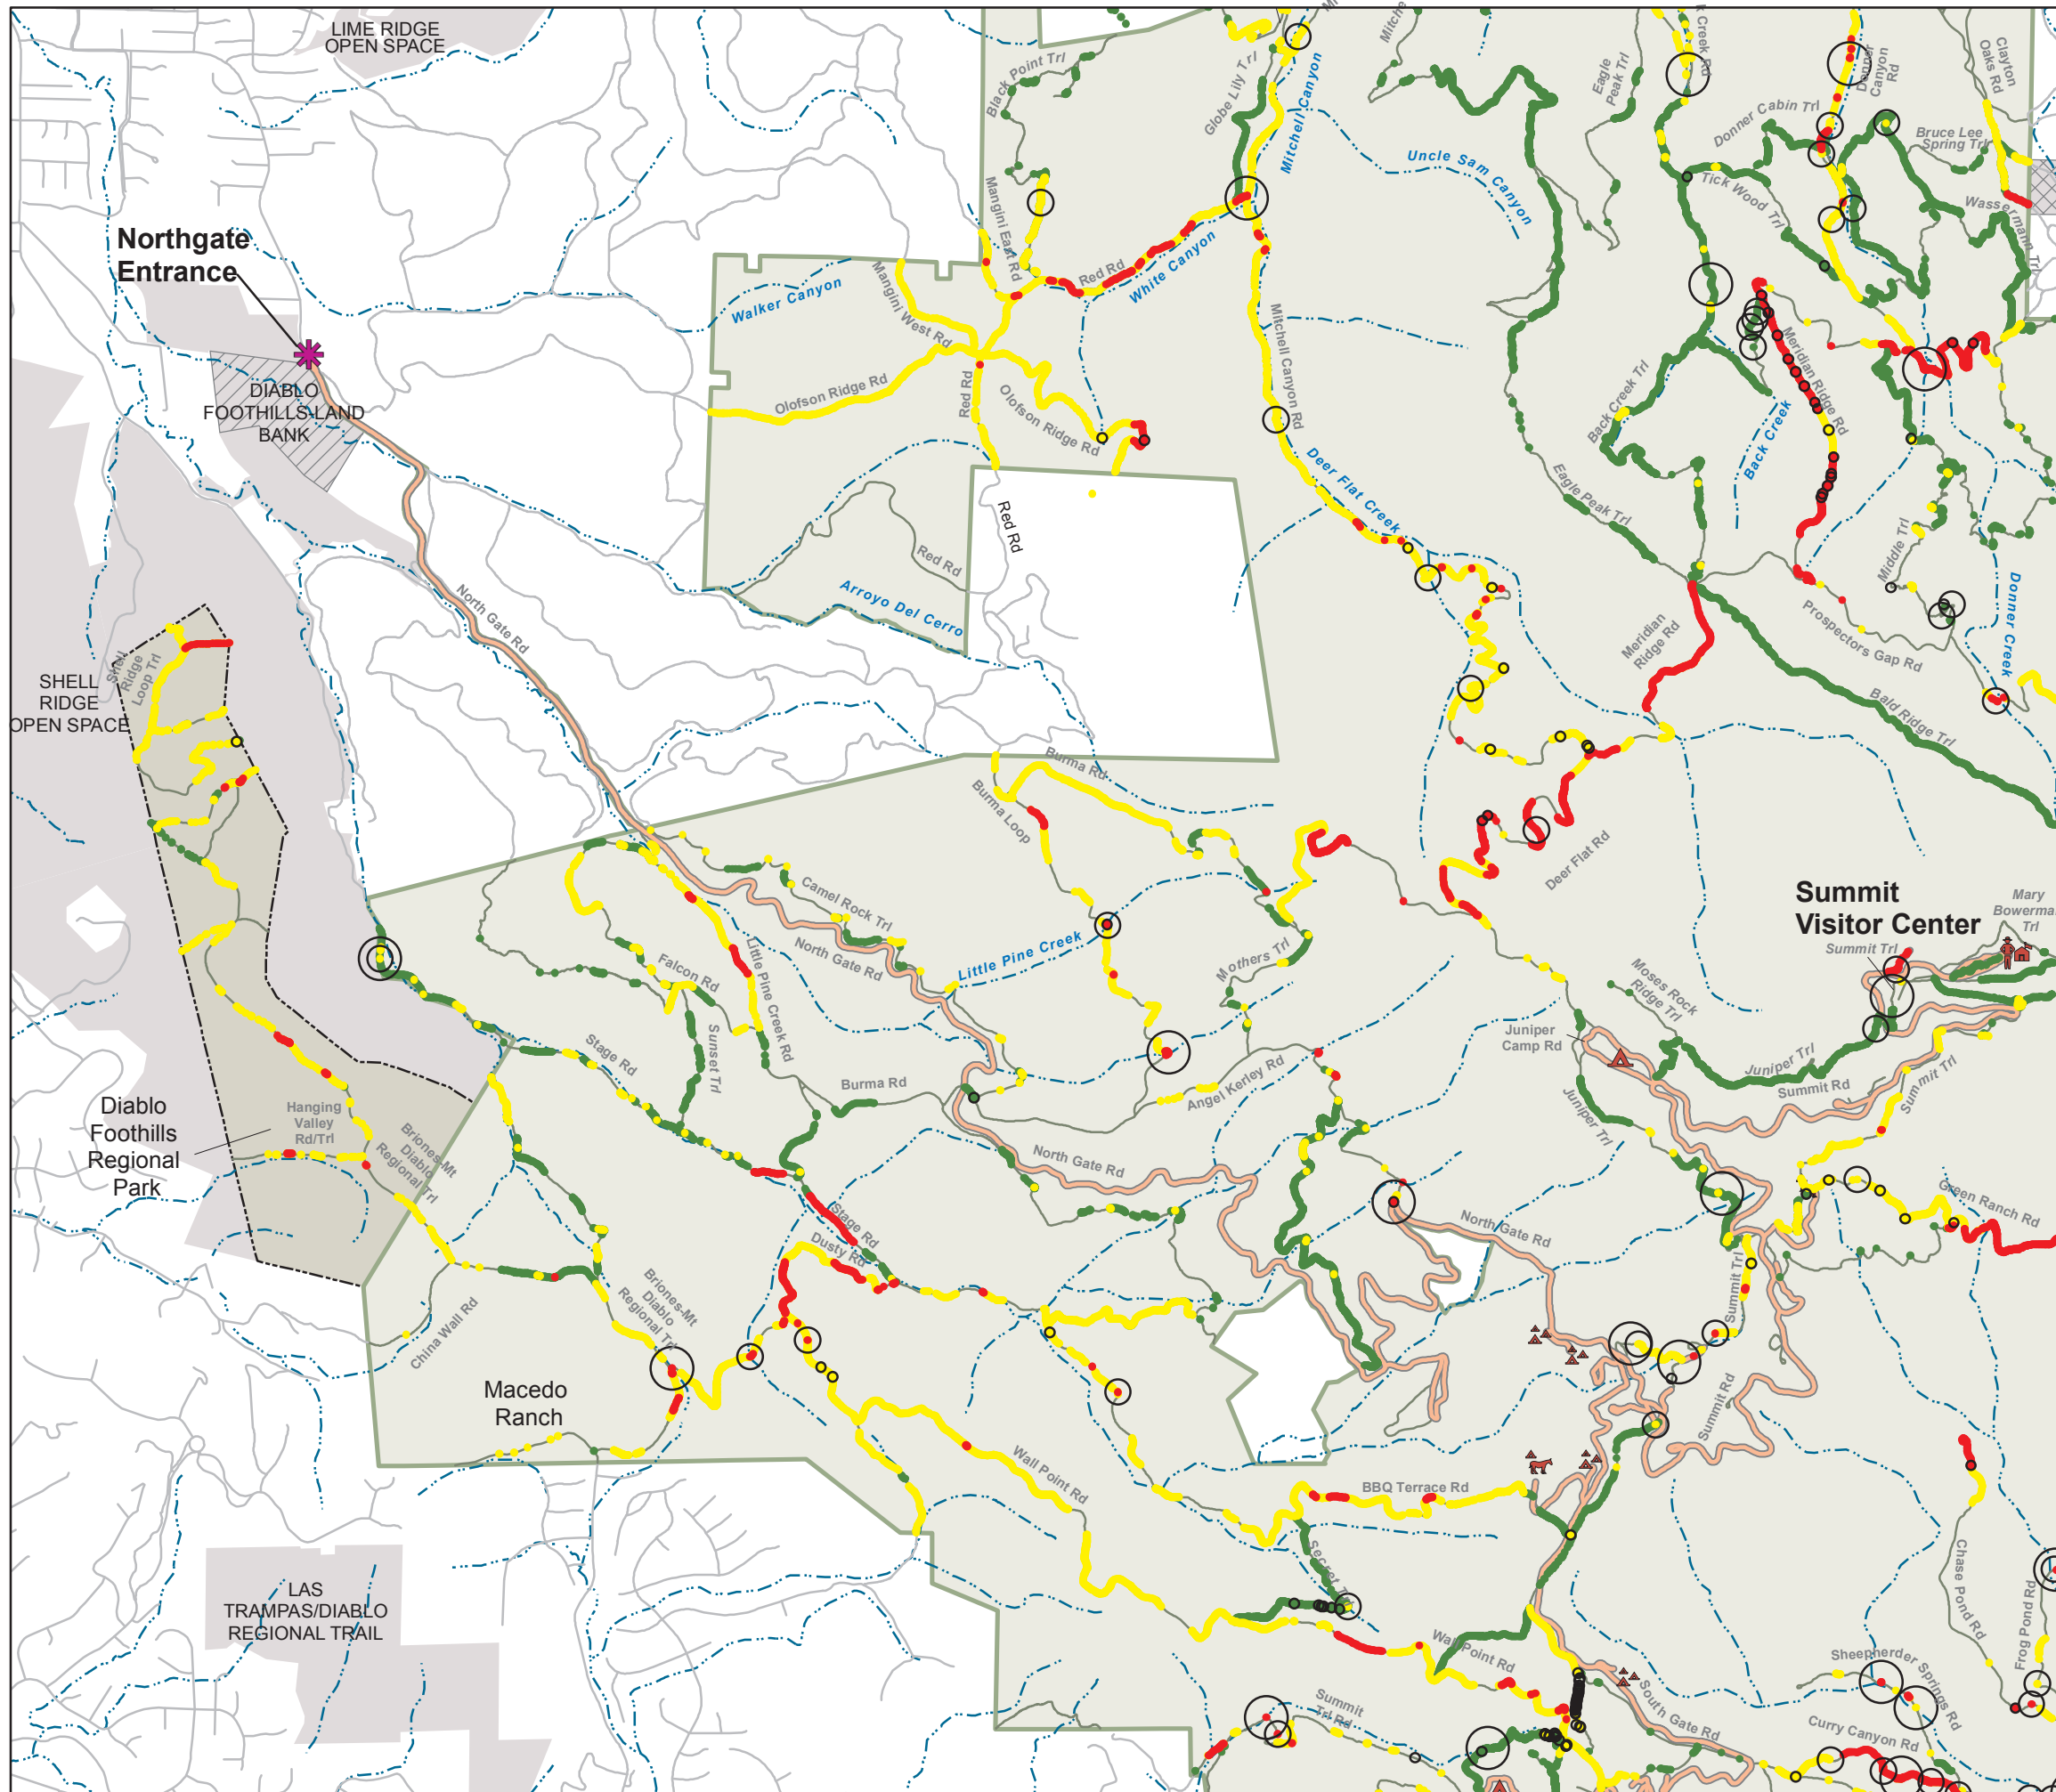
Potential Road and Trail Impacts To Water Resources

Drainage Structure Condition Index
Higher Score = poor condition of structure
