Local Watershed Plan

# MILL CREEK PROPERTY AND WATERSHED

Del Norte Coast Redwoods State Park

California Department of Parks and Recreation

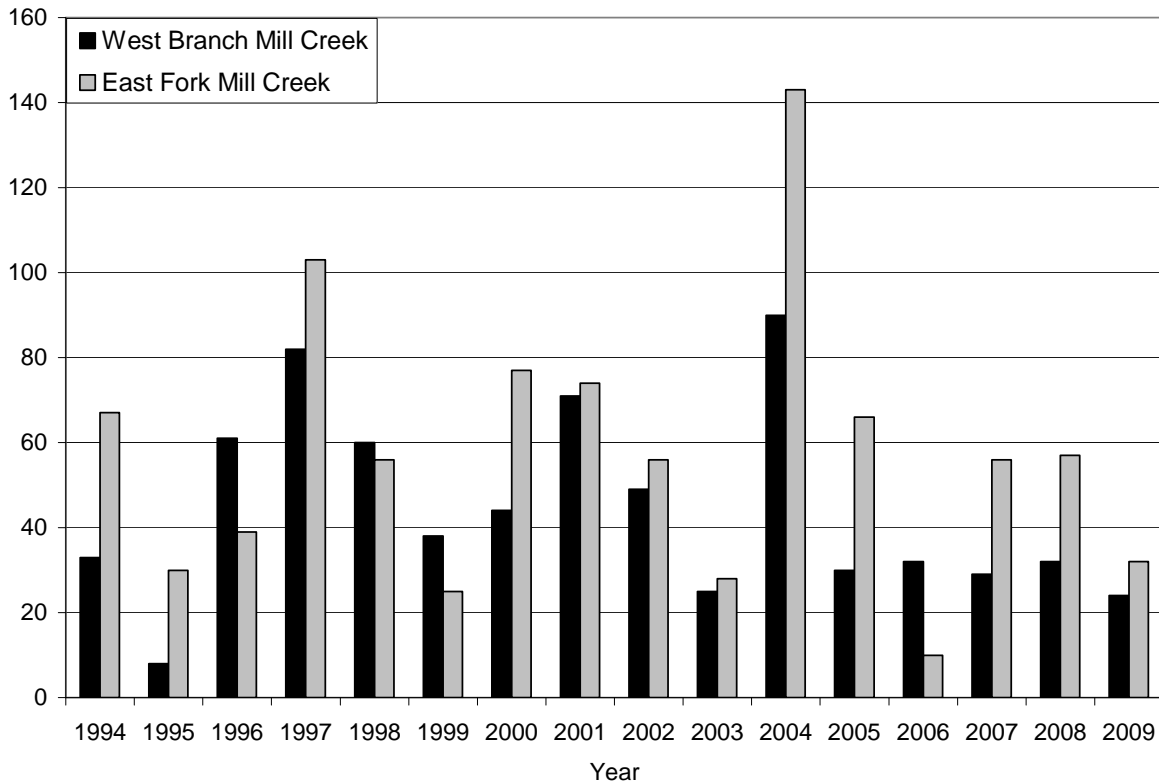
**Figure 2-8. Steelhead Kelt Catches in Outmigrant Traps in the West Branch and East Fork (Water Years 1994–2009)**

Postspawning adult steelhead (“kelts”) are captured in outmigrant traps, and the number of kelts observed has ranged from 8 to 82 in the West Branch and from 25 to 82 in the East Fork (Albro and Gray 2001) (Figure 2-8). Based on the number of kelt catches, overall adult escapement in both tributaries appears variable, and kelt catches have been slightly below average in both tributaries since 2006.

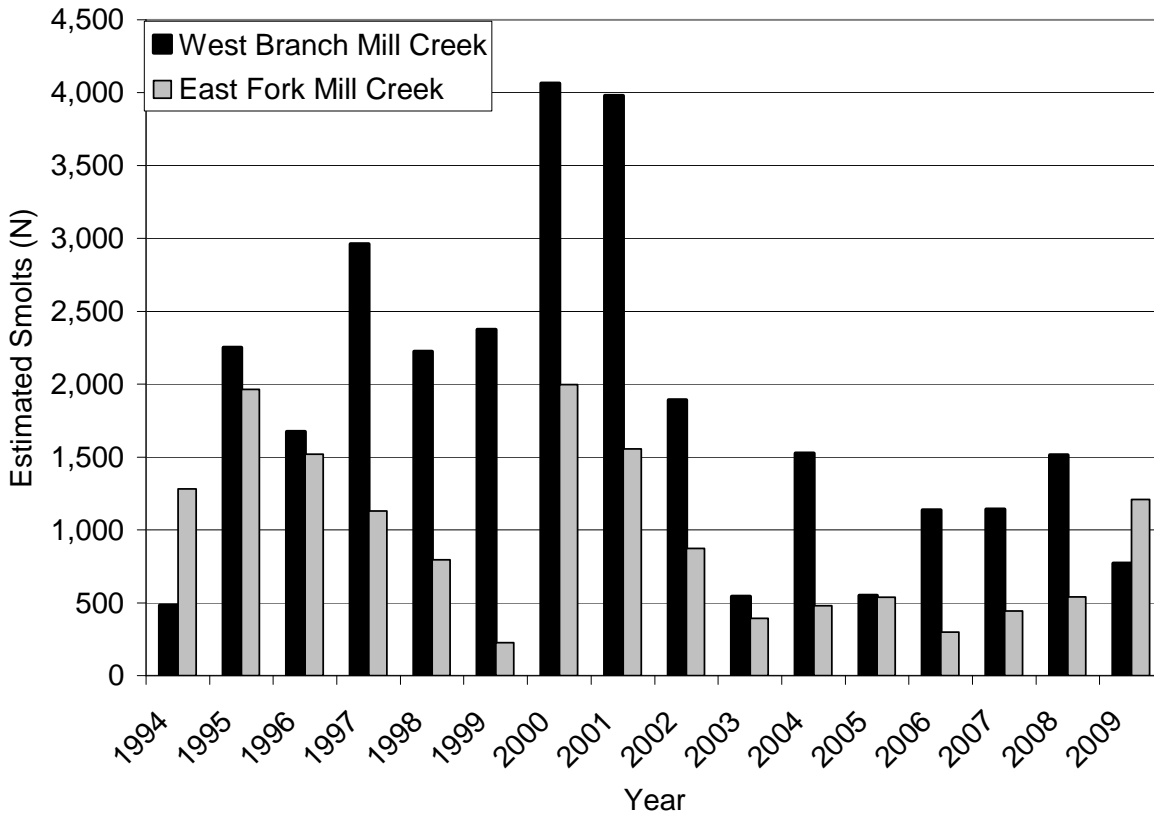
**Figure 2-9. Steelhead Smolt Outmigration Estimates for the West Branch and East Fork (Water Years 1994–2009)**

All juvenile life stages of steelhead (from fry to smolt) have been observed in the outmigrant traps, indicating that extended freshwater rearing occurs in the watershed. Because distinguishing between juvenile steelhead and coastal cutthroat trout is difficult, counts of juvenile steelhead captured may include cutthroat trout. Steelhead smolts are captured in the outmigration traps from late February through June (McLeod, 2010a) and have been highly variability since trapping began in 1994 (Figure 2-9). Mean annual smolt production since 1994 was 1,818 in the West Branch and 953 in the East Fork. Outmigration estimates have been below average since 2003.

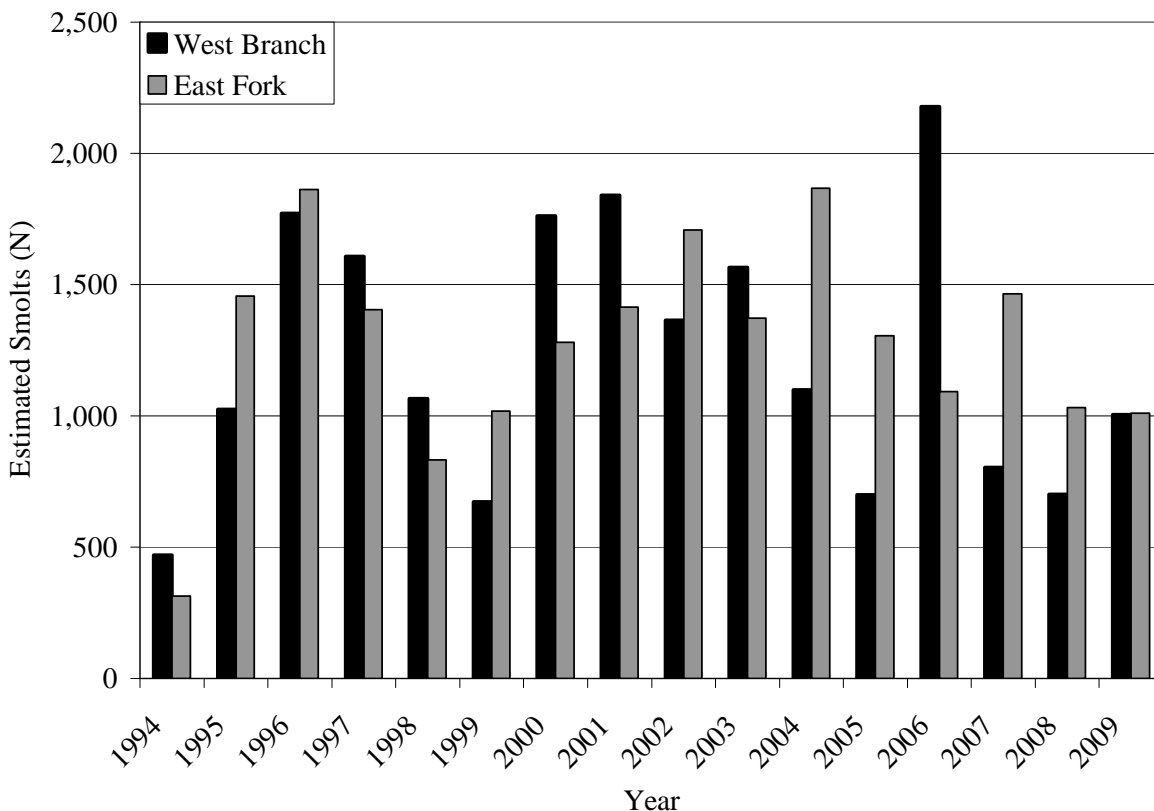
**Figure 2-11. Coastal Cutthroat Smolt Outmigration Estimates for the West Branch and East Fork (Water Years 1994–2009)**

All life stages of cutthroat trout (i.e., fry, juveniles, smolts, and adults) have been captured during outmigration trapping in both the East Fork and West Branch. Because distinguishing between juvenile steelhead and coastal cutthroat trout is difficult, counts of juvenile cutthroat captured may include steelhead trout. Nonsmolting juvenile cutthroat trout captured in the outmigrant traps may be outmigrating to estuarine or ocean habitats or simply dispersing in the river system. Cutthroat trout smolts in Mill Creek outmigrate over an extended period, from late March through early July, with irregular peaks in late April or early May (Howard and McLeod 2005a, 2005c). Since monitoring began, cutthroat smolt populations appear to have varied on about a 5- or 6-year cycle, and the populations appear similar between tributaries (Figure 2-11). Outmigration estimates have ranged from 469 to 2,178 in the West Branch and from 314 to 1,867 in the East Fork.

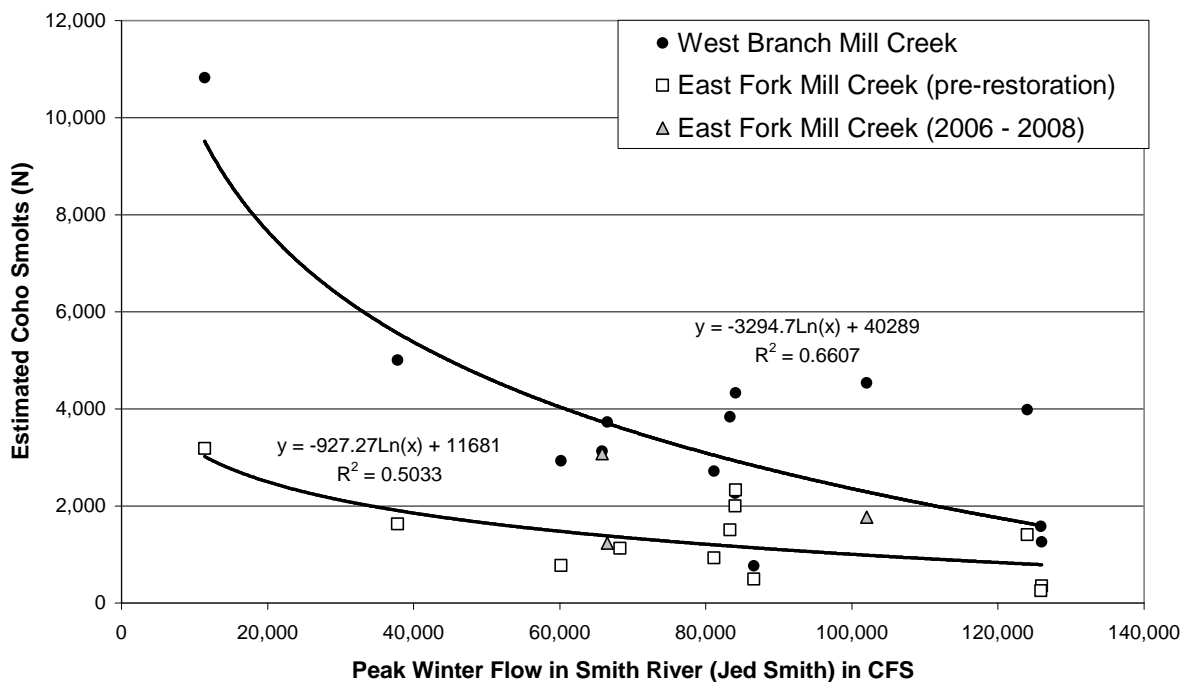
Recent instream habitat restoration efforts have been implemented in the East Fork and may be having a positive impact on coho smolt production (Figure 2-12), although the data are limited and not conclusive. Efforts have focused on the East Fork because populations there seem to be more density-dependent due to the lack of suitable rearing habitat. Despite having similar lengths of anadromy, the West Branch consistently produces more coho smolts than the East Fork.

Note: Hydrological data from the Smith River are used as a surrogate because flow data are not available for Mill Creek for all years.
