California Archeological Reports
No. 15

**The Central Pacific Railroad
Passenger Station,
Sacramento**

**Historic Sites Archeology at the Location of the
Western Terminus of the Transcontinental Railroad**

by
David L. Felton
State Park Archeologist I

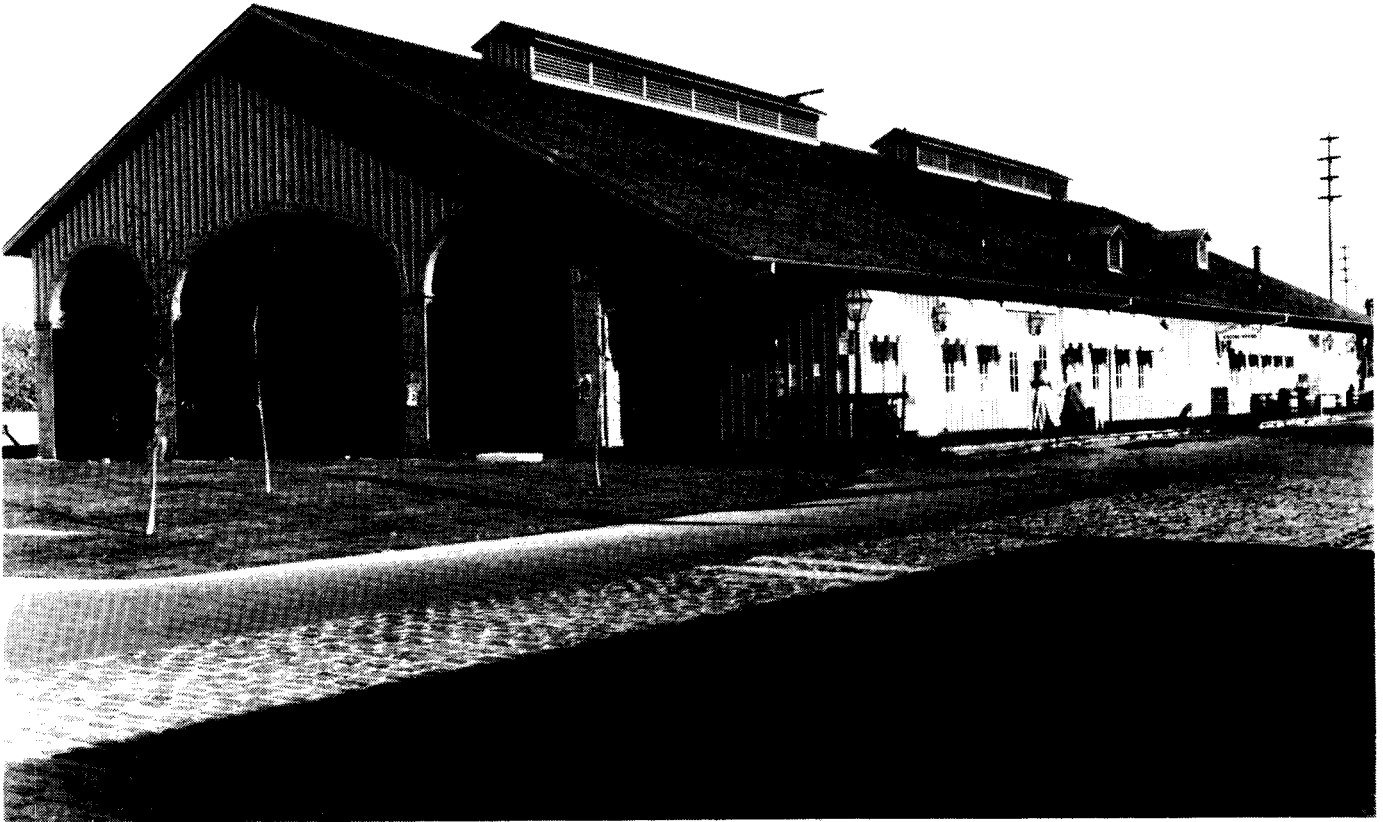
PLATE 1. RECONSTRUCTED CPRR PASSENGER DEPOT.

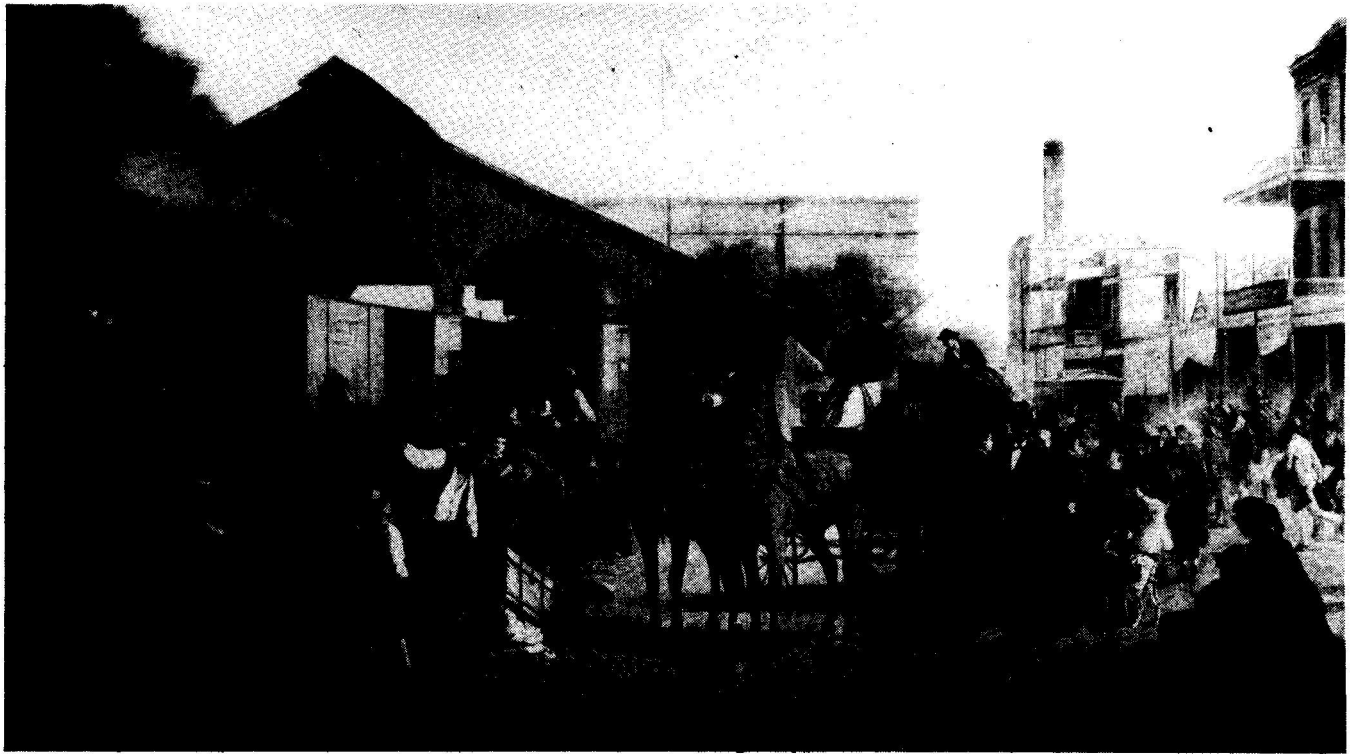
PLATE 4. PAINTING OF SACRAMENTO RAILROAD STATION, 1874.

The depot was of an "arcade" type construction as is evidenced by several photographs (Plates 2 and 3), a lithograph (*Bird's Eye View of the City of Sacramento*, A. Koch, 1870; Plate 5), and a painting (*Sacramento Railroad Station*), C.W. Hahn, 1874, De Young Museum; Plate 4). However, to refer to this structure as "The Arcade Station" is probably a misnomer, as the term applies only to its architectural style. The north and south ends, as well as possibly the west side,

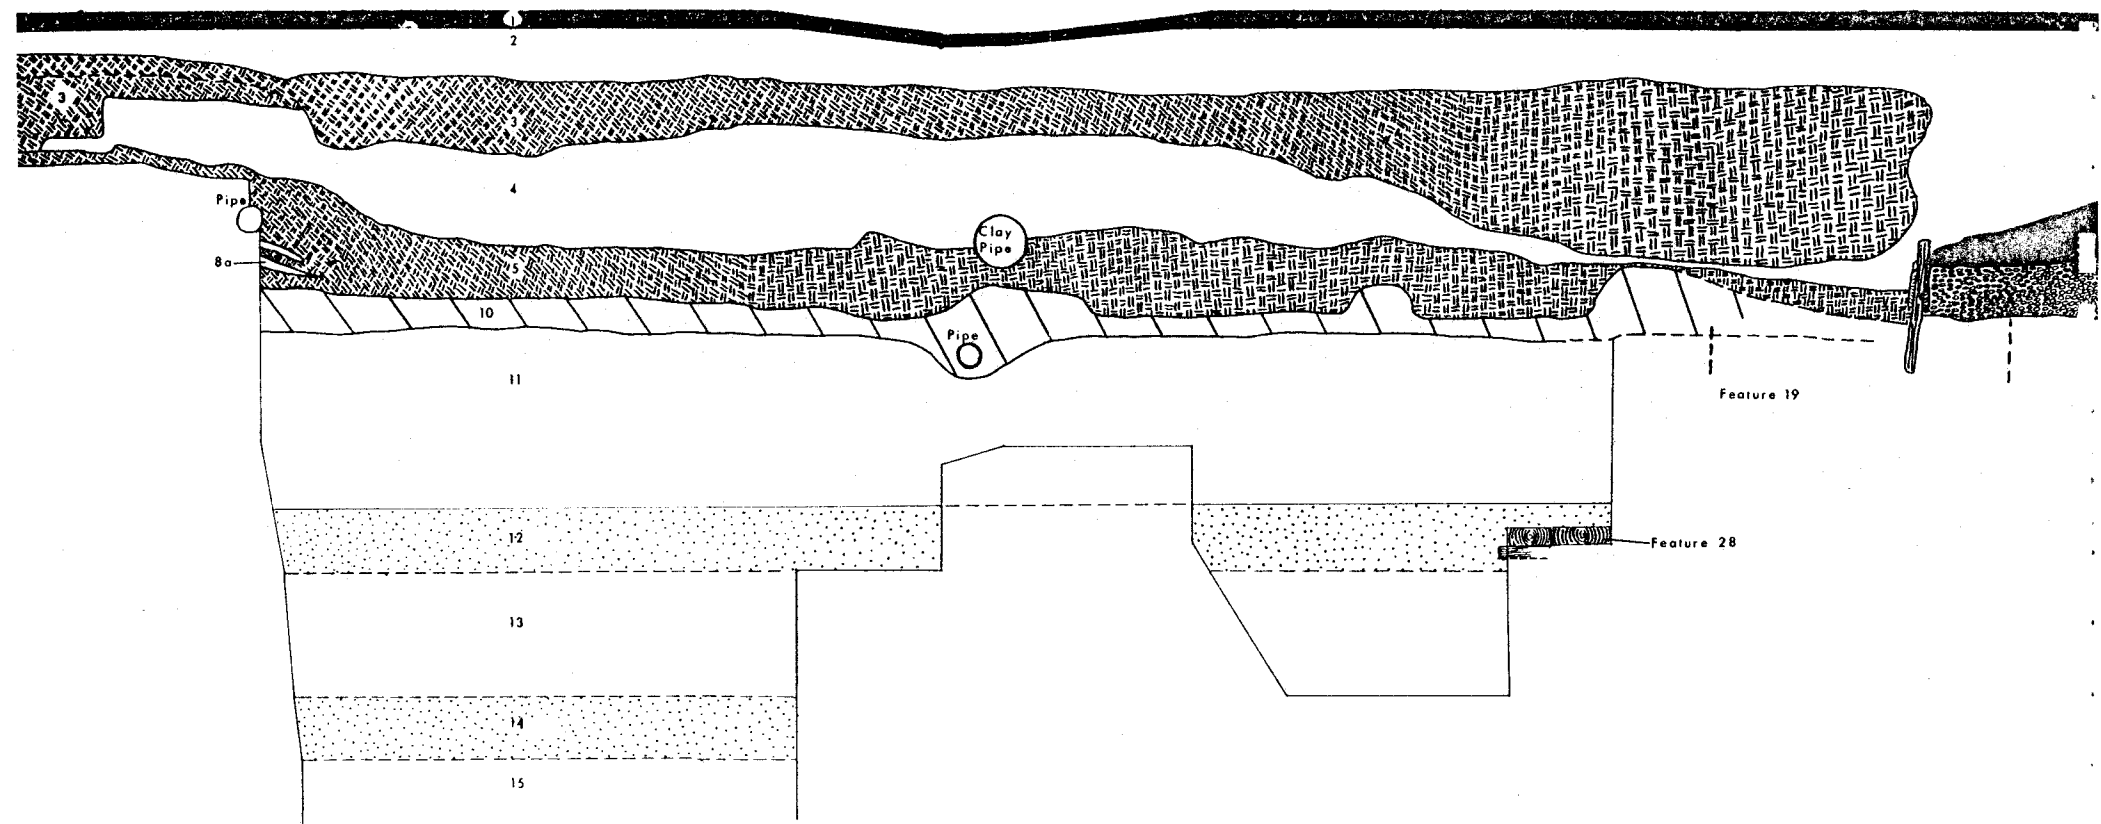
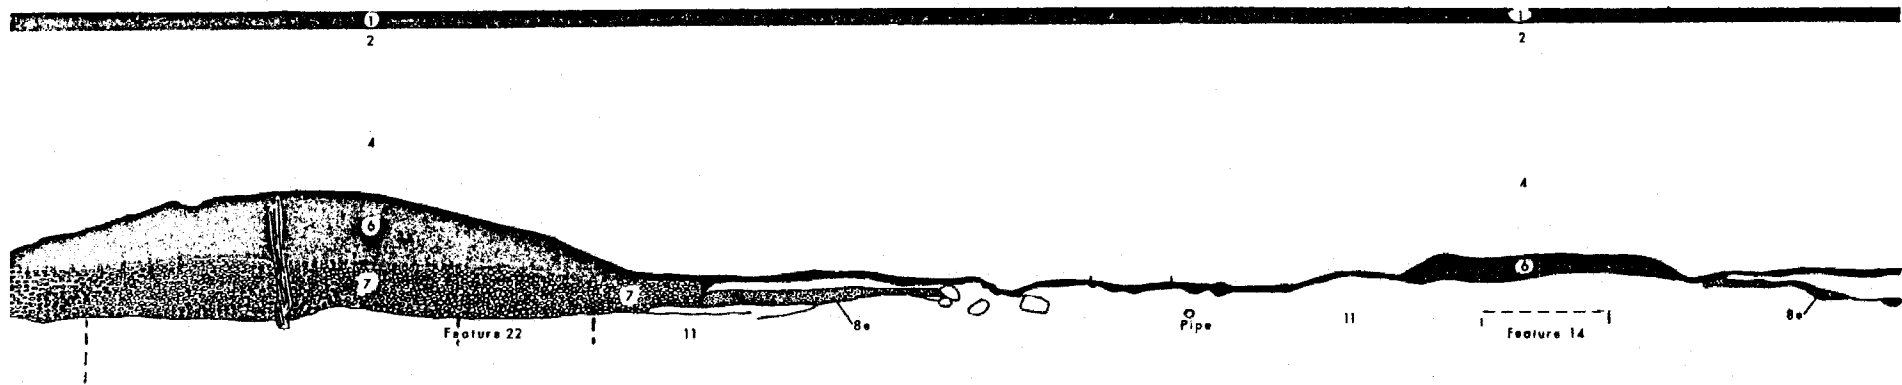
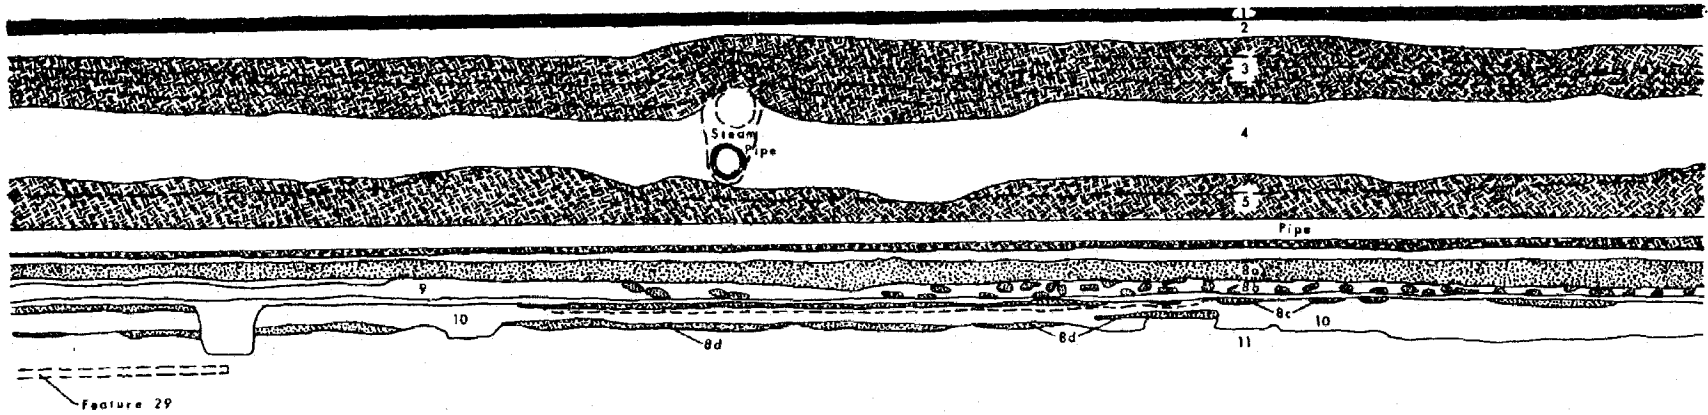
Figure 3
STRATIGRAPHIC PROFILE

The following are brief descriptions of the major distinct stratigraphic levels encountered during the excavations of the Central Pacific old depot site in September 1975. They were numbered sequentially, with numerically smaller strata designations generally superimposed over and postdating levels bearing large numbers. These strata are referred to by these designations on the accompanying profiles (Figs. 2-6, inclusive).

Stratum 9 – Deposit of loose sand and gravel occurs beneath Stratum 5 and 8-a in the extreme western area of the site. This probable track bed deposit rests in a square-bottomed depression comparable to that noted for Stratum 5. This stratum appears to be roughly contemporaneous with Stratum 8-b (see Fig. 5).

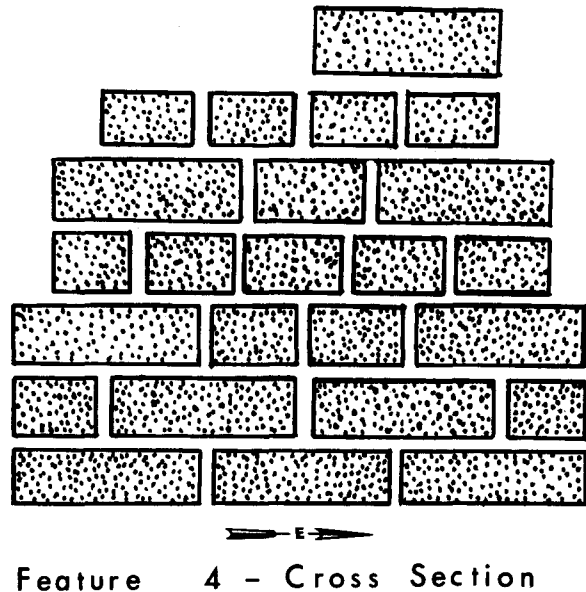
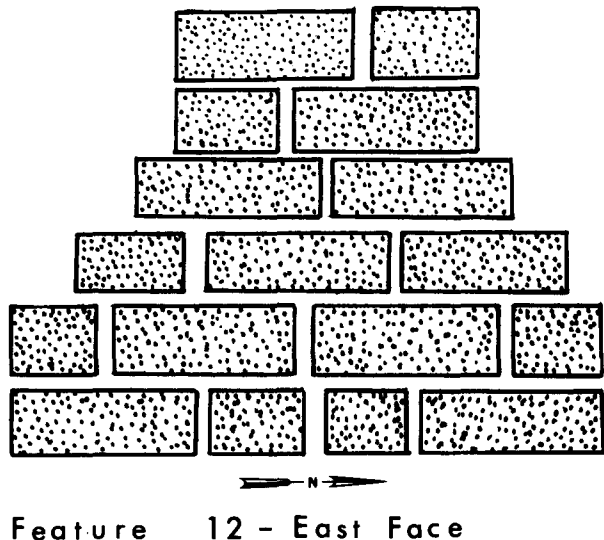
Figure 7
DIAGRAMS OF FEATURES
4 AND 12 (BRICK FOOTINGS)

The brick footings (Features 7, 10, 12, 14, 15, 18, 20, 22, 23, 24, 25, 26) are about 26 inches square, and, like Feature 4, have progressively higher tiers inset from those below (see

accompanying diagrams of these architectural features). The small, square footings are uniformly spaced, about 9'-3" to 9'-6" apart, center to center, from east to west, and about 7'-10" to 8'-2" apart from north to south. This pattern is broken only by the absence of footings west of Feature 18 in Unit D and between Features 14 and 22 in Unit B. A pile of semi-articulated brick (Feature 27) was located in Unit B. This appears to be the remnant of one of the square brick footings. Feature 27, slightly to the west of Feature 19, rests on the top of an apparent extension of Stratum 5 (gravel roadbed deposit) which in turn partially overlies Feature 19, the westernmost double brick footing.

Most of the small footings had been damaged at some time before the deposition of the thick layer of sandy clay (Stratum 4) which covered them. They appeared to have had their upper layers removed, with those furthest south having only two tiers of bricks remaining, while those to the north remain somewhat more intact. It appears that this damage may be the result of a leveling process during which the upper portions were removed. Mortar on the top of the truncated foundations does indicate that they, in fact, did support added tiers of brick.

The upper surfaces of Feature 4 (the long, north-south brick foundation) and 19 (westernmost double brick footing) have also been damaged, and show evidence of having had concrete poured on their upper surfaces. Feature 19 exhibits chunks of concrete adhering to its fragmented upper surface, and more concrete chunks were found in the fill immediately above it. Portions of a concrete form remain, also constructed with round nails. This appears to have consisted of 1-inch boards attached to either side

of a long stake. Feature 4 had numerous pieces of concrete resting on and conforming to its upper surface along its entire length. Portions of the uppermost tier of brick are missing in many areas. In the southern area of Unit D a large chunk of concrete with these bricks still attached was located during the removal of overburden.

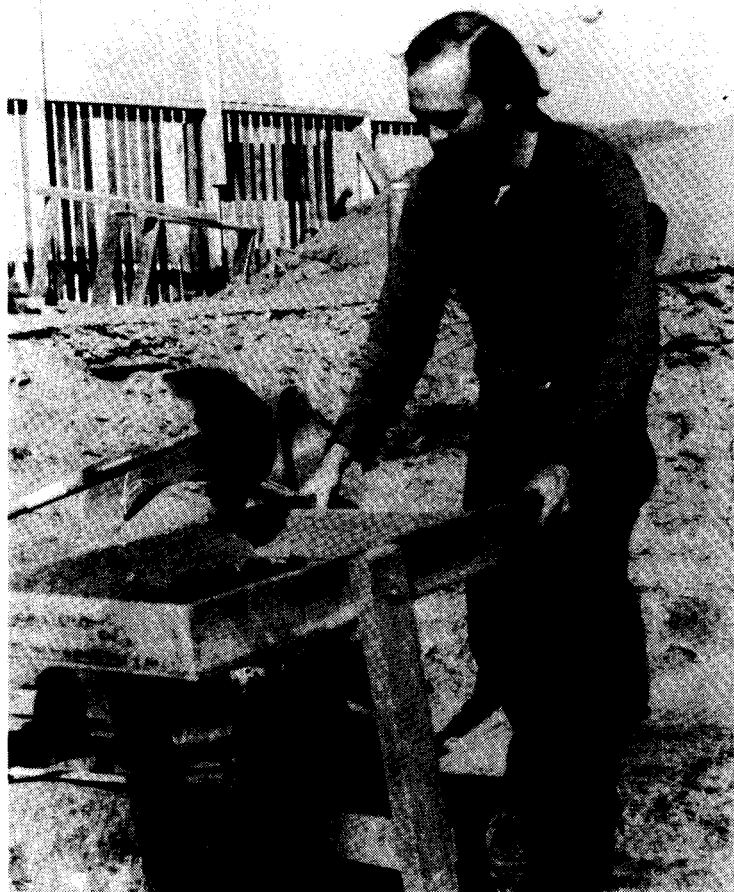
PLATE 6. CPRR EXCAVATION SITE.

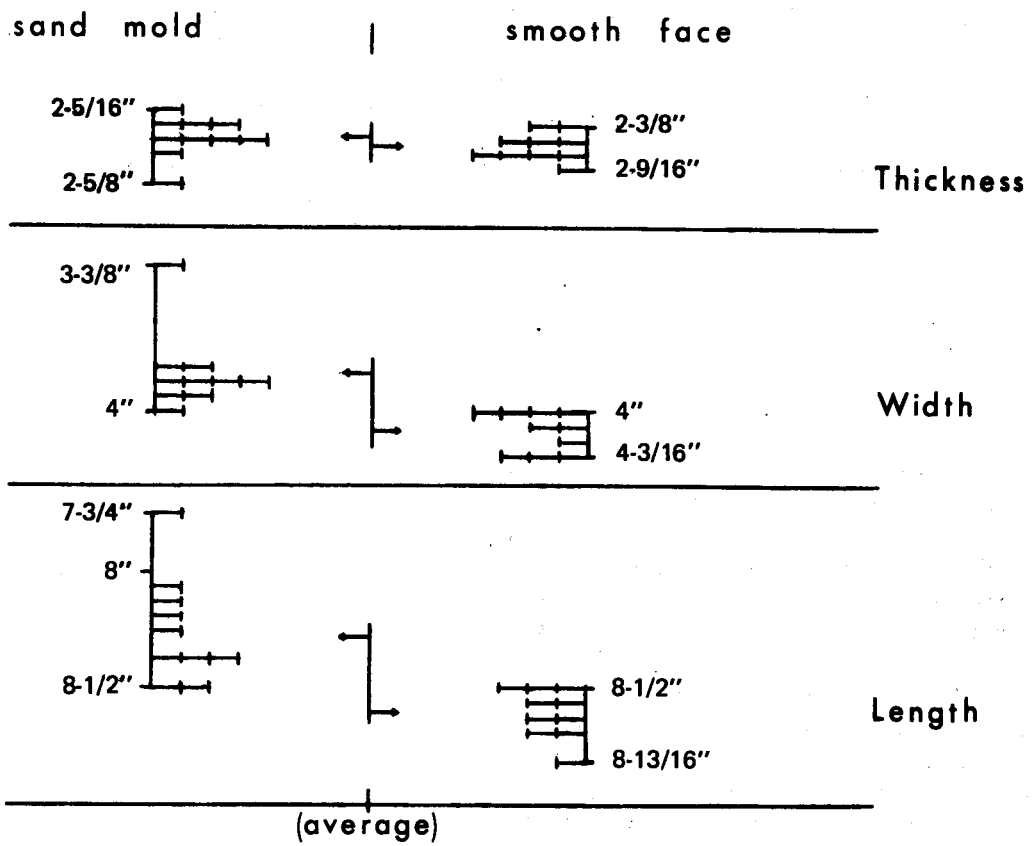
Figure 10A

Brick Dimensions

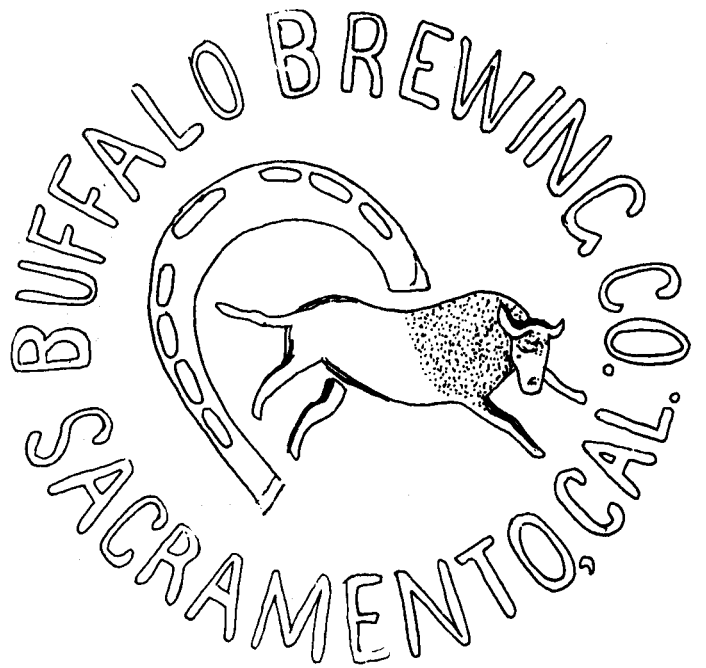
Figure 11

Figure 11A – Brown glass beer bottle, 11¼ inches high (Unit D, Component 1). Raised lettering and symbol on body – *BUFFALO BREWING CO. SACRAMENTO, CAL.* The letters *PCGW* appear in raised letters on the base. These initials were used by the Pacific Coast Glass Works, San Francisco, between 1902 and 1924 (Toulouse 1971, p. 416). The Buffalo Brewing Co. is first listed in the 1891 *Sacramento City Directory* and last appears in the 1929 edition. A white porcelain stopper with a leather washer and a wire fastener were found in situ. *PAT'DK. HUTTER, FEB 7, 1893* appears on the bottom of the stopper. The mold seams run vertically to within 1¾ inch of the lip. (Neck Finish Type 1).

Figure 11B – Brown bottle glass fragment (Unit B, Component 1). Portions of the words *Buffalo* and *Sacramento* in raised letters on exterior. Possibly this is a fragment of another Buffalo Beer bottle, exhibiting a variation of the logo appearing on the intact "Buffalo" bottle.

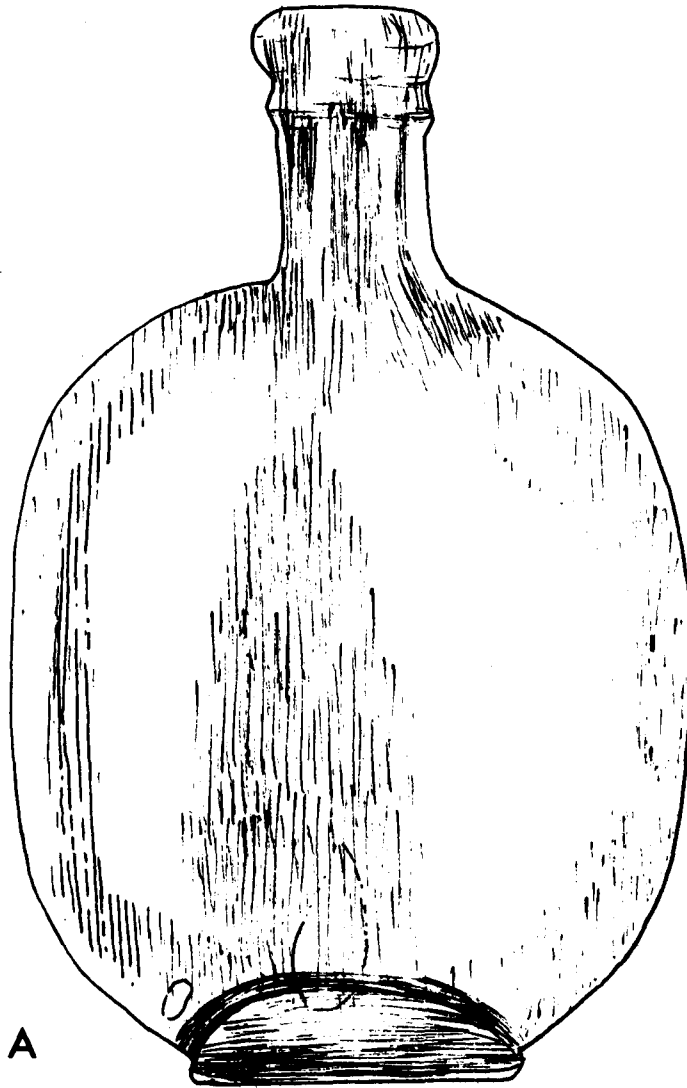
Figure 12

Figure 12B — Clear glass flask (Feature 35, Component 1) 6-1/8 inches high. Mold seam extends onto collar to within 1/2 inch of lip. This flask is designed for a screw type closure; the lip is heavily ground (Neck Finish Type 31).

Figure 12C — Clear glass flask (Feature 36, Component 1) 5 3/4 inches high. Very similar to bottle 12B, but has no neck; the collar sits directly on flask body. Indications of mold seam extend to lip. Collar is designed for screw type closure, but has more threads than bottle 12B. Lip is heavily ground (Neck Finish Type 31).

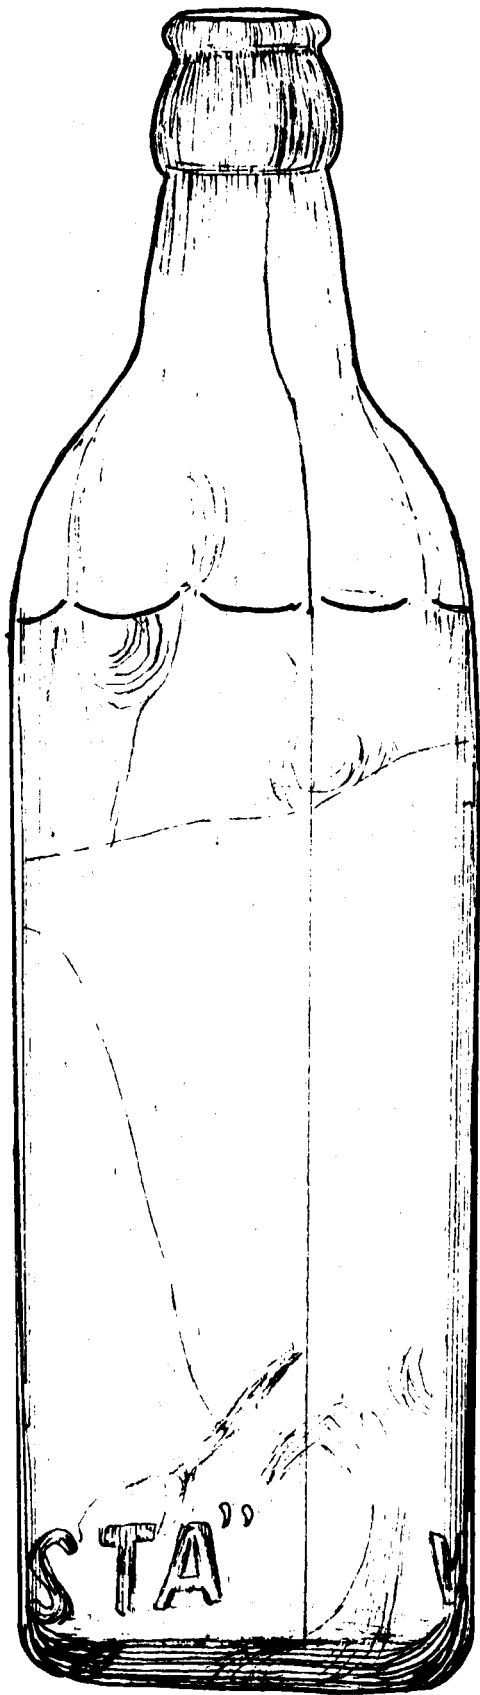
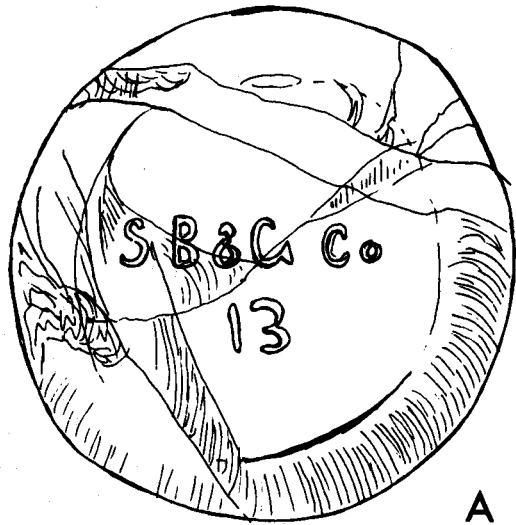
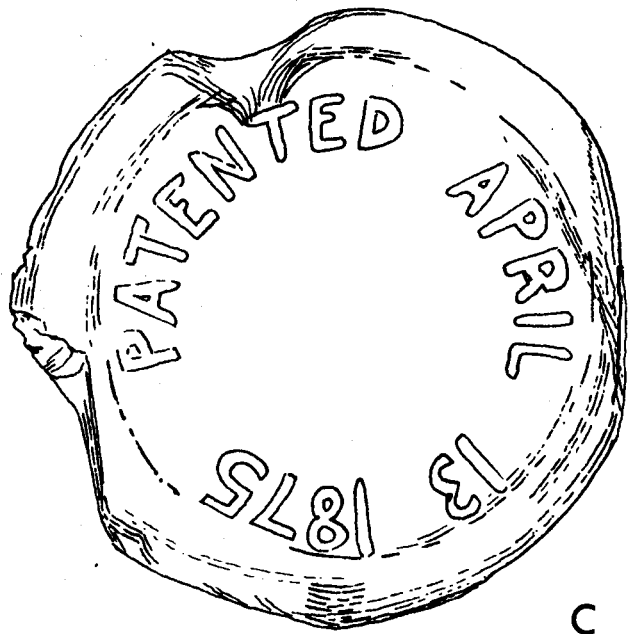
Figure 13

Figure 13A – Pale green bottle, possibly for soda, beer or water (Component 1) 9-5/8 inches high. *SB & G Co.* in raised letters on base. These initials were used by Streator Bottle and Glass Co., Streator, Ill., between 1881 and 1905. A white porcelain stopper was found with this bottle. Mold seams fade about 1½ inch from lip. (Neck Finish Type 1, 8).

Figure 13B – Clear to greyish water bottle (Stratum 6, Component 1) 8¾ inches high. “*SHASTA*” *WATER CO.* appears in raised letters around base. Mold seam extends to within 1 inch of lip, with horizontal striations above that point. “Pop bottle” (crown cap) type neck finish.

Figure 13C – Basal fragment, blue-green bottle or jar (Stratum 6, Unit A, Component 1). The phrase *PATENTED APRIL 13, 1875* appears in raised letters around the center of this object.

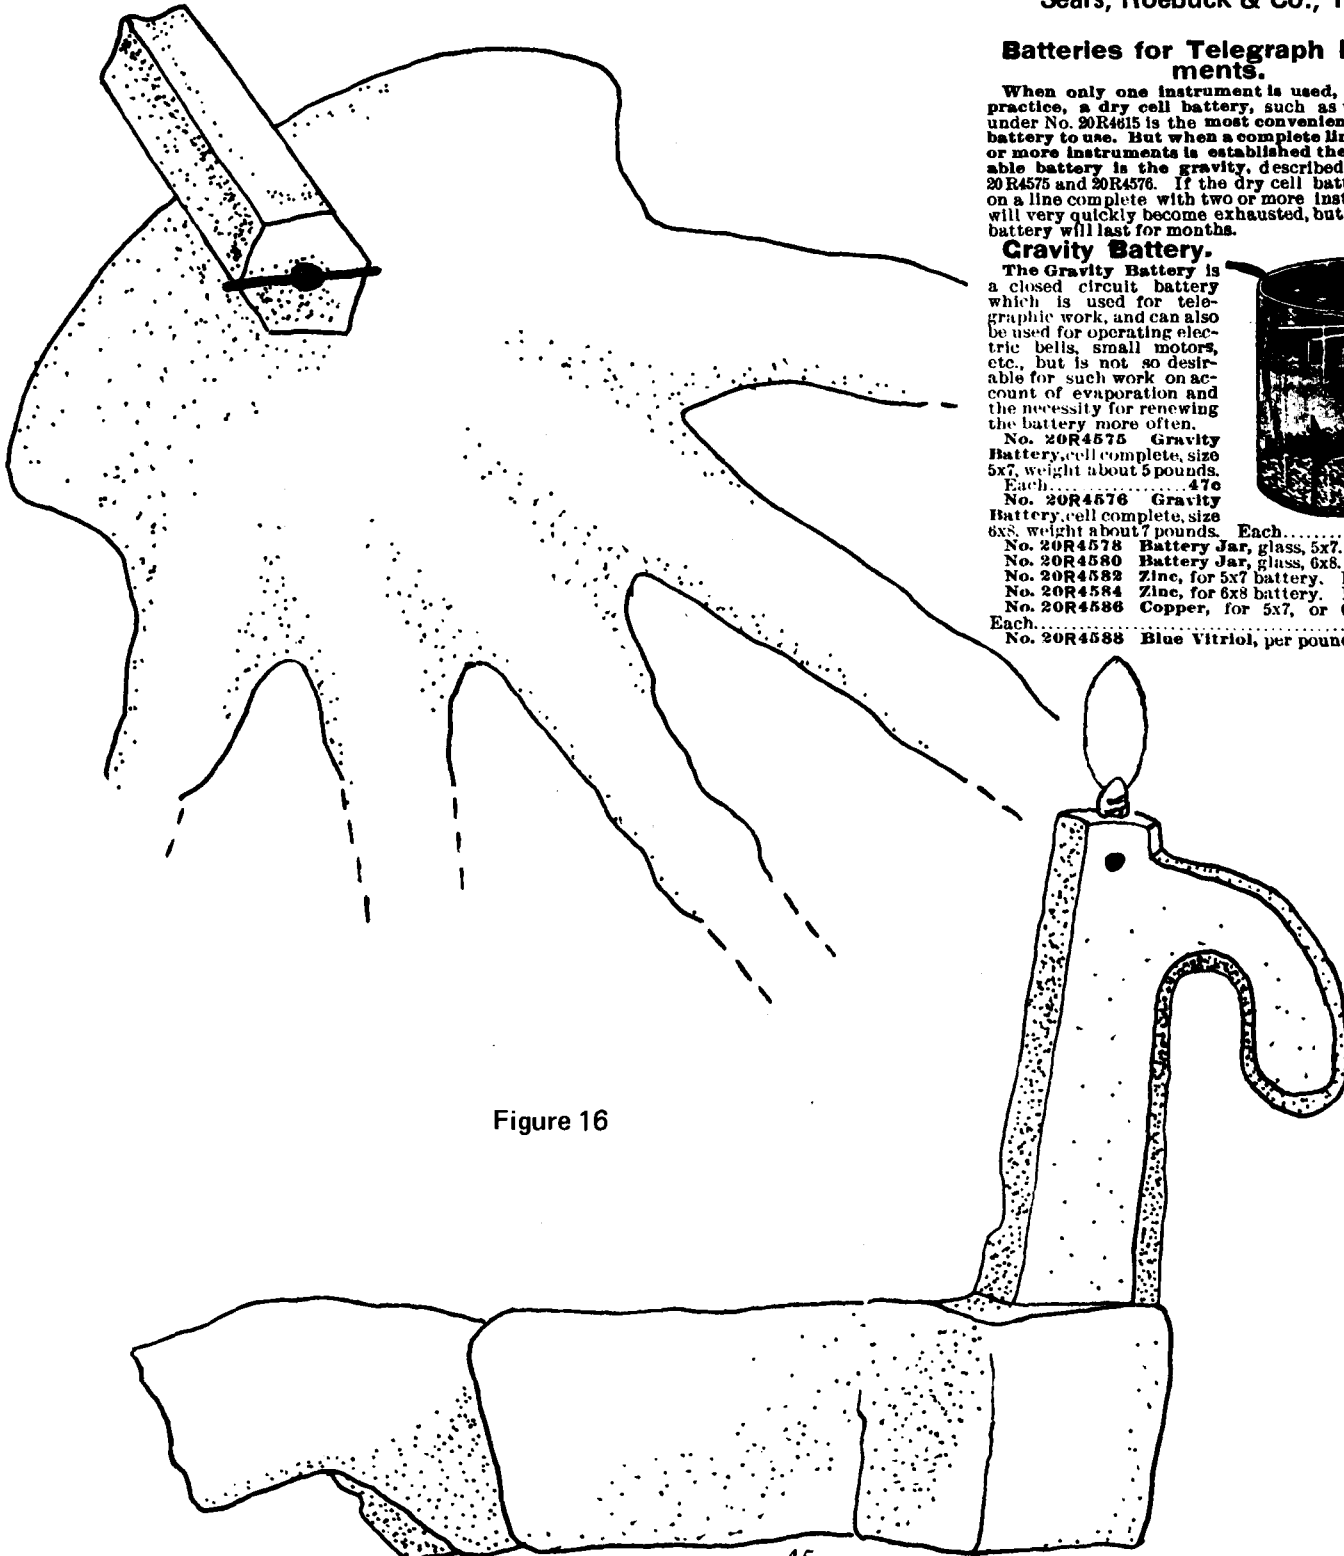
Figure 16 – Zinc electrode for wet cell gravity battery of type used for telegraph instruments (Sears, Roebuck & Co. 1902 Catalogue, p.

151). Seven of these objects were recovered in Stratum 6 and in fill of Feature 36. These are very corroded, but identifiable as they are almost identical to the illustration in the 1902 Sears Catalogue.

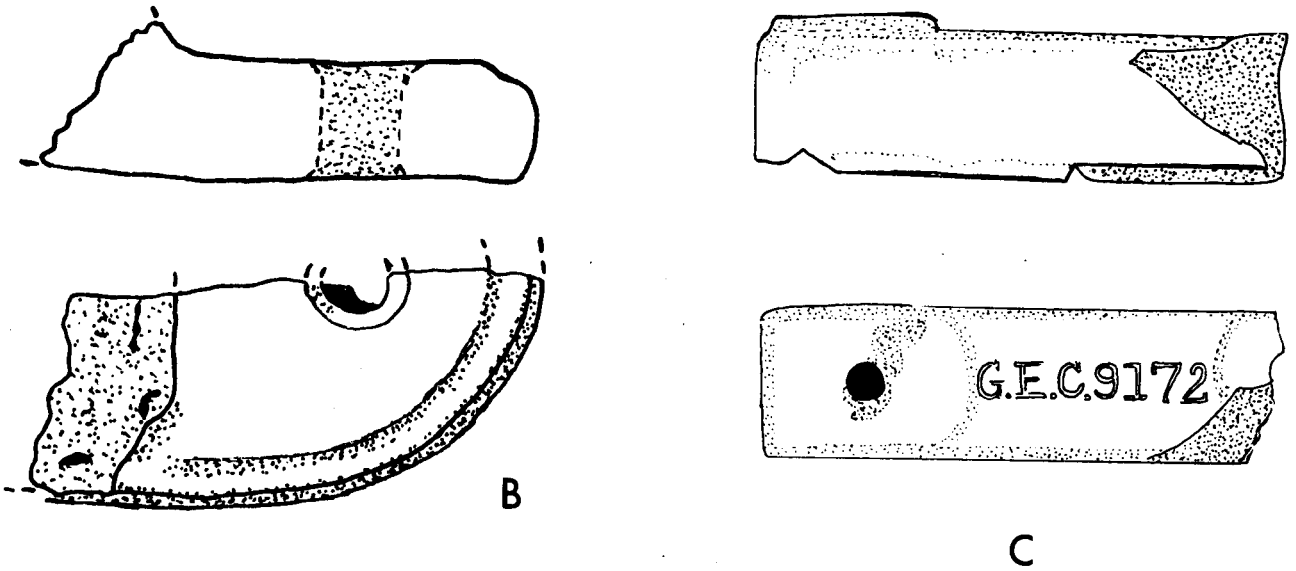
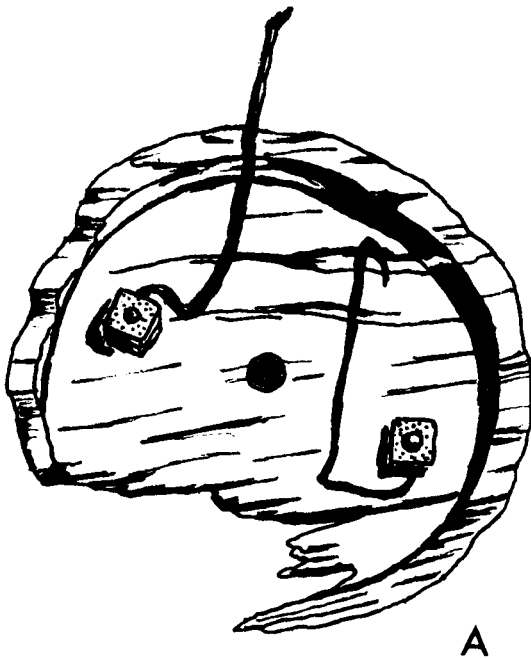
Figure 18A – Circular wooden object with two copper wires attached to small brass lug nuts. A small copper sleeve is fitted into the hold through the center of the wooden dish. The function of this object is unknown, although it is suggested that it may be a battery element.

Figure 18B – Fragment, ceramic electric insulator (Component 1).

Figure 18C – Upper portion, 2-wire, porcelain electric “cleat” insulator (Component 1) bearing the figures *G.E.C. 9172*.

Figure 18D – Unidentified lead objects (Component 1) 15/16 inches long, 1/4 inch in diameter.

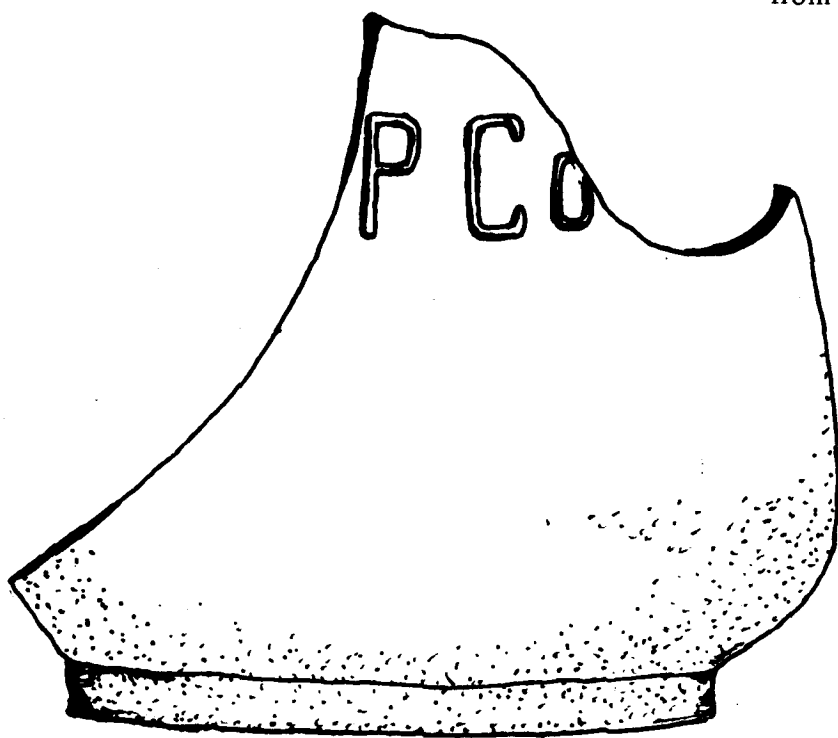
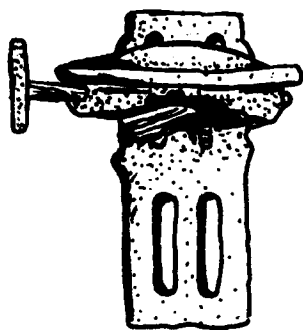
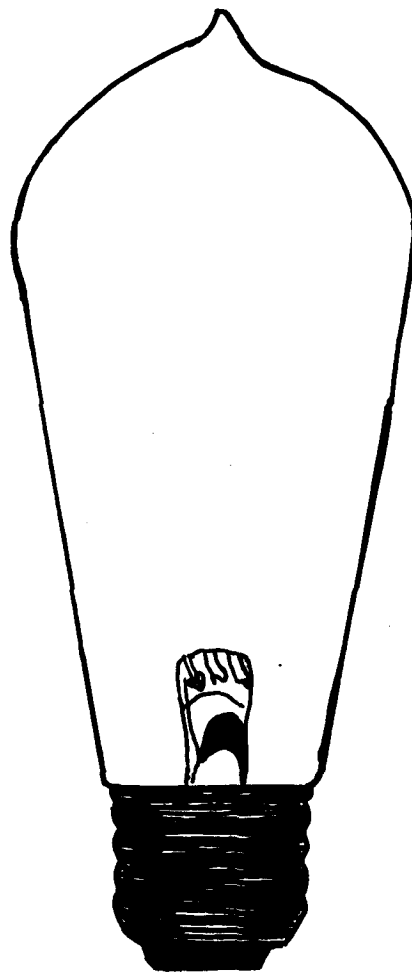
Figure 19

Figure 19C – Light bulb and several brass bulb bases (Unit A, Stratum 6, Component 1). Bulb was broken when recovered; Figure 19C is an artist’s reconstruction from fragments. The letters G.E., in several cases, were written on remaining glass portion of filament assemblage. These probably postdate 1895, the date that electric power from the generating plant at Folsom became available to the residents of Sacramento. Bulbs of this general form, however, were utilized for special applications as late as 1941 (see “carbon lamp,” Westinghouse 1941 catalog, p. 248). This bulb and the several bulb bases indicate a post-1895 origin for the Stratum 6 from which they were recovered.

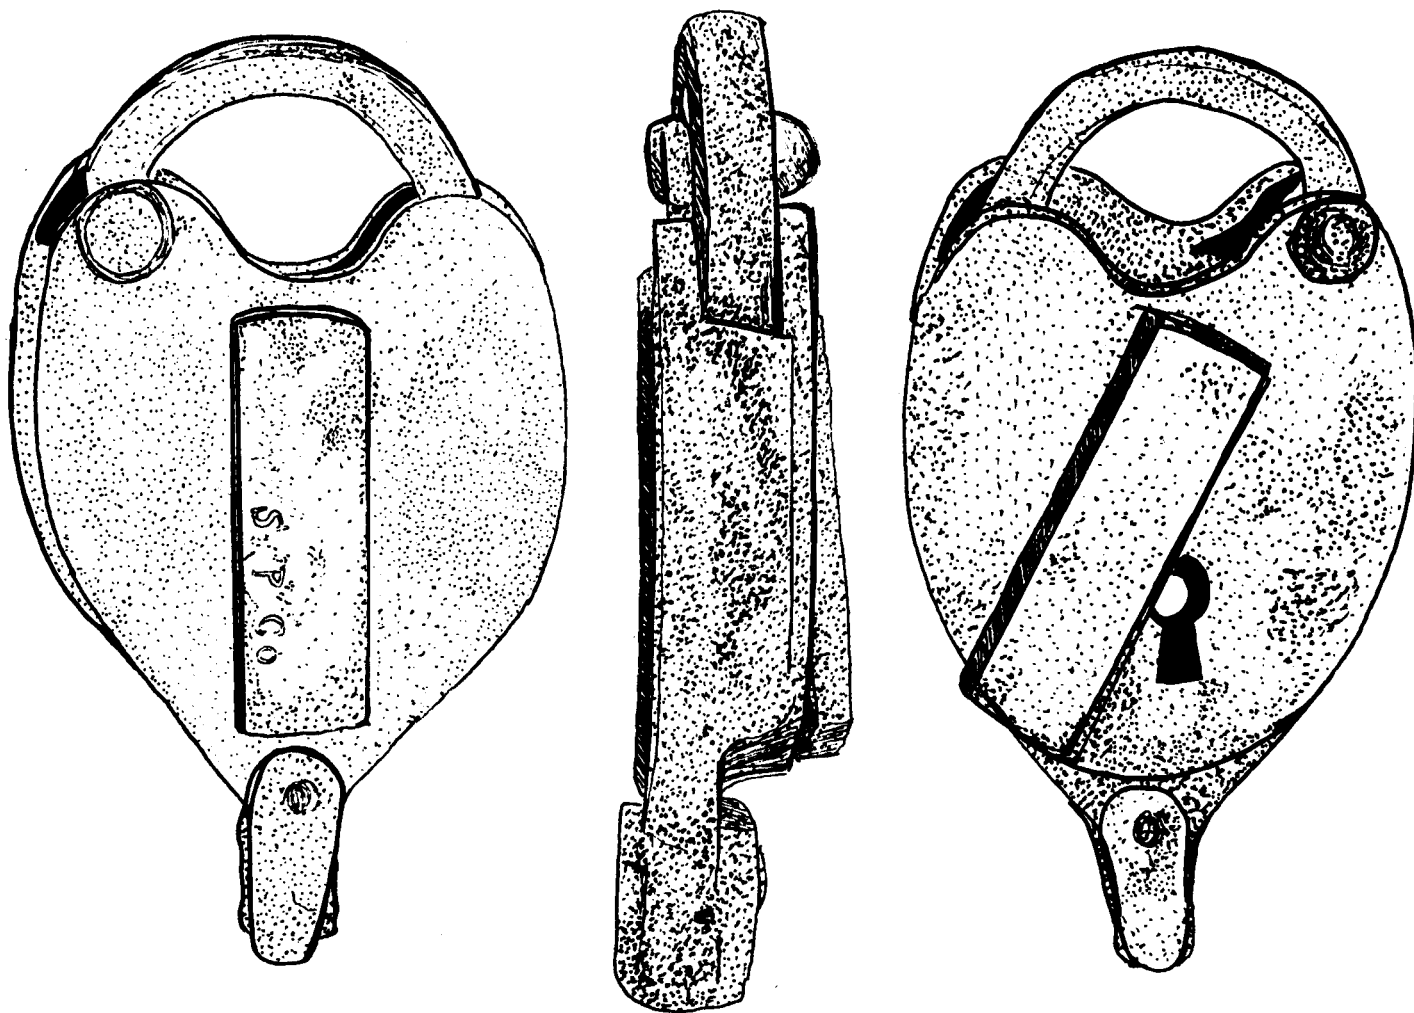
Figure 21 – Brass Padlock (Stratum 6, Unit A, Component 1). The letters *S.P. Co.* are stamped into one face of the body, probably referring to Southern Pacific Railroad Company. A very similar lock is pictured on page 546 of the Sears and Roebuck catalogue 1902.

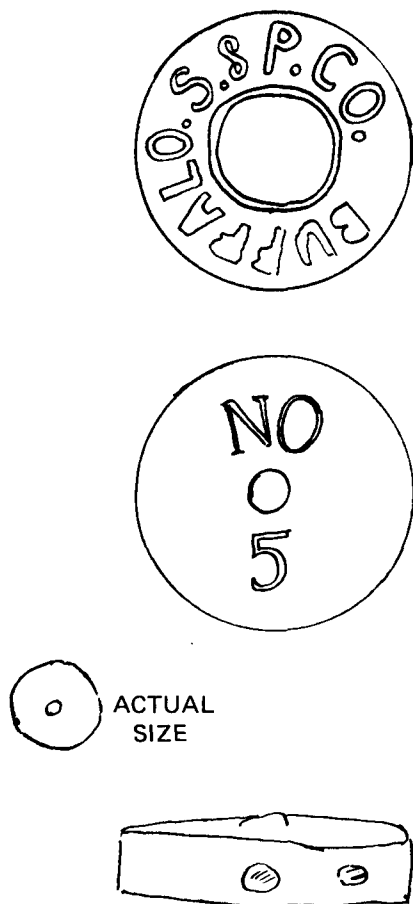
Figure 22 – Six soft lead seals of the type fastened by crimping to a loop of wire passed through the holes in the body of the seal, like those used to seal utilities meters, etc. (Stratum 6, Unit A, Component 1). They bear the raised letters *BUFFALO .S.&P.CO.* on one face and the numeral *NO 5* on the other. This does not appear to refer to the Buffalo Brewing Co.; possibly the initials represent the firm which manufactured the seals.

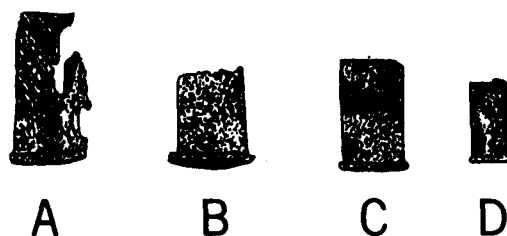
Figure 23

Figure 23A – Brass shell cartridge – (Feature 29, Component 2). .38 caliber short, center-fire, no markings apparent.

These cartridges (Figures 23A–D) were tentatively identified by Karl Gurke, using page 580, Sears and Roebuck 1897 catalogue as primary reference.
