## ARCHAEOLOGY AND HISTORY IN AÑO NUEVO STATE PARK

## *Part I: Archaeological Investigations*

## *Part II: Historical Documentation*

*NUMBER 26, 2009*

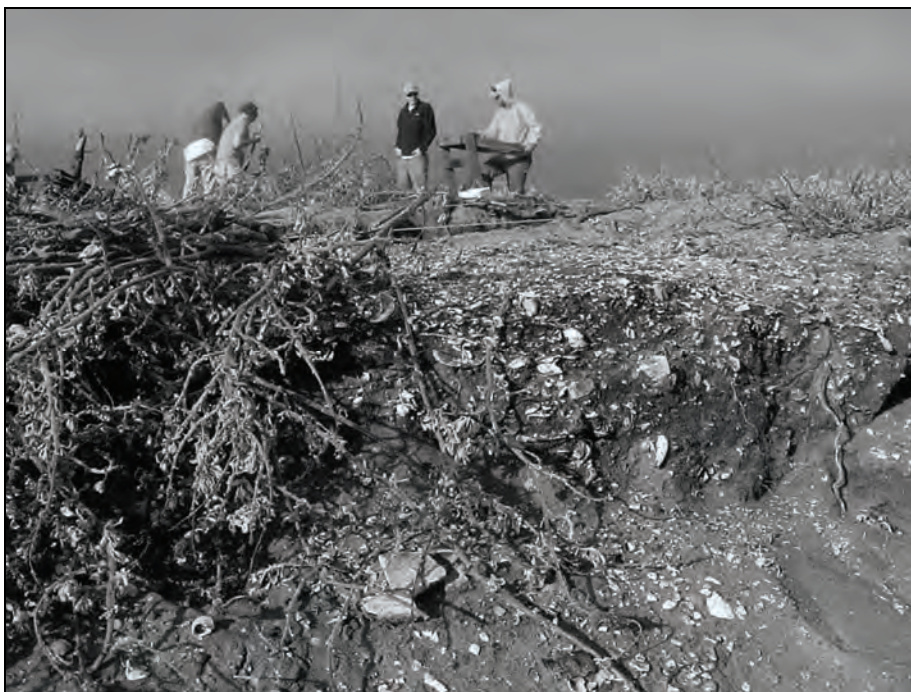
Figure 4. Eroding Eastern Margin of CA-SMA-18.

At the time of the 2004 excavations, intact deposits covered an area of about 15 x 15 meters. Reduction in the size of these deposits is clearly evident at the site, particularly along its eastern margins where an eroded profile is exposed and the deflated archaeological materials lie scattered across the inter-dune depression to the east (Figure 4).

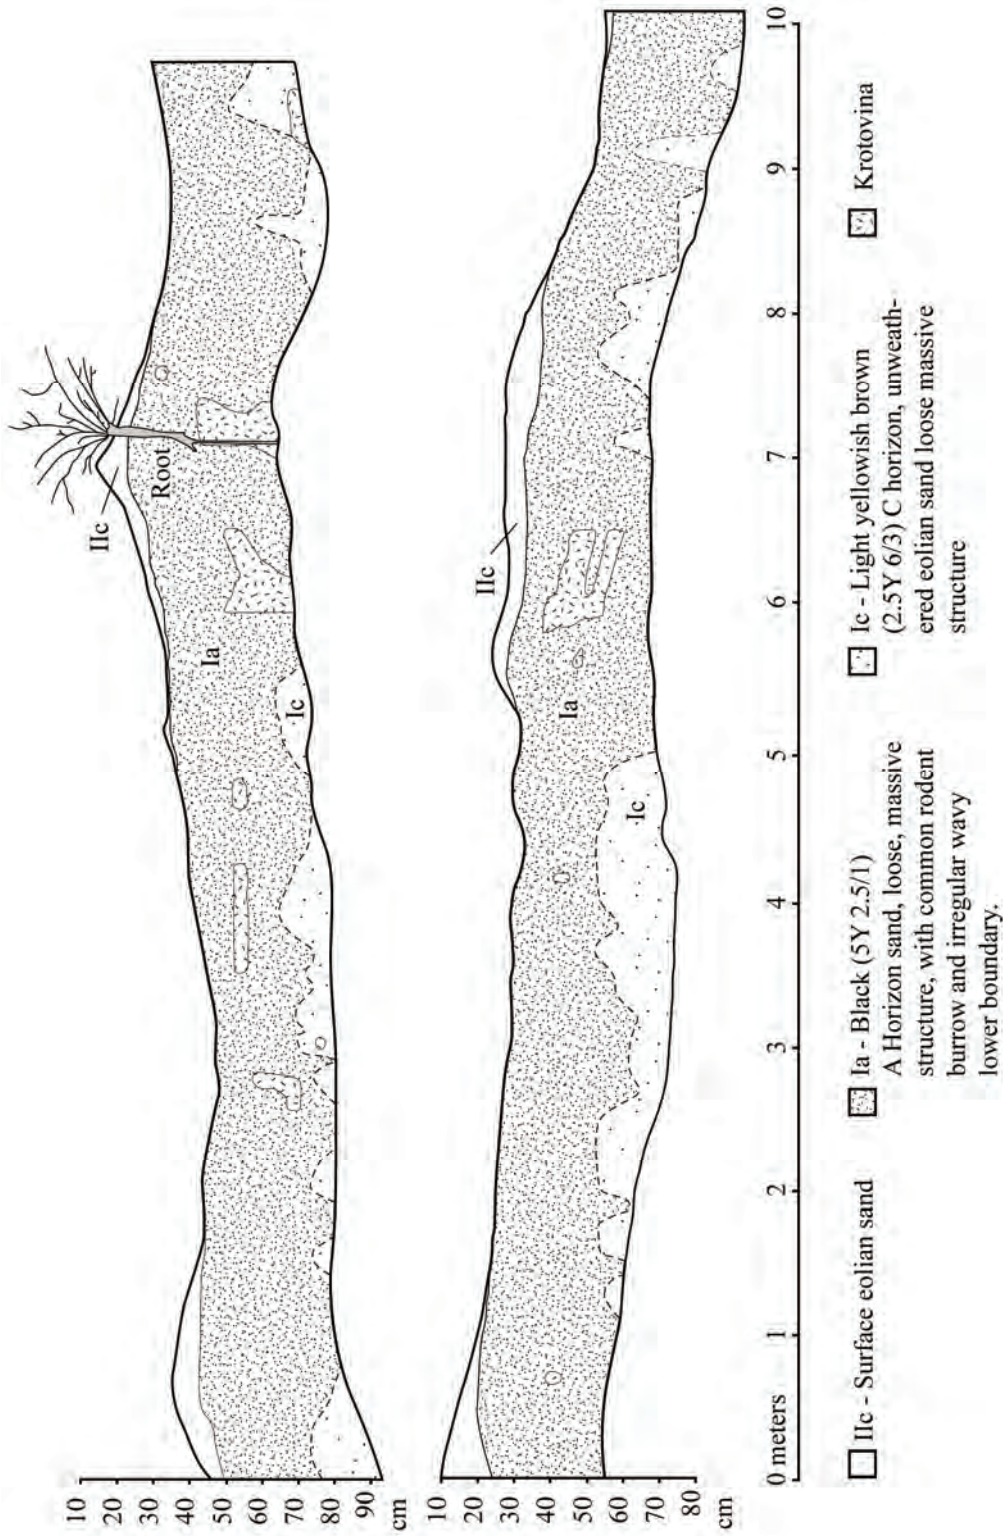
Figure 6. Stratigraphic Profiles from CA-SMA-18.

Stratigraphic profiles were drawn for both of the north-south trench lines (Figure 6). Both trenches exposed a black (5Y 2.5/1) “A” horizon of sand with a loose massive structure (Figure 6 and Figure 7). This soil horizon contains all the archaeological material in the site deposit and is reflected by the numerous flecks of shellfish visible in the profile. The dark, organic-rich color of the horizon is probably the outcome of both anthropogenic and natural processes, as charcoal from human fires combined with a long-term presence of stable vegetation can result in this level of discoloration. Portions of this soil/midden horizon are covered with modern aeolian sands, while it bottoms-out on a lower “C” horizon of light yellowish brown (2.5Y 6/3), unweathered, aeolian sand. The “A” and “C” horizons are separated by an irregular, wavy boundary and the lower “C” horizon sands also have a loose massive structure.

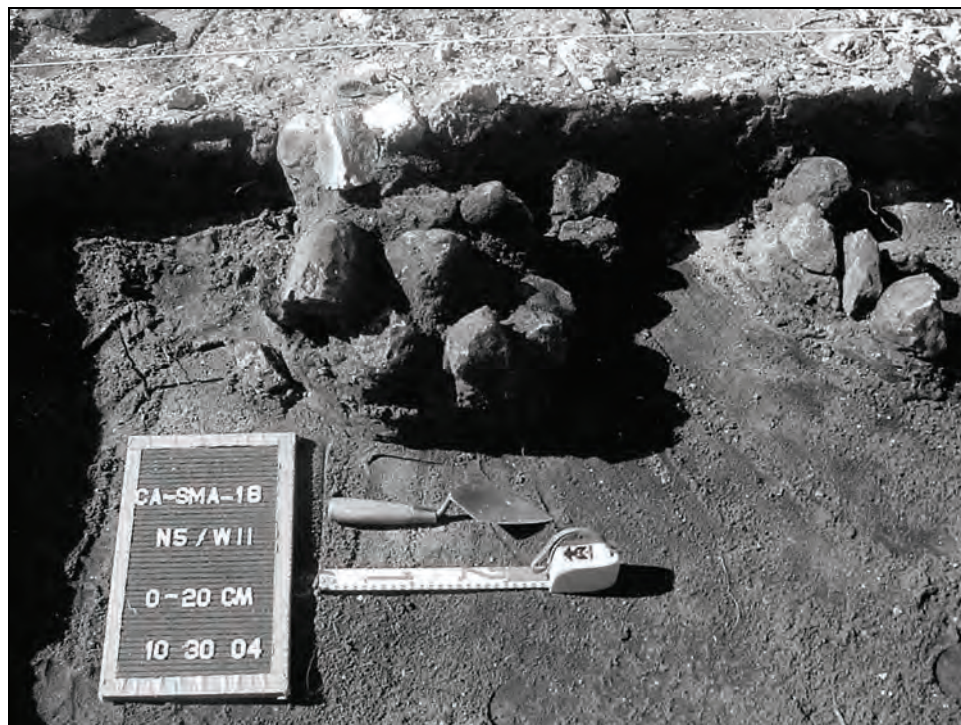
Figure 8. Feature 1 at CA-SMA-18.

Two features were discovered at the site—both are simple concentrations of fire-affected rock (Figure 8). Feature 1 was found in unit N5/W11 and is a tight cluster of fist-sized cobbles surrounded by a more dispersed scatter of stone. Some of the rocks were visible on the surface, and all were restricted to the upper ten centimeters of the deposit. Although the soil directly associated with the feature was quite dark and filled with shellfish, it was indistinguishable from the surrounding deposits exposed in the unit. No formed artifacts were associated with the feature. A flotation sample was collected directly below the rocks and yielded a small amount of wild cucumber, hazel nut, and a variety of small seeded taxa. A more detailed accounting of these materials is provided below (see *Charred Plant Remains* on page 31).

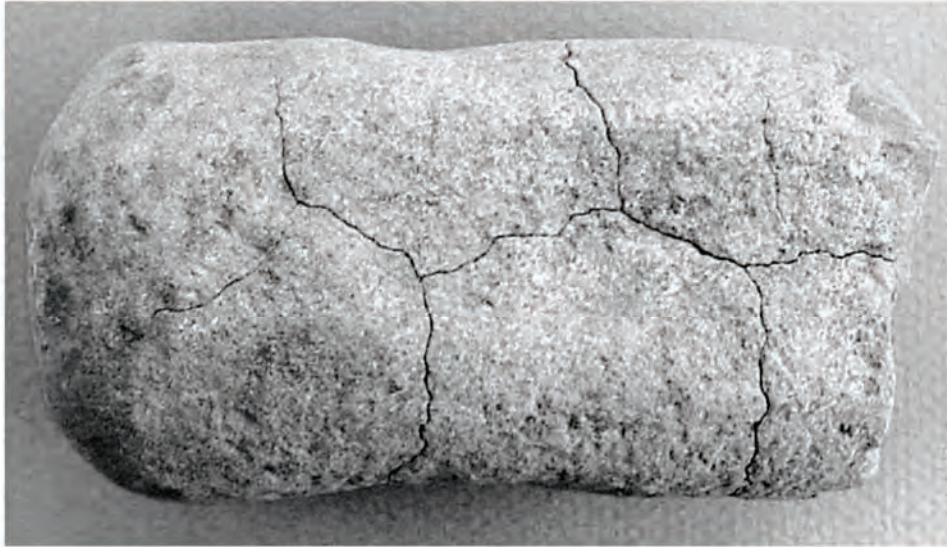
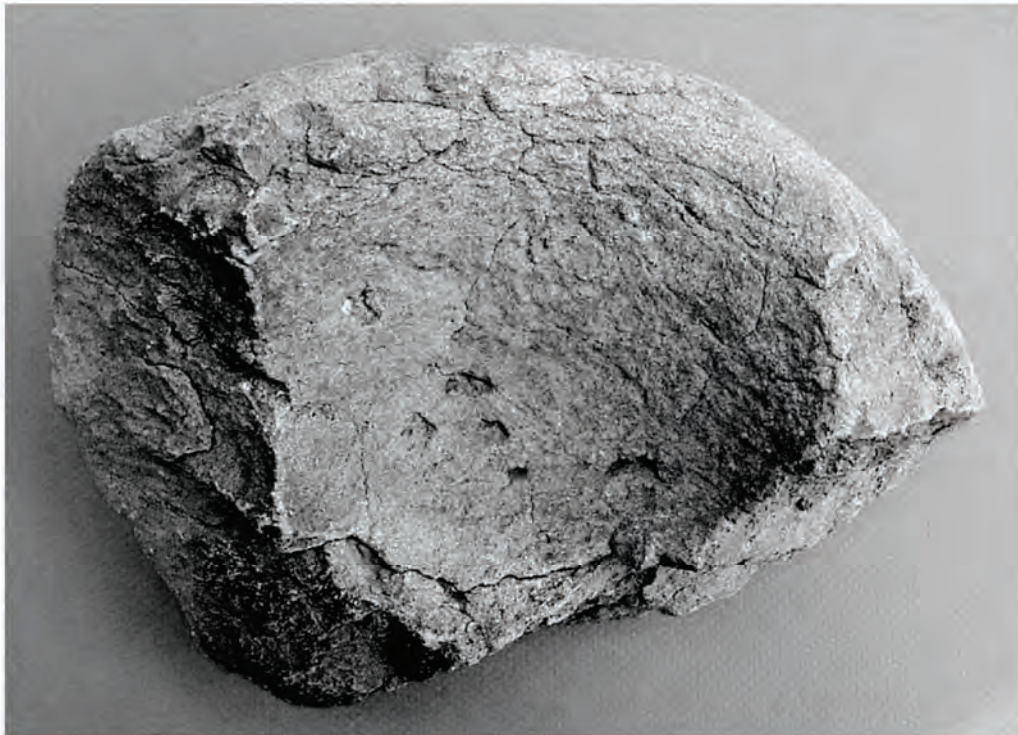
Figure 12. Surface Collected Milling Gear from CA-SMA-18.

-11  
Pestle  
0 5  
Centimeters

-10  
Mortar  
0 10  
Centimeters

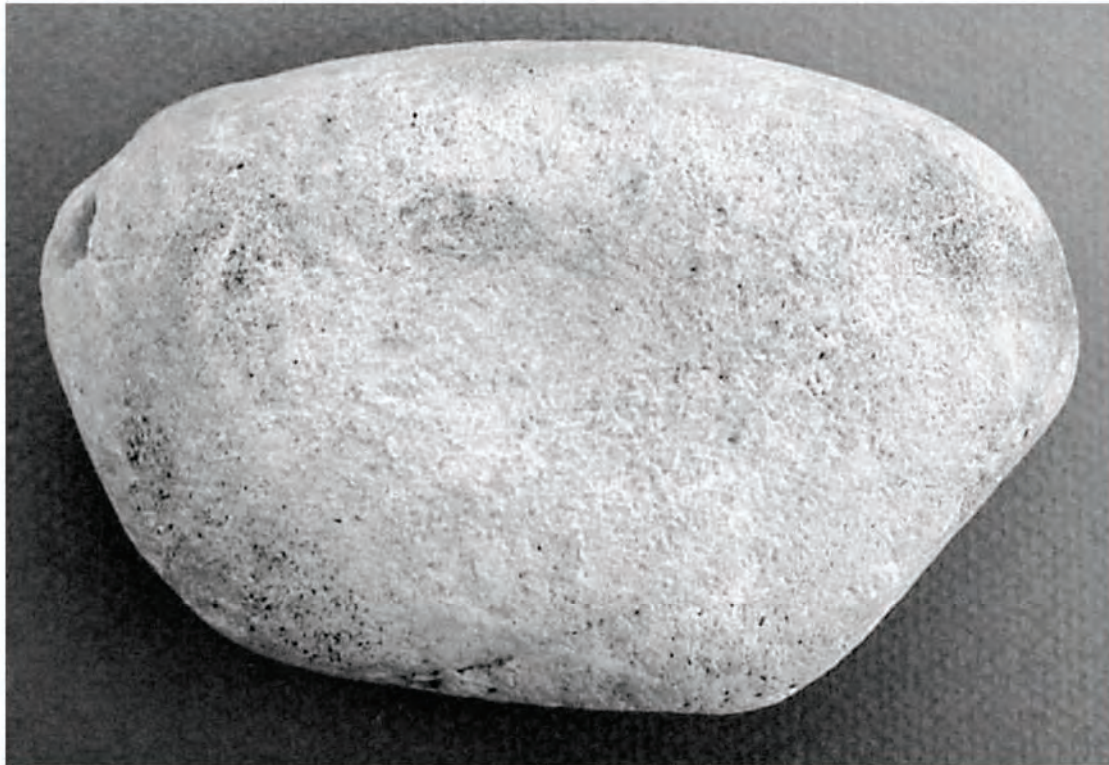
-35  
Pitted Stone

The ground and battered stone assemblage also includes eighteen grooved and notched stones. Eleven specimens have been notched with light to moderate pecking on two opposing margins and may have been used as net sinkers, while the others which have grooves around the circumference of the stone are thought to be sinkers for hook-and-line fishing (Figure 13; Hylkema 1991). Three specimens exhibit additional pecking on flat faces, indicating that the tools also served as pitted or anvil stones.

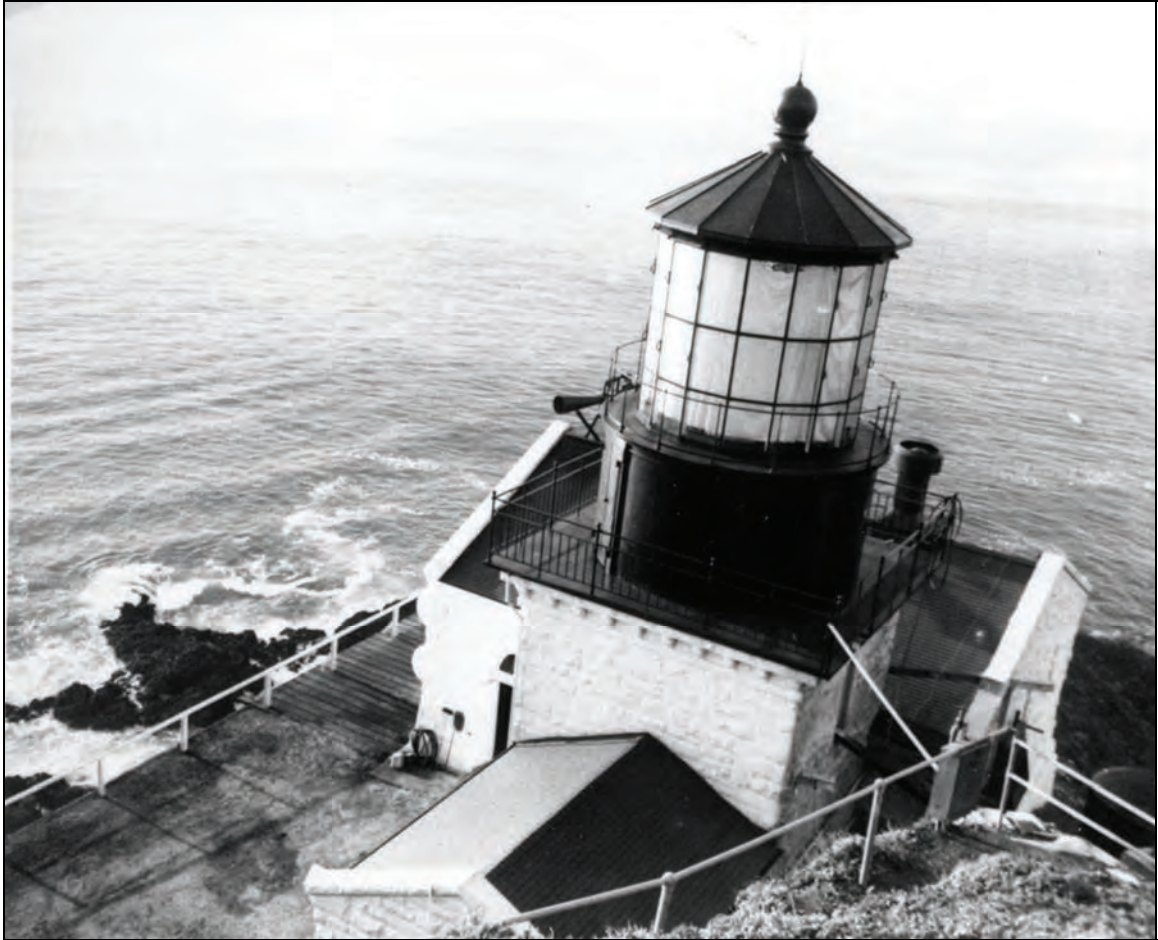
Figure 27. Point Sur Lighthouse, circa 1920s.

Regional differences affected the type of facilities installed. Lighthouses on the east coast tended to have tall towers to elevate the lens high enough to be visible at sea for several miles. On the west coast, however, shorter towers were built on rocky cliffs, high enough to project out to sea (Figure 27).

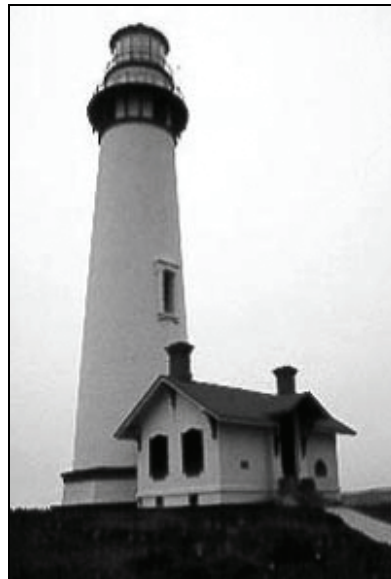
Figure 31. Pigeon Point Lighthouse showing attached Oil Room and Shop Structure.

Fuel oil was predominantly stored in the lighthouse in the early years, but by the early 1850s it was stored in basements or attached structures (Figure 31). By 1890, however, most lighthouses were using kerosene, which necessitated the construction of separate structures built of brick, stone, or concrete.

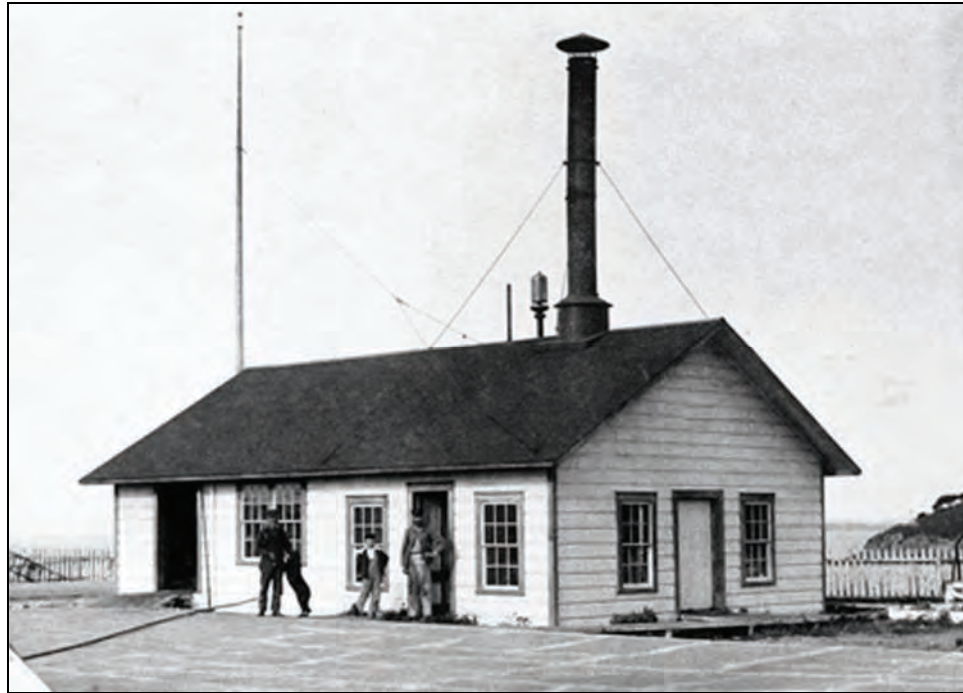
Figure 32. Fog Signal Building at East Brother Lighthouse, Richmond, California.  
*Steam whistle is immediately left of large smokestack. Photograph by Nels Stenmark.*

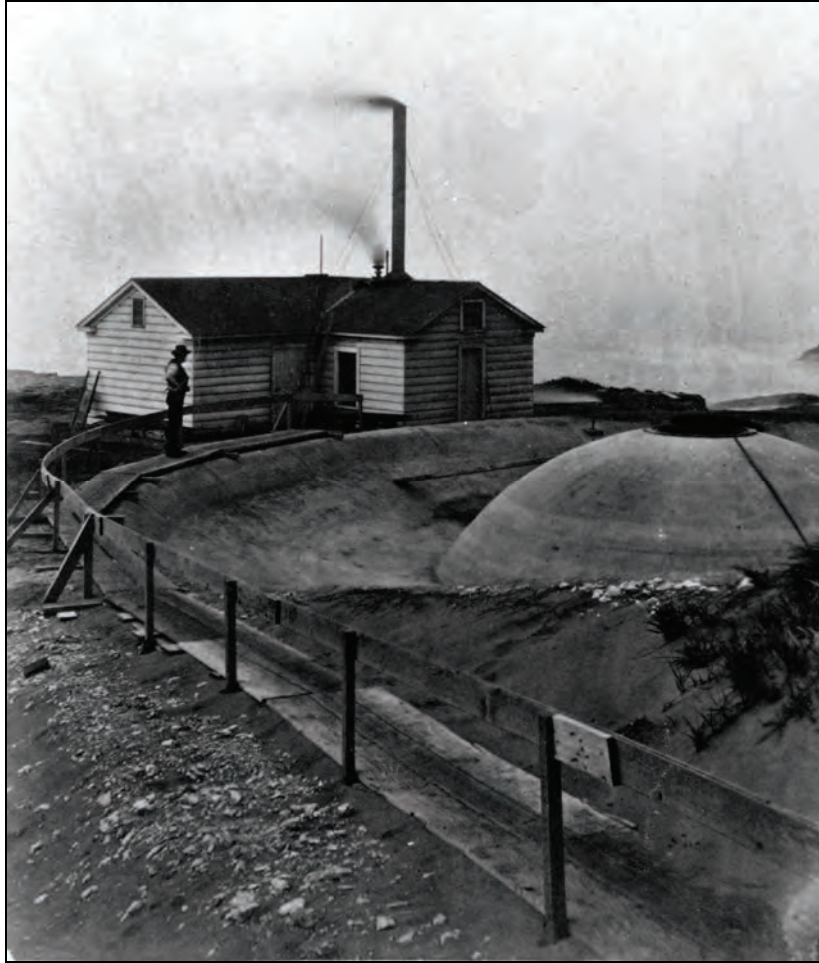
Figure 38. New Years Island Fog Whistle, circa late 1870s.

The combination of the fog whistle at Año Nuevo and a coal-oil light at Pigeon Point (built in 1872) were deemed the best way to warn the ships of danger along this stretch of coast. The Lighthouse Board published a notice regarding the new whistle on June 19, 1872, indicating that blasts of fifteen seconds were separated by 45 second intervals (Henry 1872, Figure 38). The wood frame gable building was constructed in an L-shape, with shiplap siding. The whistle required roughly fifty tons of coal per year to keep it operating. This was supplied to the island by ship. Because of the treacherous water surrounding the island, a row

*“New Years Island, fog whistle, blasts of 15 seconds with intervals of 45 seconds.”  
Courtesy of the California Historical Society. Photograph by E. Muybridge.  
Stereographs from the Pacific Coast series. Box 03: PC-RM-Stereos. FN-36238.*

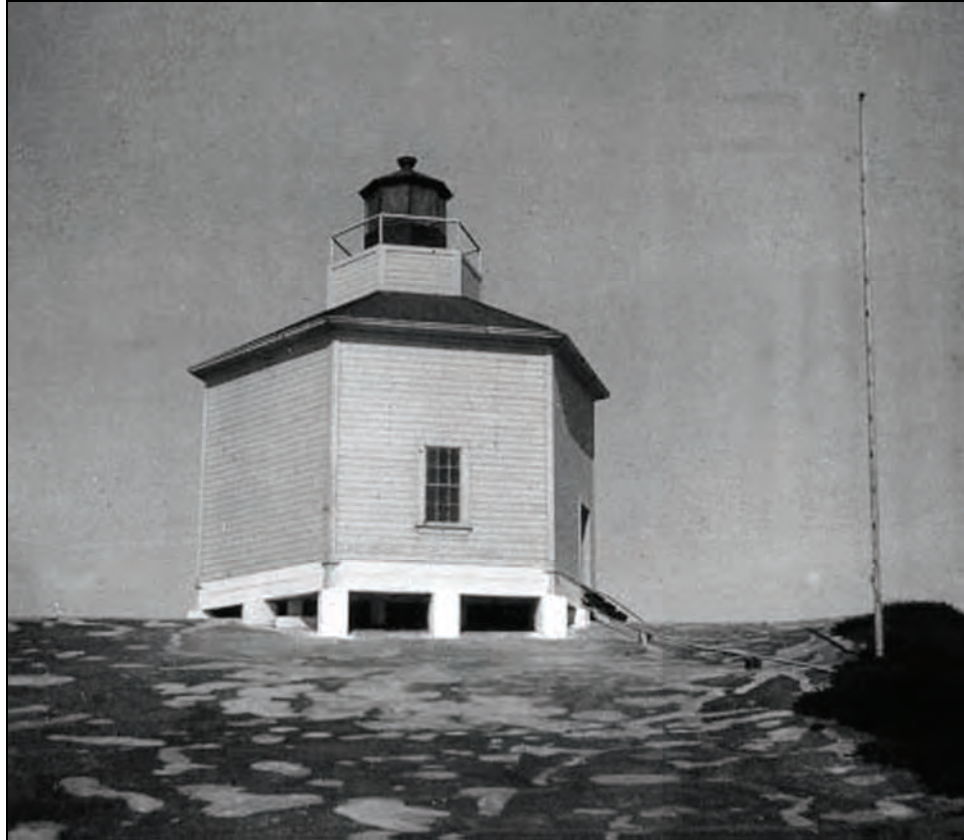
Figure 40. Tank House with Light at Top.

As a result of these hazards, in 1890, a light was installed on the island in order to bolster the warning system. Some indicate that the light itself came from the station at Point Montara (Wayne Wheeler personal communication 2005). The light consisted of an oil lens lantern and was listed as “Fixed White” in a description of the station a few years later. The lantern consisted of a polygonal lens with six sides, 6 feet in diameter. It was 32” in height, with one plate on each side, each measuring 16 inches by 32 inches by ¼ inch thick. Unlike other lights, this one lacked a balustrade, or many of the other embellishments typically found on lighthouses. It contained a wood door to the lantern, with a ventilator on top. The lamp itself was described as tubular, with one wick to the burner. A spare lamp and two spare lamp burners were kept at the station. The manufacturer of the lantern is not known. The light was originally installed on top of the water tank (tank house), supported by six inches by six inches wood posts on a concrete foundation, which was painted white (U.S. Lighthouse Establishment 1907, Figure 40). In 1911, the light was rated to have an effective range of 8.8 miles.

*Photograph taken prior to the construction of the light tower in 1913.  
Courtesy of California State Parks.*

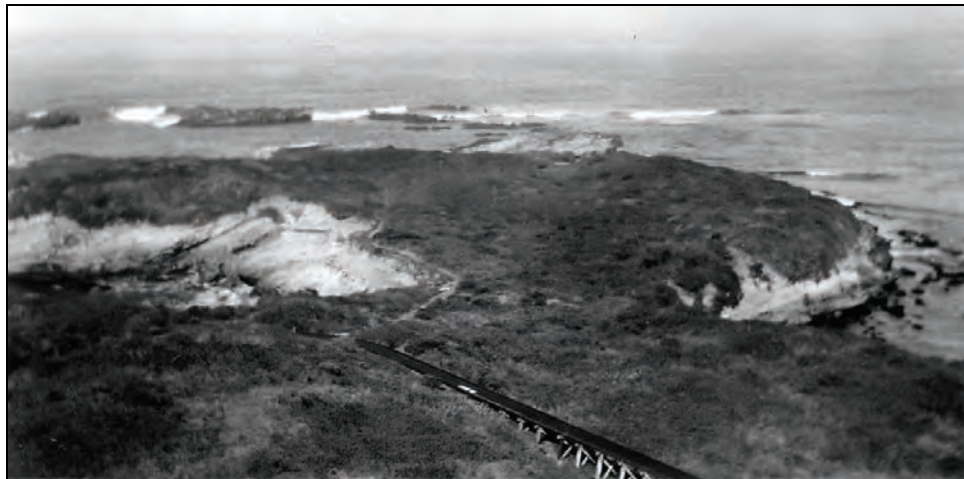
Figure 41. Portion of Tramway at North End of Island, 1926.

In 1894, the existing tramway was overhauled and repaired, with 675 feet of it renewed with iron rails being put down (Figure 41). The tracks were two inches wide by ½ inch thick. A turntable was put in place in order to eliminate a long curve at the north end of the island, thereby shortening the track. The trestle walkway from the dwelling to the signal building was also rebuilt. At the same time, a 4,500 gallon water tank was built. Two years later (1896), a larger 35,000 gallon water tank was built on a masonry foundation. In 1897, the keeper constructed a landing for the wharf, built with lumber salvaged from the beach supplemented with a small quantity provided to him (U.S. Lighthouse Board 1897).

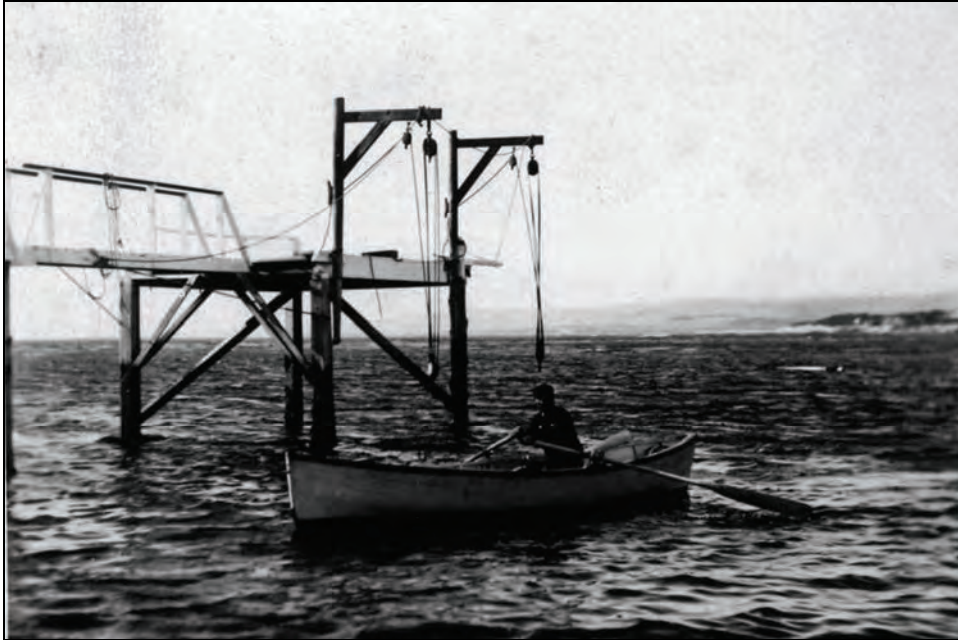
Figure 44. Row Boat at the End of the Pier at Año Nuevo Island, Unknown Date.

During this same period, a small frame structure with plate-glass panes was built around the lens lantern to protect it from the weather. A new building, known as the boathouse (or storehouse) was constructed at the landing at the pier (Figure 44). The boathouse contained two stories, with the lower on the beach level and the upper at the tramway. Inside the building, a hoist with block and tackle transported supplies for the fog signal from the landing to the upper story of the boathouse. From there, it was loaded into a tram car, which was pushed by hand all the way to the fog signal building. A boat dock extended into the water from the boathouse, and a coal house was built at the landing, to house not only coal but also oil in the upper part of the structure (U.S. Lighthouse Board 1900).

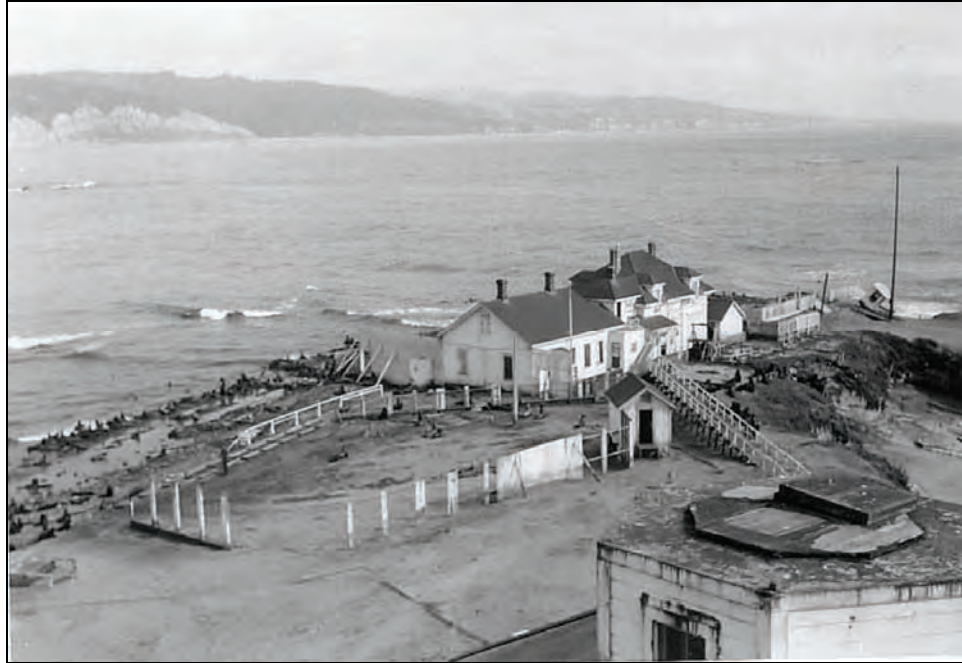
Figure 45. View of Keeper's Dwelling, circa late 1950s.

In 1904, a larger, more substantial house, including 8 rooms for the keeper and 7 rooms for the assistant keeper was planned for the light station (U.S. Lighthouse Board 1904, Figure 45). Work was delayed, however, because of the difficulty in getting supplies to the island. Landing was treacherous. Nevertheless, the addition was constructed on the south side of the existing building in 1906, adding nine more rooms including a bathroom. The house was described as white with red roofs. There were three outhouses, and a cement walkway was placed around the buildings (U.S. Light House Establishment 1907).

*Photograph taken from top of light tower.  
Small chicken house is visible in front of keeper's dwelling.  
Courtesy of California State Parks.*

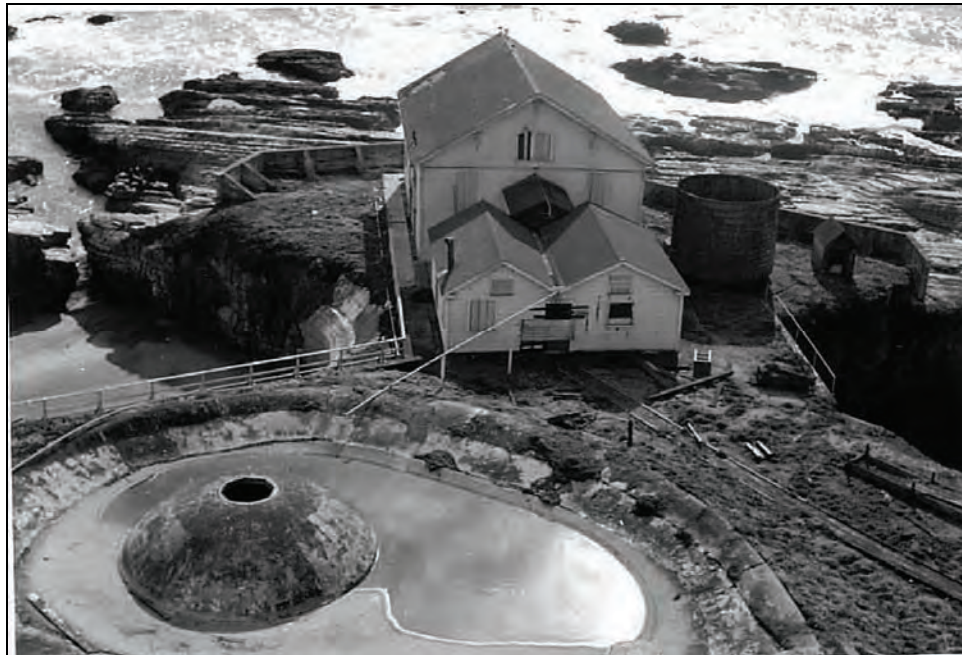
Figure 46. Fog Signal Building, 1957.

The rain-shed was also improved at this time (U.S. Lighthouse Board 1905), and by 1907, a 15,000 gallon redwood water tank was built on a redwood frame on concrete piers (U.S. Lighthouse Board 1907). By that year there were three wood tanks and one concrete cistern (Figure 46). One tank was located on the northwest side of the fog signal building; one on the highest point of the island 300 feet north of the fog signal; one on the north side of the keeper’s dwelling; and the cistern was 100 feet north of the fog signal building (U.S. Light House Establishment 1907). The original tank was eventually replaced by a larger one, though the new one was not treated properly, and as a consequence the water was unfit to drink. The water was only used for washing and bathing.

*Water tank and distillate house to the right.  
Water shed and cistern are in foreground. Seawall is visible at rear of fog signal building.  
Courtesy of California State Parks.*

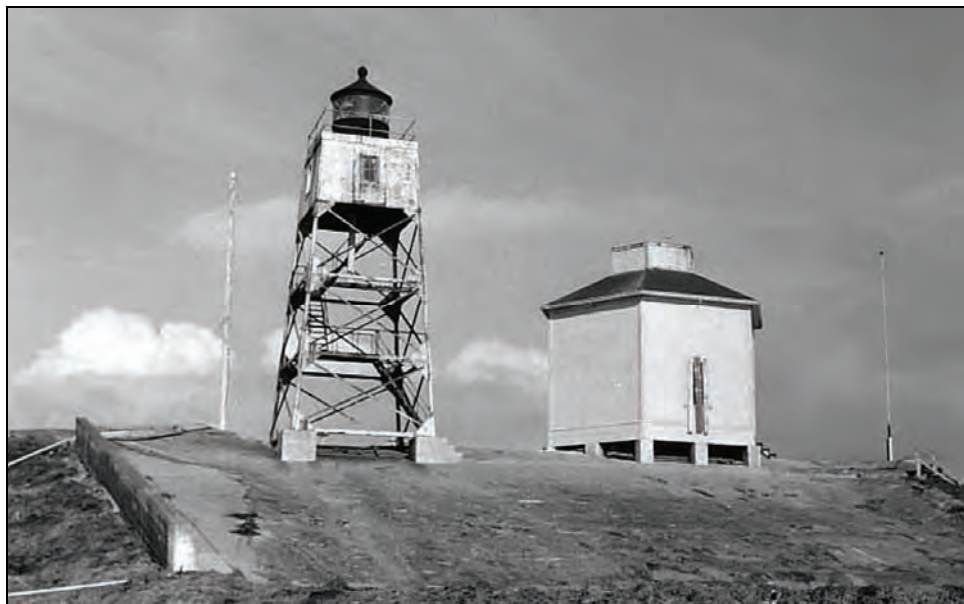
Figure 48. Steel Light Tower adjacent to Tank House, circa late 1940s.

In late 1913, the keeper noted that a new tower was under construction (U.S. Treasury Department 1913; Table 23). The following year, the lens was installed on this steel tower, 73 feet above the water (Figure 48). This tower was used for the remainder of the station's existence.

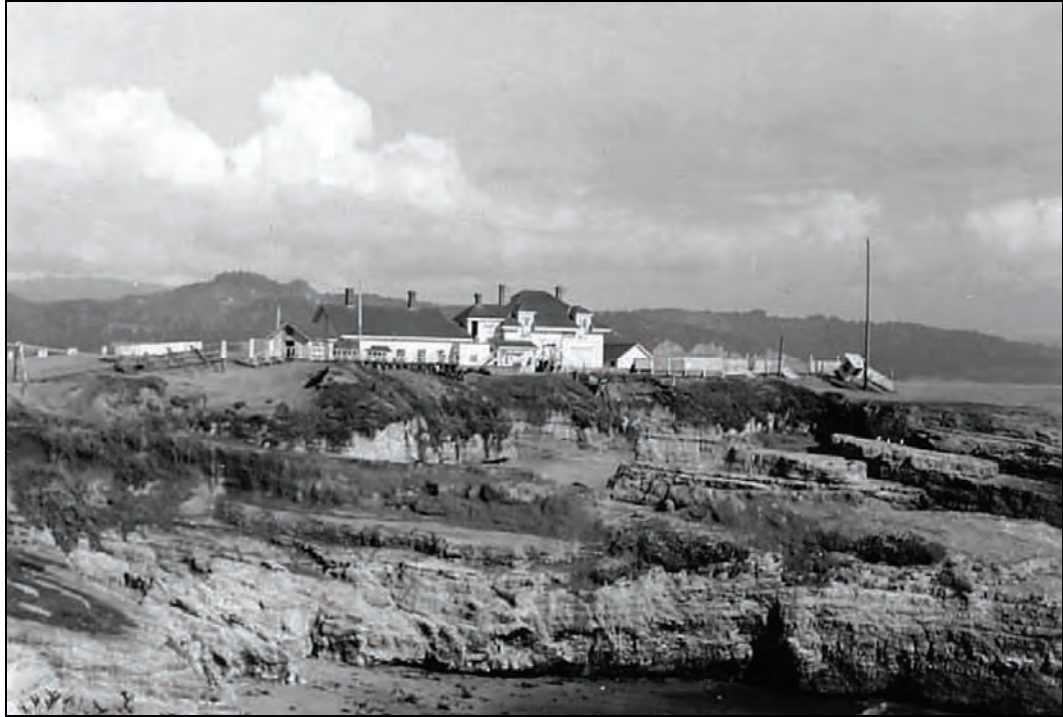
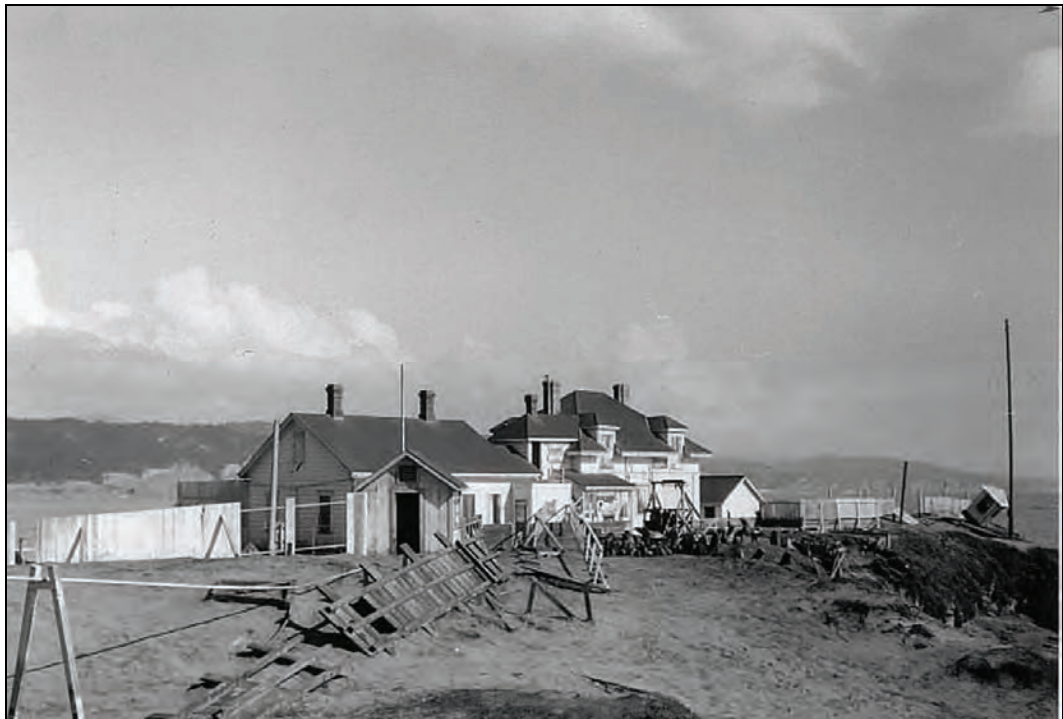
Figure 58. Keeper's Dwelling, Original on left, 1906 Addition on right, looking South, circa 1950s.

This building consists of two parts, the older section built in 1872, and the addition constructed in 1906 (Figure 58 through Figure 61). Though the buildings are joined, they are not connected and are very different in style. That section built in 1872 measured 36 feet by 28 feet. The two keepers lived in this one structure with their families, and partitioned it into two sections. The house was described as white with drab trimmings and red roofs (U.S. Light House Establishment 1907). At other times, the window sashes were painted in a brown metallic, Venetian, and Vermillion mixture. The 1906 addition was built to the south of the existing building, adding nine more rooms including a bathroom. The building was renovated in 1911, although specific work completed is not currently known. Plans for another addition to the keeper's dwelling were made in 1916. These were drafted by the Office of the Lighthouse Inspector, Eighteenth District, in San Francisco. It appears that addition was never completed, however. Some sources seem to believe that the older section of the dwelling represents that portion built in 1904, while the original section (1872) is completely gone today. This does not appear as plausible, however, as it is unlikely that a large addition (1906) would be built only two years after that time.

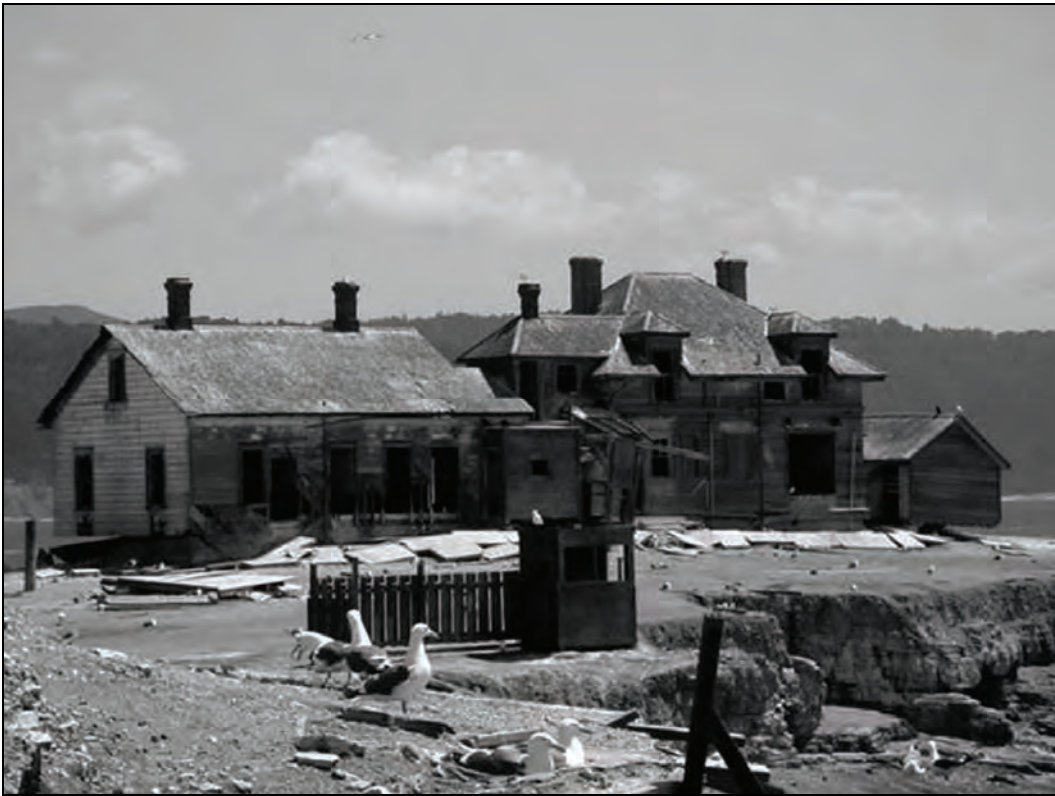
Figure 61. Keeper's Dwelling, looking Southeast, 2005.

There are four chimneys, two on each section. The roof is clad in wood shingles. Windows consist of double-hung sashes, with most of the panes missing. Entrances consist of wood doors, most of which are missing. Each quarters contained two bed rooms, a bath, kitchen, and living room, as well as a Eureka #7 1884 stove. The interiors contained lath and plaster sheathing. The interior also contained many wood surfaces which were frequently varnished.

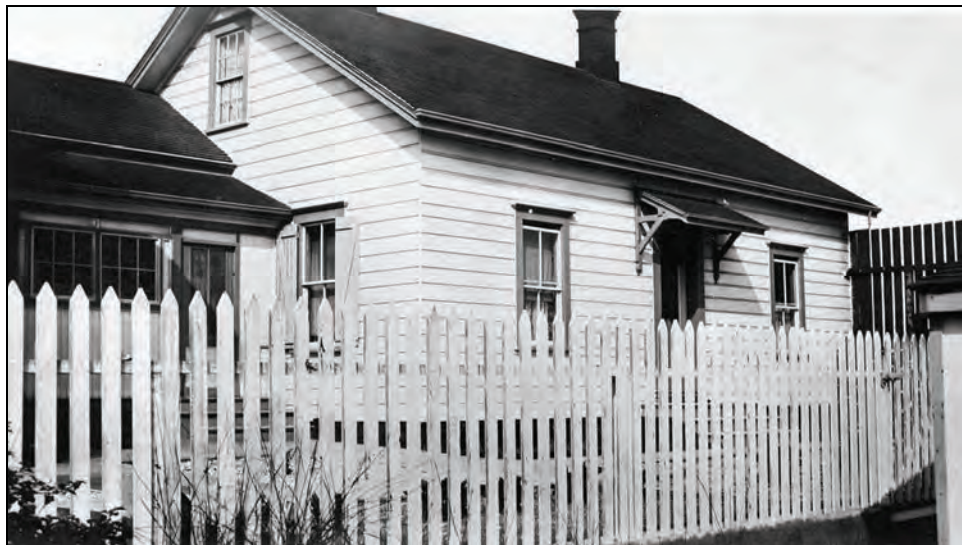
Figure 62. Keeper's Dwelling, Original on right, 1906 Addition on left, circa early 1920s.

This was the original keeper's dwelling, and was occupied by the keeper once the addition was built (Figure 62 through Figure 66). It contained eight rooms (U.S. Lighthouse Board 1904). It measures 36 feet by 28 feet. It was constructed in a Greek-Revival style, and was far simpler in plan and design than the subsequent addition. The side gable roof is medium pitch, and is clad in wood shingles. The building contains symmetrical façades on front and rear, with an entrance flanked by sash windows. It is a 1 ½ story building, though contained only one floor for living space. The building rests on a brick foundation. Siding consists of eight inch wide clapboards over diagonal board sheathing. It contains four rooms and a single bathroom complete with toilet, enameled iron sink, and bathtub.

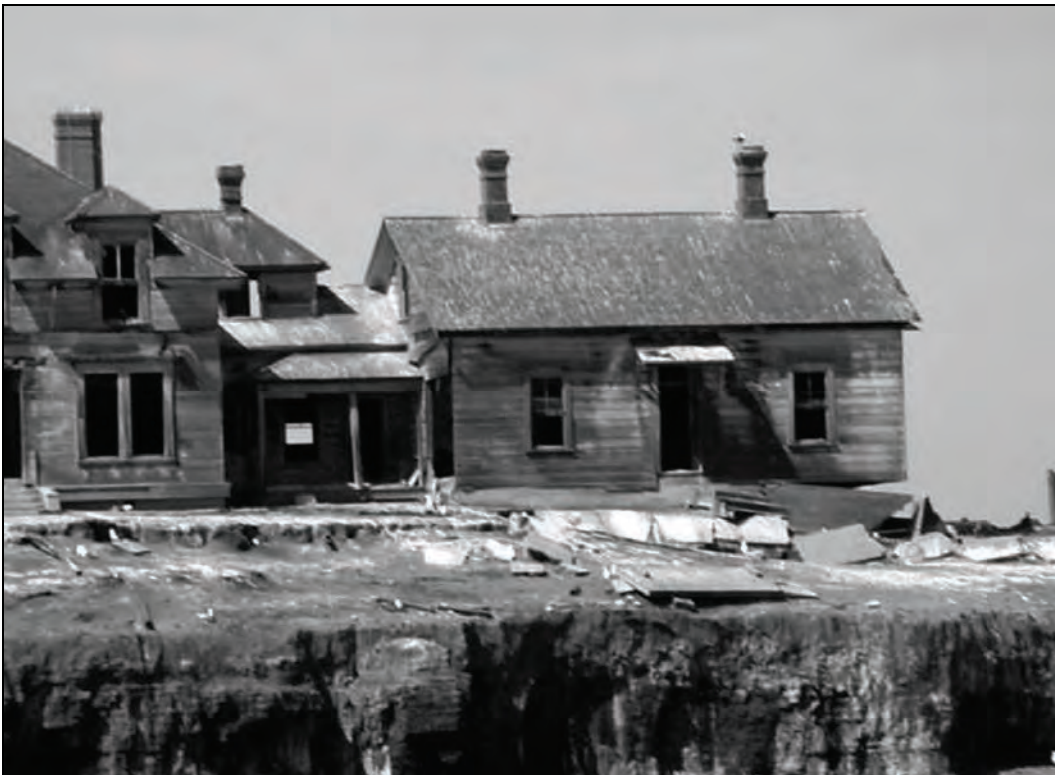
Figure 64. Keeper's Dwelling, Original on right, 1906 Addition on left, 2005.

The foundation has been seriously undermined by erosion of the adjacent beach. The building is in danger of collapse as a result.

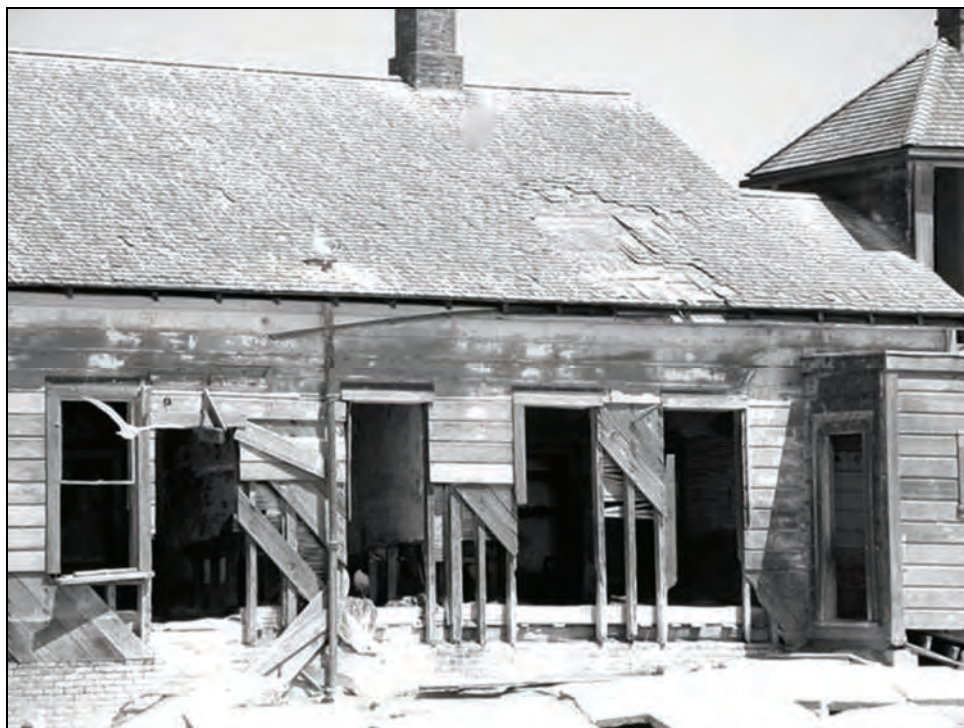
Figure 66. Keeper's Dwelling, Original Portion, West Side, 2005

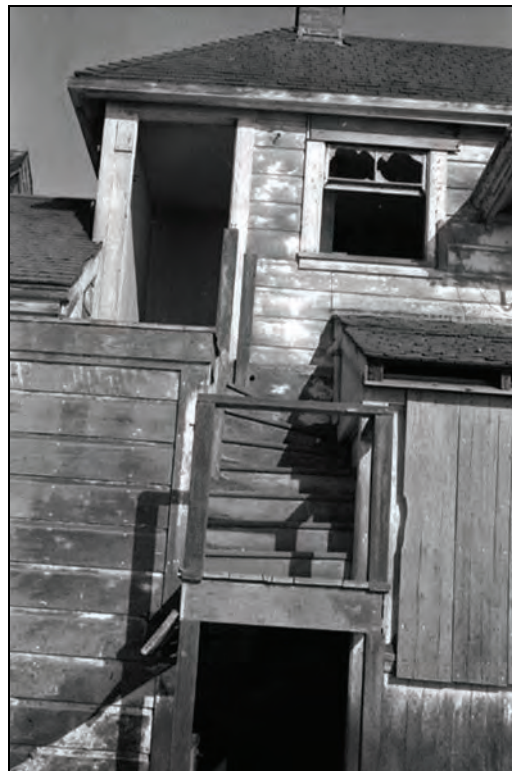
Figure 70. Rear of Keeper's Dwelling (1906 Addition), Stairway to Landing, West Side, 1982.

*This stairway was added sometime later judging by previous figure.  
Courtesy of State Parks. Catalog #24738, Archaeology Laboratory, West Sacramento.*

This was the addition built in 1906, and served thereafter as the assistant keeper's quarters (Figure 67 through Figure 75). It consists of two stories and contained nine rooms originally. The interior appears to have been altered over subsequent years, as there were only seven rooms by Coast Guard abandonment. The building rests on a concrete pier

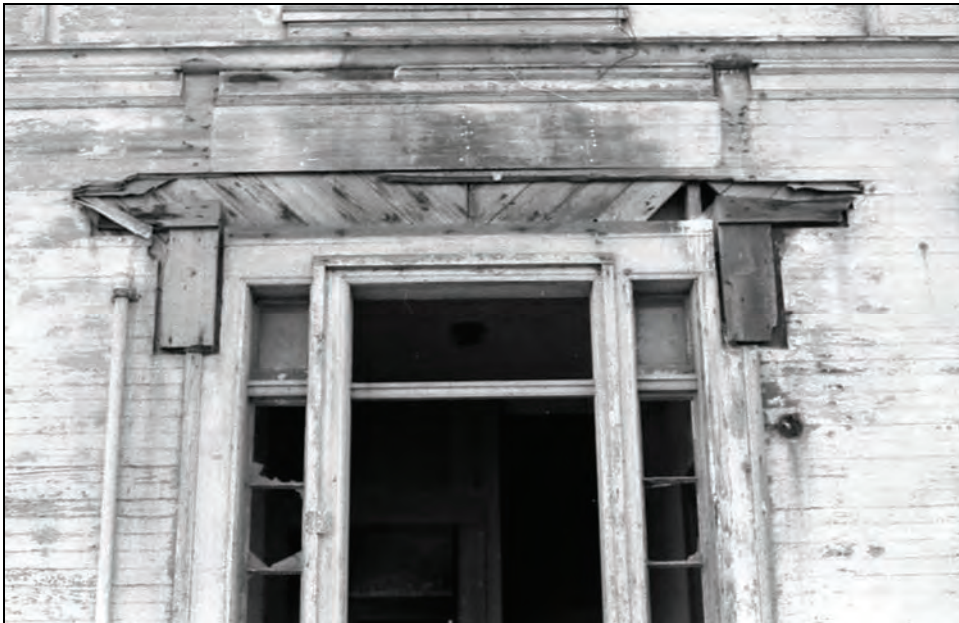
Figure 72. Front (east) Entrance to Keeper's Dwelling (1906 Addition), 1982.

*Note scar from portico and boarded transom.*

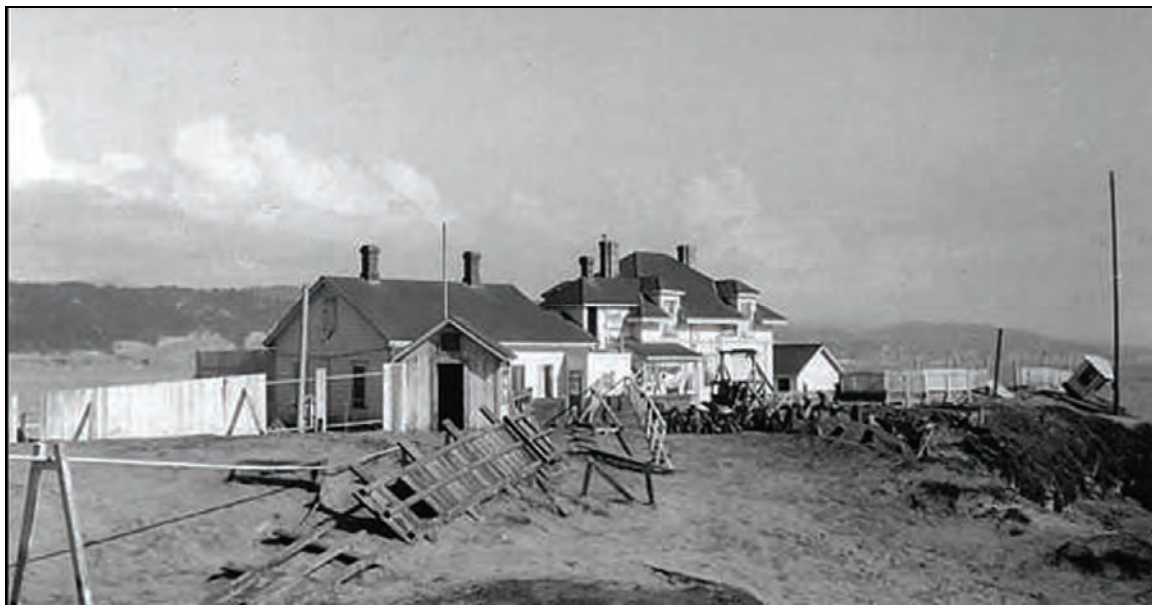
Figure 76. Keeper's Dwellings with Chicken House in Foreground, 1957.

Lighthouse keepers often kept a small number of animals to provide additional sustenance, and a small chicken house was in place north of the keeper's dwelling (Figure 76). It was a wood frame structure measuring ten feet by fourteen feet. Other small structures were built to house chickens at other times, including to the south of the keeper's dwelling. None of these structures remain today.

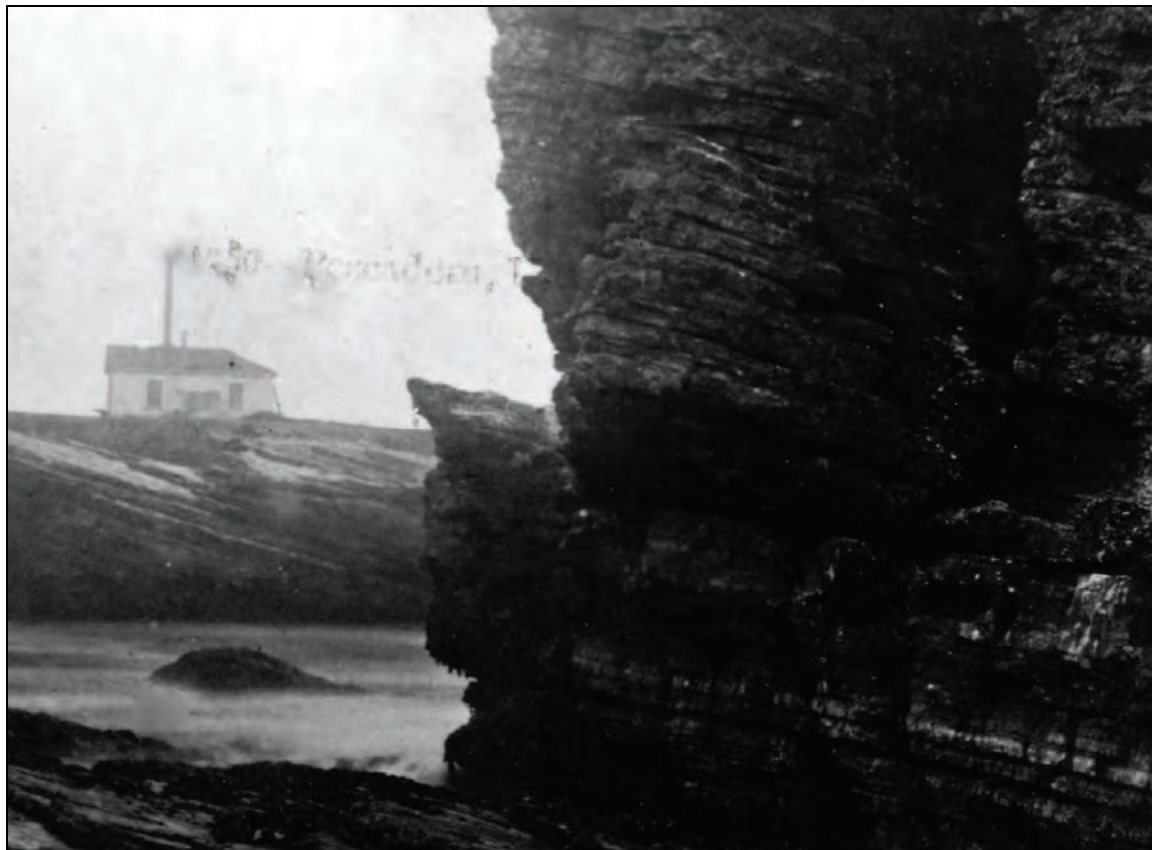
Figure 77. New Years Island Fog Whistle, Looking South, circa late 1870s.

intervals of 55 seconds (Figure 77). The fog horn itself was frequently painted with aluminum paint.
