## ARCHAEOLOGY AND HISTORY IN AÑO NUEVO STATE PARK

## *Part I: Archaeological Investigations*

## *Part II: Historical Documentation*

*NUMBER 26, 2009*

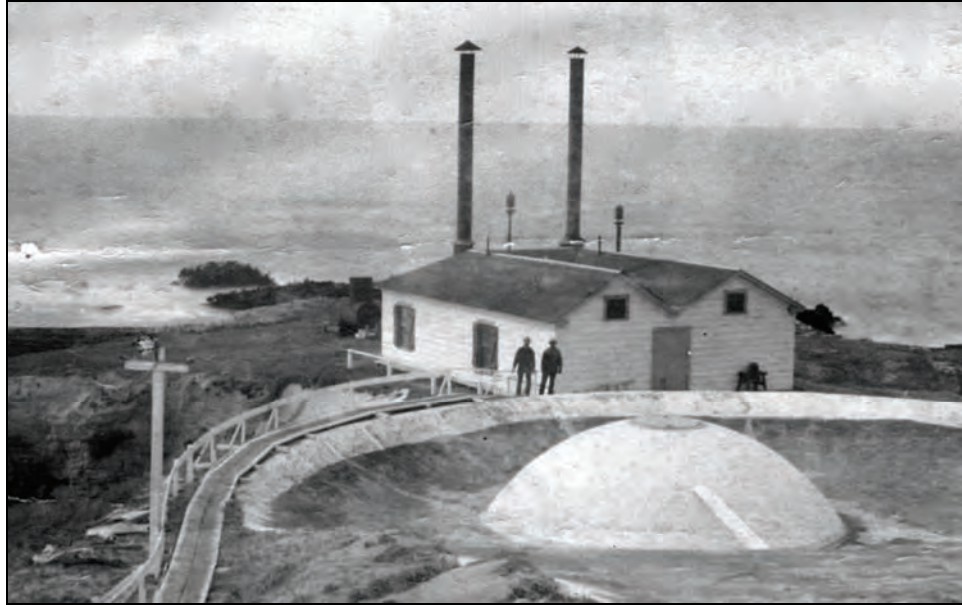
Figure 78. Second Fog Signal Building (built 1881)  
in front of Water Shed and Cistern, circa late 1880s.

*Fog Whistles are smaller vertical members protruding from roof. larger pipes are vents for boilers.  
Note similarity to fog signal building at pigeon point in Figure 34.  
Courtesy of Department of Special Collections, Stanford Libraries.*

The building was expanded in 1880 following the placement of a second fog signal, and at some point was demolished to make room for a second building, which was completed in 1881 (Figure 78). It appears possible that one gable portion of the original building was used in the second building, as their shape and form are similar. Immediately adjacent to the building was a large water tank that was used to cool the fog signal boilers. Frequent repairs were made to these boilers. In 1885, for example, one was replaced, followed by another in 1887. They were built by F. J. Moynihan of San Francisco.

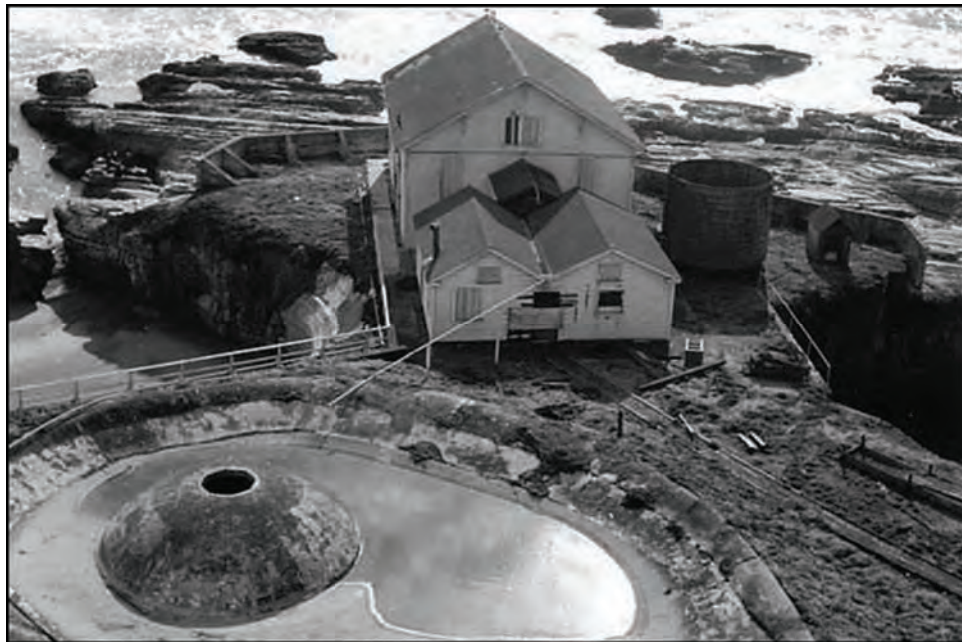
Figure 79. Fog Signal Building with Water Tank and Distillate House to the Right, 1957.

*Second (1881) fog signal building is twin gable structure at rear of larger building (1899).  
Water shed and cistern are in foreground. Seawall is visible at front.  
Courtesy of California State Parks*

In 1899, a new frame building was constructed in front of the older building in order to house a new fog signal (Figure 79 through Figure 84). The fog signal apparatus was moved into it and made operational the next year. New four inch whistle valves replaced the older ones. The building measured forty two by thirty four feet. The older fog signal building was connected to the new one by an enclosed gallery. The older building was converted to use as a coal house and tool shop. The original building (1872) was torn down at that time. A concrete walk was built to connect the building to the light.

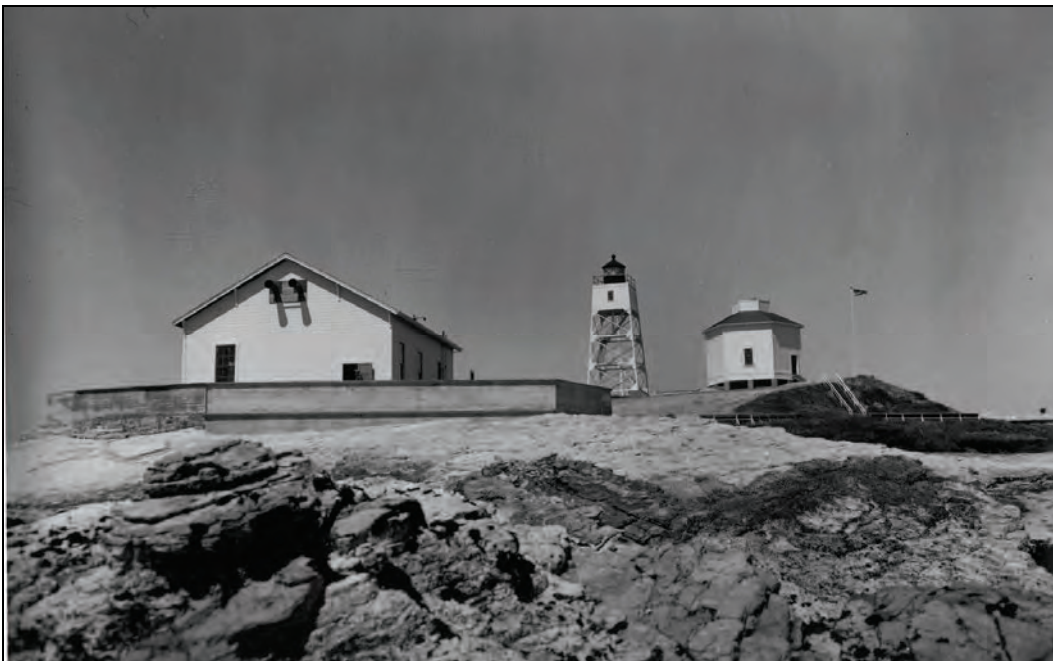
Figure 81. Fog Signal Building (at left) adjacent to Light Tower and Tank House, Unknown Date.

*Flag pole is barely visible to right of tank house. Note fog signals in gable end.*

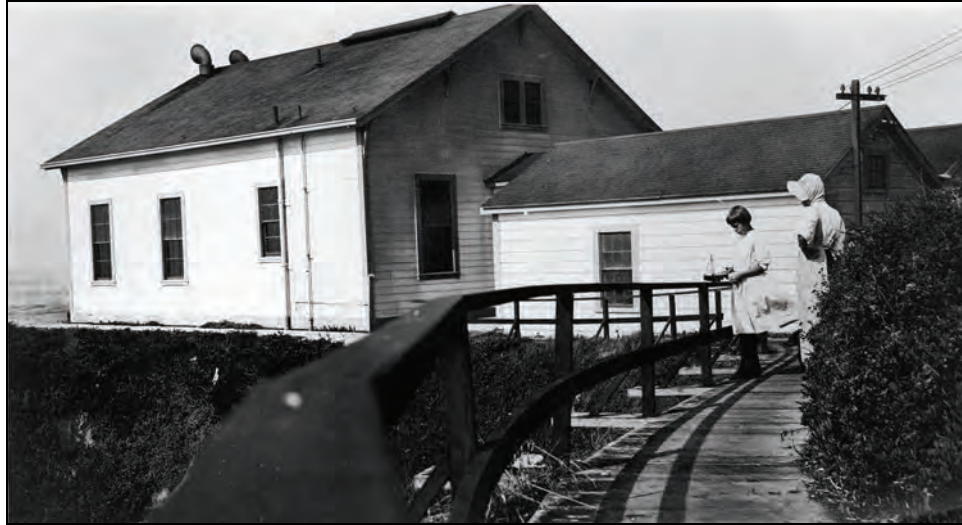
Figure 82. Fog Signal Building and Wood Walkway, circa early 1920s.

*Note fog signals in gable end at left.  
Courtesy of U.S. Lighthouse Society, San Francisco, California.*

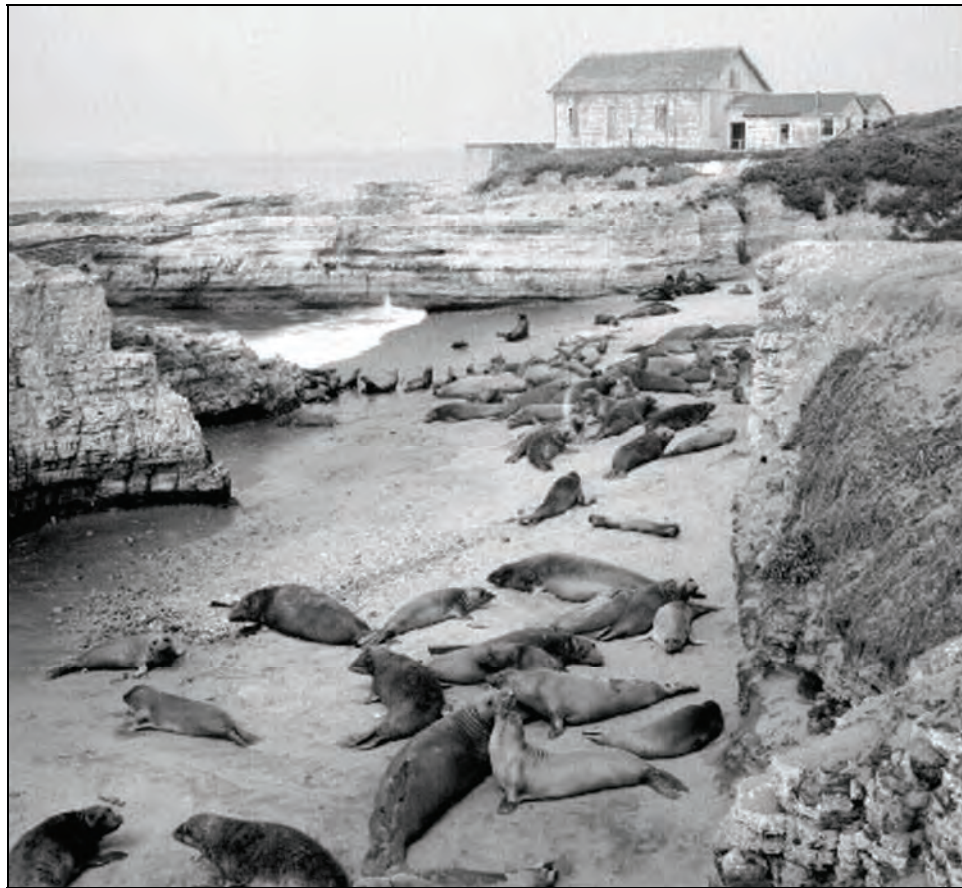
Figure 83. Fog Signal Building in background with Seawall visible to Left, 1966.

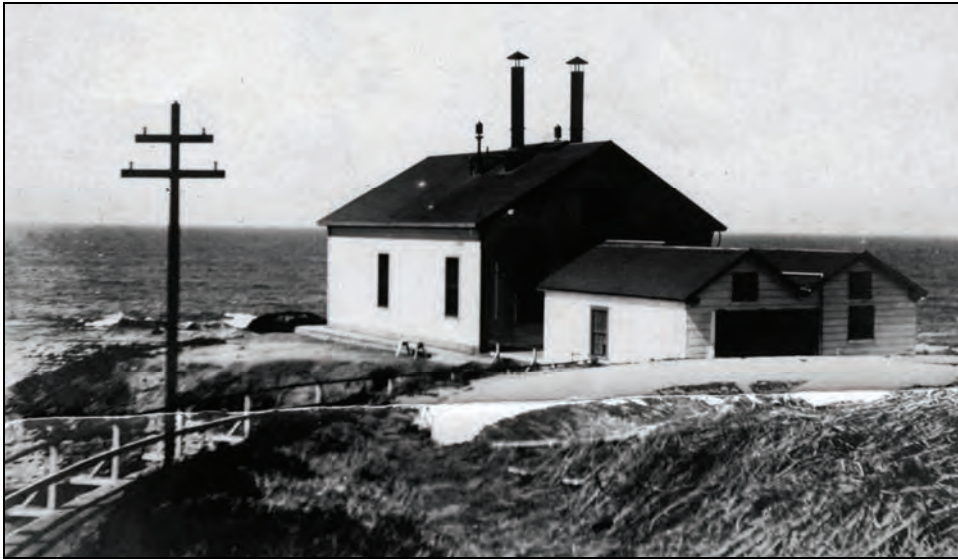
Figure 85. Fog Signal Building looking North, Unknown Date.

*Note sliding door on front of 1881 building. Fog signal whistles are visible on 1899 building.  
Courtesy of Department of Special Collections, Stanford University Libraries.*

This wood frame building measures forty four feet by thirty four feet, and was constructed to house newer fog signal equipment. As with the 1881 building, this one is sheathed in shiplap siding (Figure 85 through Figure 97). It contains a gable roof, clad in wood shingles over closed board sheathing. The king post trusses supporting the roof are identical to those in the fog signal building at Point Arena light station (built in 1896). Bottom and top chords consist of three by ten inch lumber, and web members are two by eight inches. Five wood brackets are found beneath the eaves on each gable end. Windows consist of several six-light fixed sashes which replaced original six over six movables sashes; two six over six sashes in the second floor of the northeast elevation; and a single four-light fixed sash on the southeast side which replaced an original six over six sash here originally (scar is visible above window). A modern, sliding aluminum window was installed in the opening for the fog signals on the southwest end. Window trim is five and a half inches wide. Siding members measure seven inches to weather.

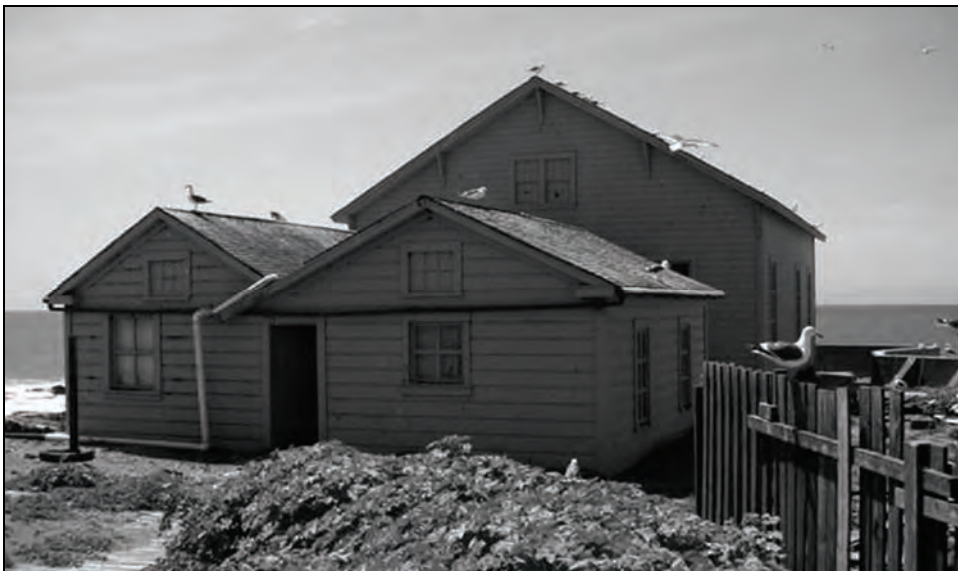
Figure 86. Fog Signal Building, 1881 Portion at Front, 1899 Portion at Rear, 2005.

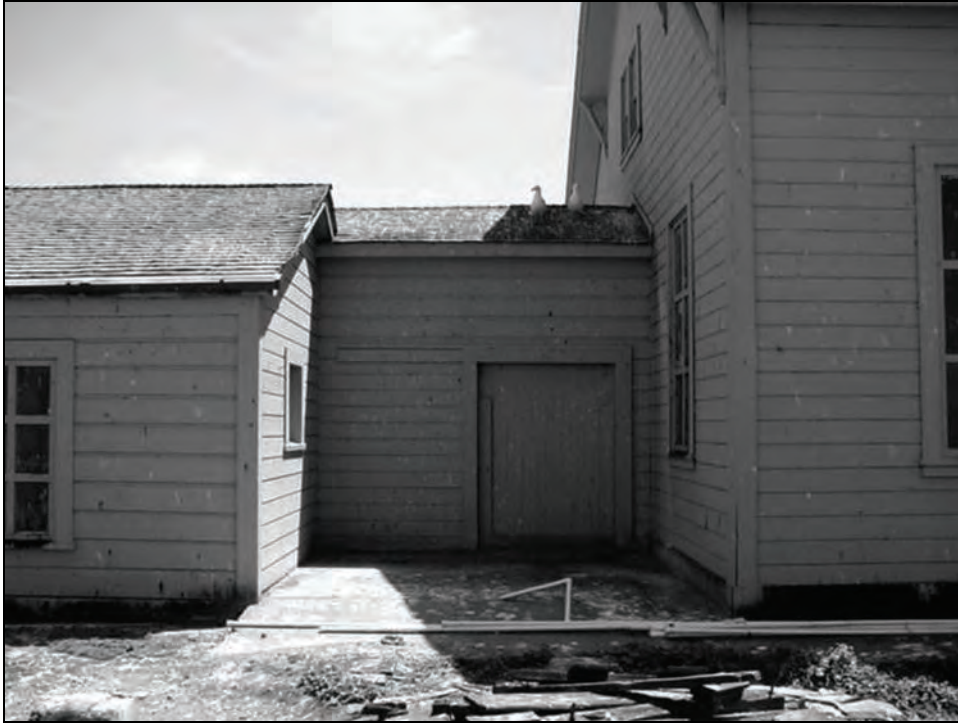
Figure 89. Fog Signal Building Gallery, 2005.

*Photograph shows galley connecting 1881 portion at left and 1899 building at right.*

The gallery was built in 1899 in order to connect the new fog signal building with the older building. The gallery is eleven feet, eight inches long by eight feet wide. Siding members measure seven inches and nine inches to weather. The structure was built using four by four inch studs, and left unsheathed on the interior. Wood sliding doors are found on each end, providing access to the exterior of the building. The tracks for these doors are replaced frequently due to rust. Trim around the sliding doors is six inches wide.

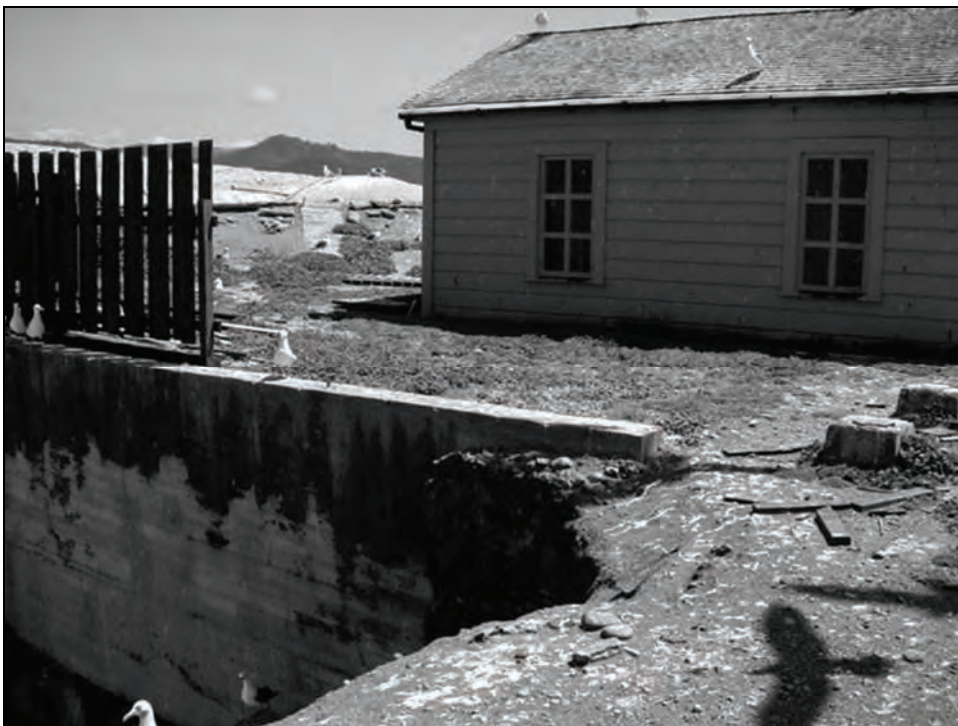
Figure 90. Retaining Wall Adjacent to 1881 Section of Fog Signal Building, looking West, 2005.

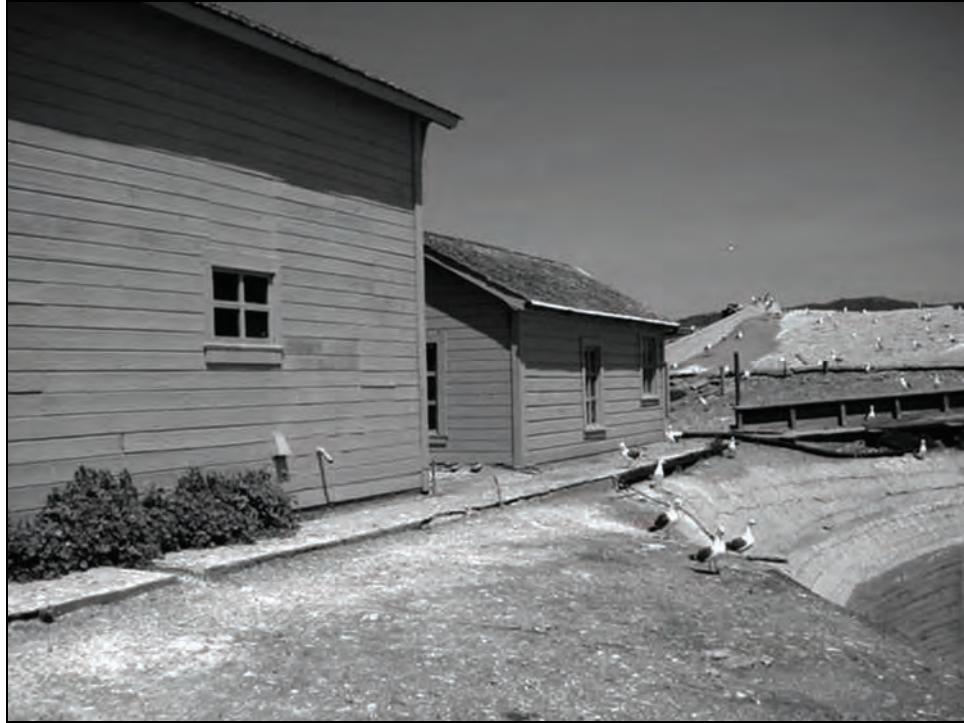
Figure 91. Fog Signal Building, looking North, 2005.

*Note concrete retaining wall at right, and remains of wood walkway.*

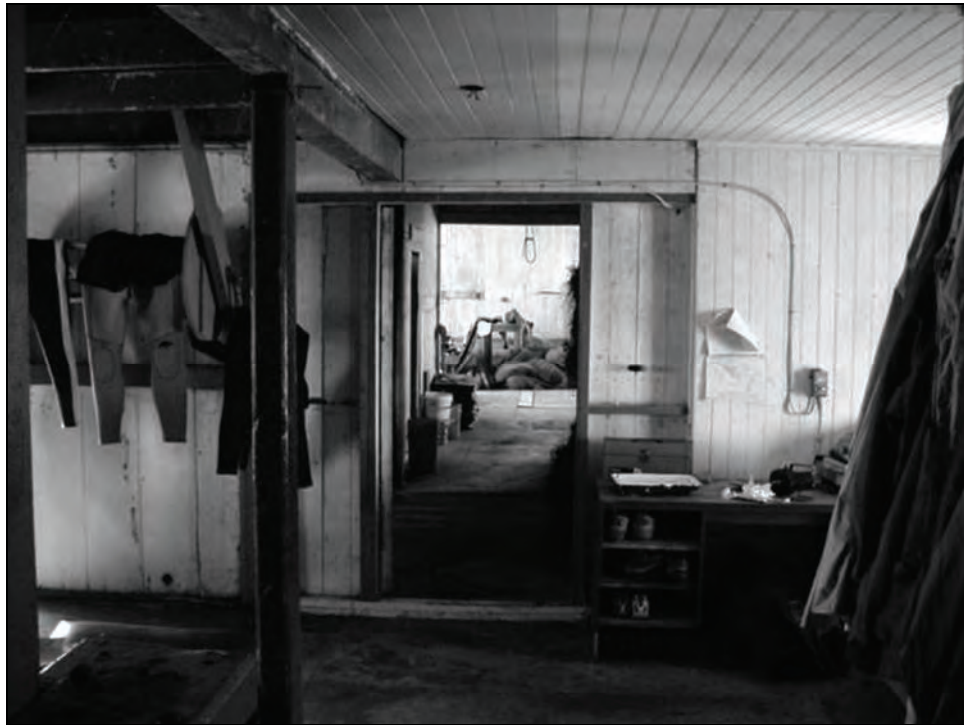
Figure 92. Interior of 1881 Section of Fog Signal Building, looking through Gallery (Southwest) to 1899 Building, 2005.

The interior contains cement floor (currently painted green). Wall sheathing varies, with shiplap, tongue and groove, and random size boards all found.

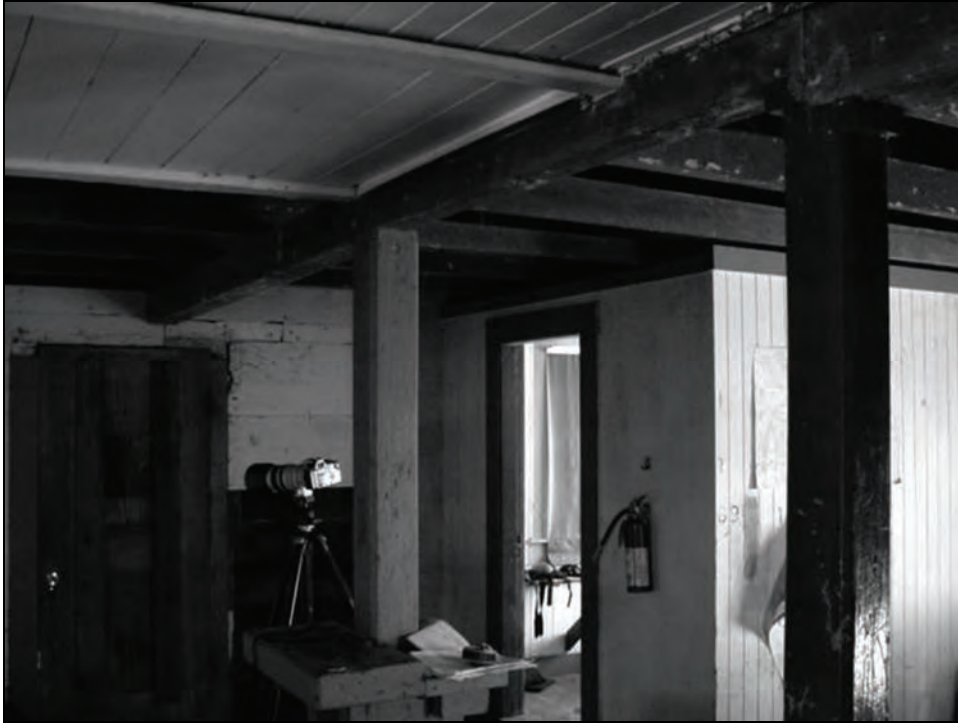
Figure 93. Interior of 1881 Section of Fog Signal Building, East Corner, 2005.  
*Photograph shows Room 2 and posts supporting beam.*

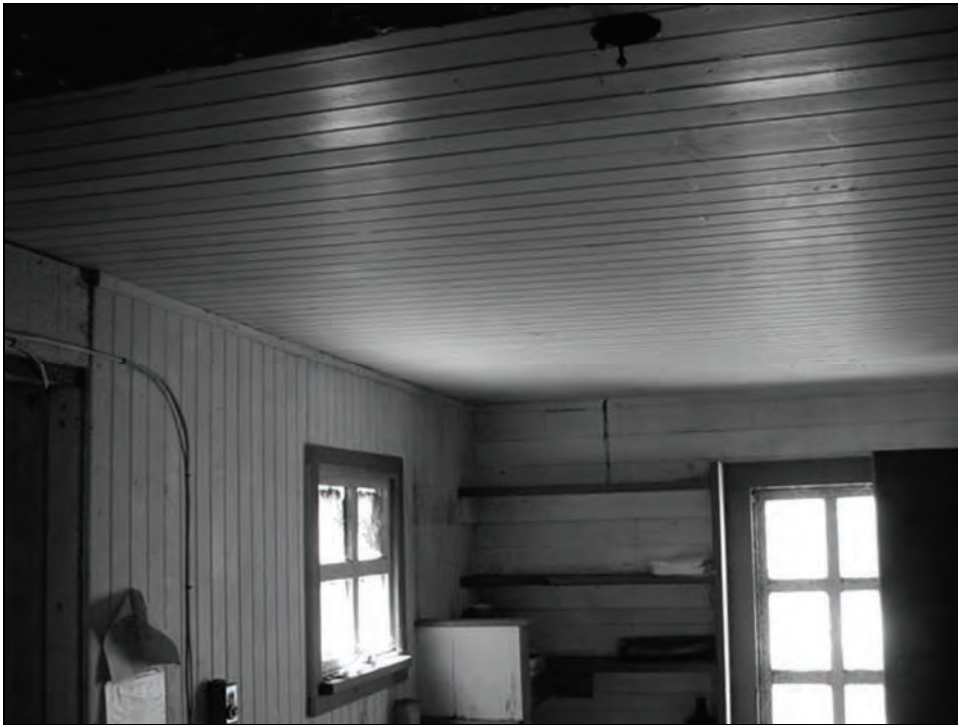
Figure 94. Interior of 1881 Section of Fog Signal Building, West Corner, 2005.  
*Note tongue and groove siding on wall to left and ceiling sheathing, and shiplap sheathing on wall at right.*

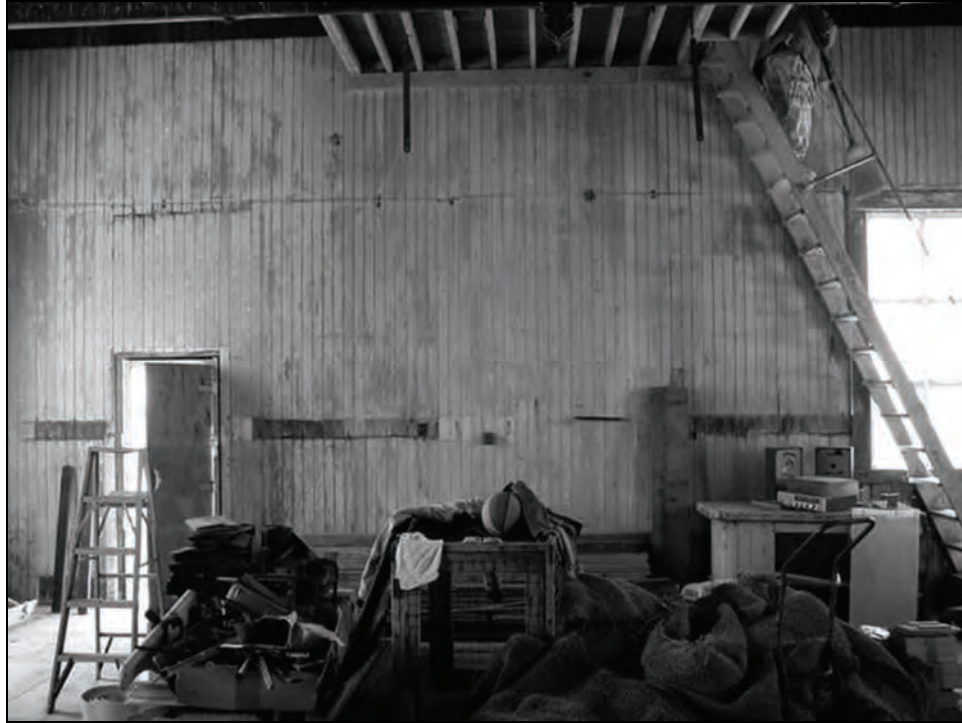
Figure 95. Interior of 1899 Fog Signal Building, Southwest Wall, 2005.  
*Loft visible at top of photograph was original location of fog signal whistles.*

The interior contains four rooms. The main room contained the fog signal boilers and apparatus. Only concrete foundations and channels (to drain water away from steam boilers) remain from the equipment, however. A single entrance is found on the southwest end of the building, currently enclosed by a plywood door. Hinge and strike plate scars on the exterior portion of the frame indicate that a door originally opened to the south. Two rooms are found on the northwest and southeast interior sections of the building. The purpose of these rooms is not currently known, although one appears to have been used as a tool room. Each room is sheathed in tongue and groove wood siding. Small windows are found on the interior of these rooms (southwest side) into the main room. There are two

doors on each of these rooms providing access from the main room. A small generator room was constructed on the south corner of the room on the southeast side. A loft was recently constructed in the second floor area of the southwest gable end, and is used for biological observation.

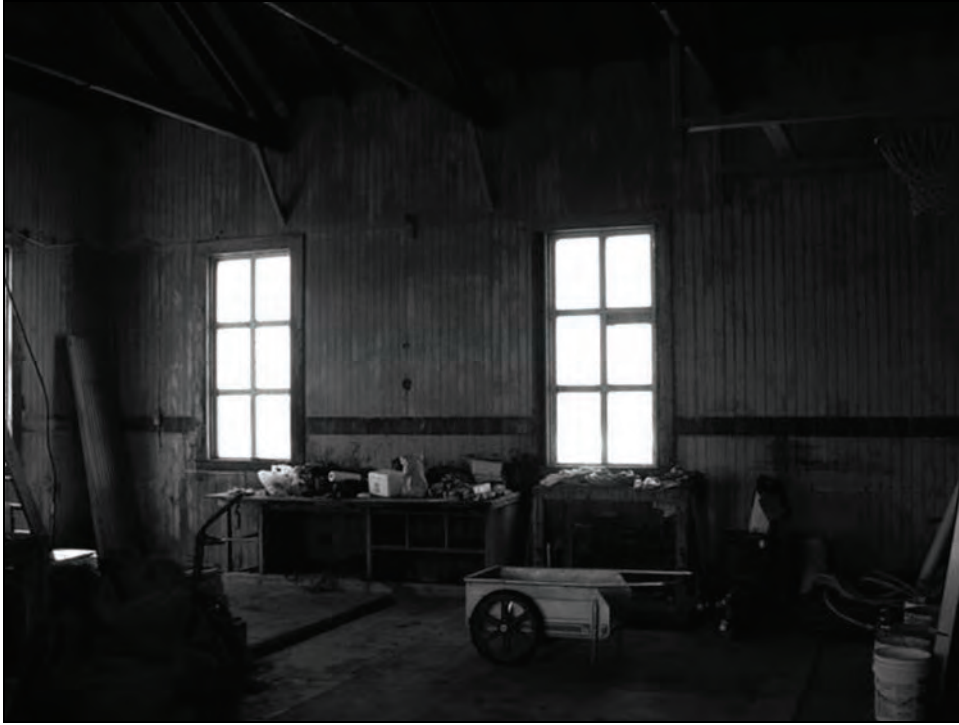
Figure 97. Interior of 1899 Fog Signal Building, Northwest Wall, 2005.

*Note tongue and groove sheathing, and lower portions of roof trusses.*

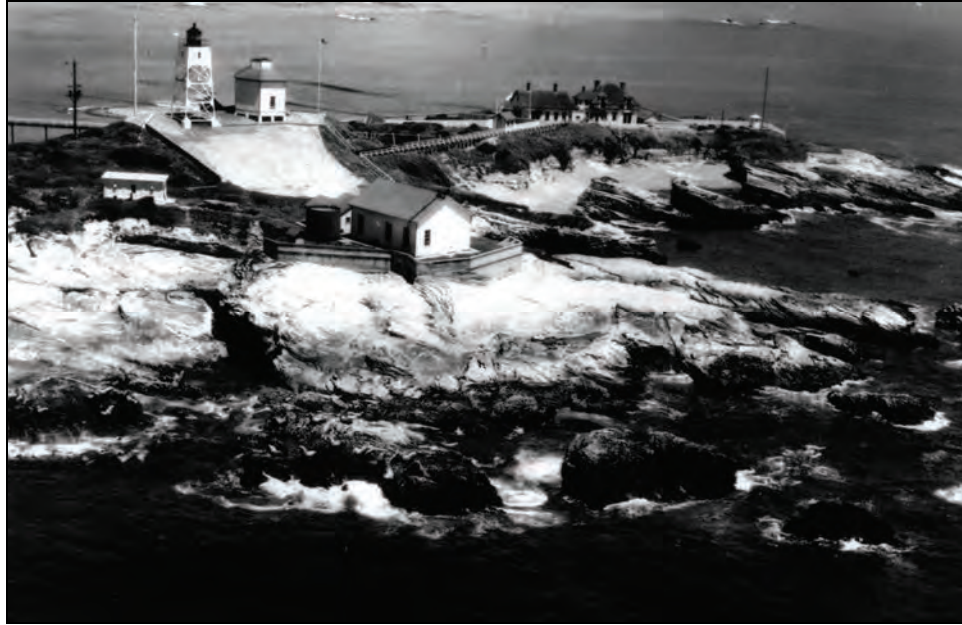
Figure 98. Overview of Light Station with Light Tower visible at Left, 1953.

*Note fog whistles are missing from gable end of fog signal building (replaced by automated system).  
Courtesy of U.S. Coast Guard Historian's Office, Washington, D.C. Photograph by U.S. Coast Guard.*

The steel tower was built in 1914, to replace the earlier housing for the light (Figure 98 through Figure 104). Originally (1890), the light was installed on top of a water tank, followed by a wood post set in a concrete foundation, which were painted white. The steel tower was 18 feet square at the base and 35 feet tall, with the lens located on the top of the tower. Immediately below this was an enclosed section known as the watch room, accessible via a hatch. As described above, the earthquakes of October 22, 1926 caused serious damage to the lens and structure. This light was soon replaced. The tower was seriously deteriorated by the early 1960s, and the one inch hand rails were reduced to less than one half inch diameter. The steel light tower was taken down in 1976 for safety reasons.

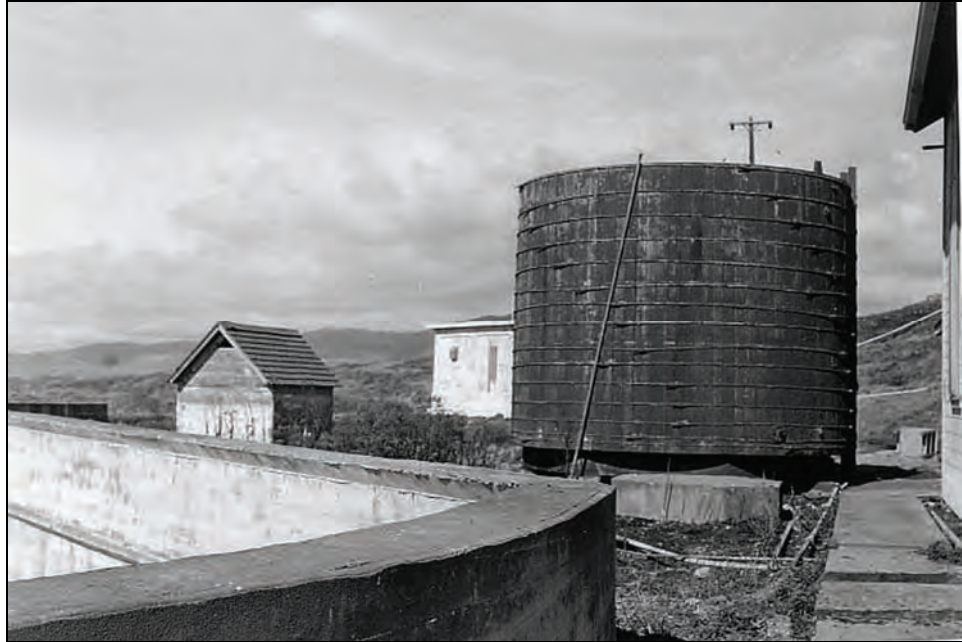
Figure 106. Water Tank adjacent to Fog Signal Building, 1957.

*Concrete retaining wall is visible in left foreground, oil storage house and paint locker in rear.  
Courtesy of California State Parks.*

Numerous water tanks were established on the island at various times (Figure 105 through Figure 107). A 4,500 gallon water tank was built in 1894. In 1896, a larger 35,000 gallon water tank was built on a masonry foundation. A new 40,000 gallon tank was constructed in 1928, replacing an earlier tank. A temporary circulating tank was also built, which would “sweeten” the water before it was stored in the larger 40,000 gallon tank. This was designed to remove the redwood stain from the new lumber (U.S. Treasury Department 1928). The large tank was supposed to provide all domestic water needs, but the water was

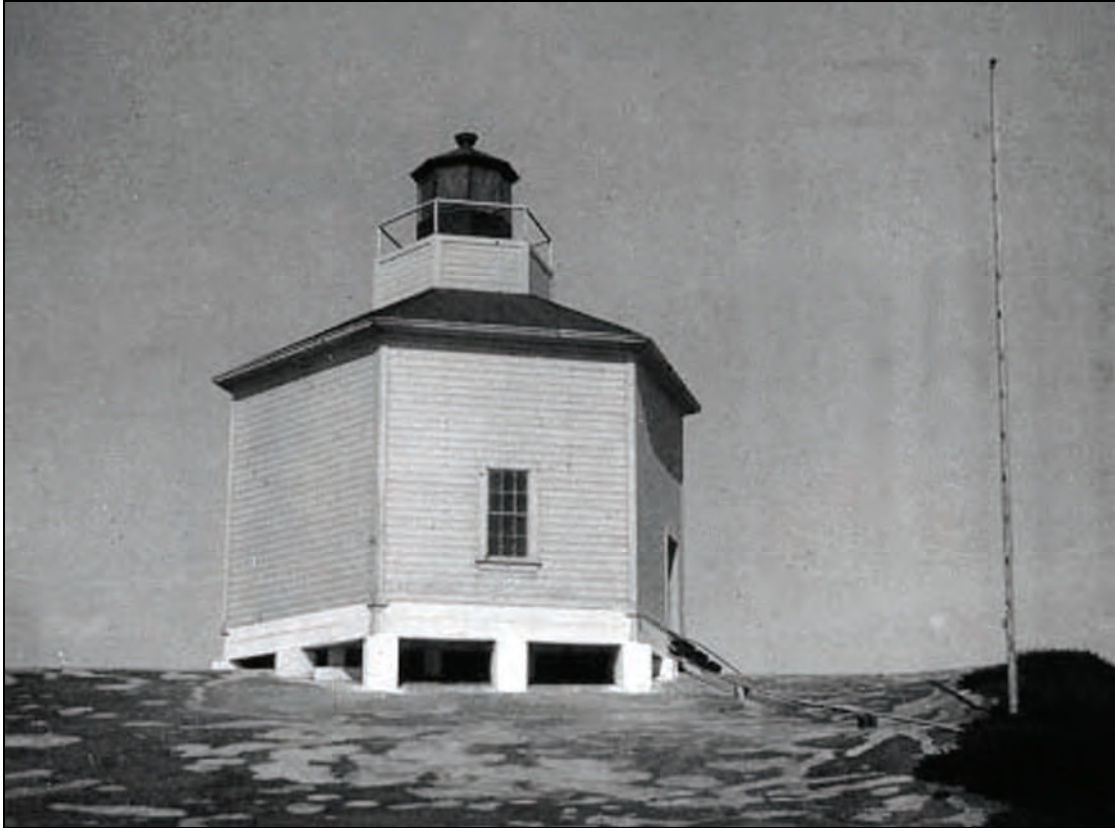
Figure 108. Tank House with Light at Top, Unknown Date.

*Photograph taken prior to the construction of the light tower in 1913.  
Courtesy of California State Parks.*

This hexagon-shaped structure was constructed of wood, and measured sixteen feet, six inches on each side (Figure 108 and Figure 109). It contained a 38,000 gallon water tank. Prior to the construction of the steel tower, the light was placed on top of this building. The building was dismantled by the state in 1962. The area around the tank was “cleaned-up” of all debris at that time.

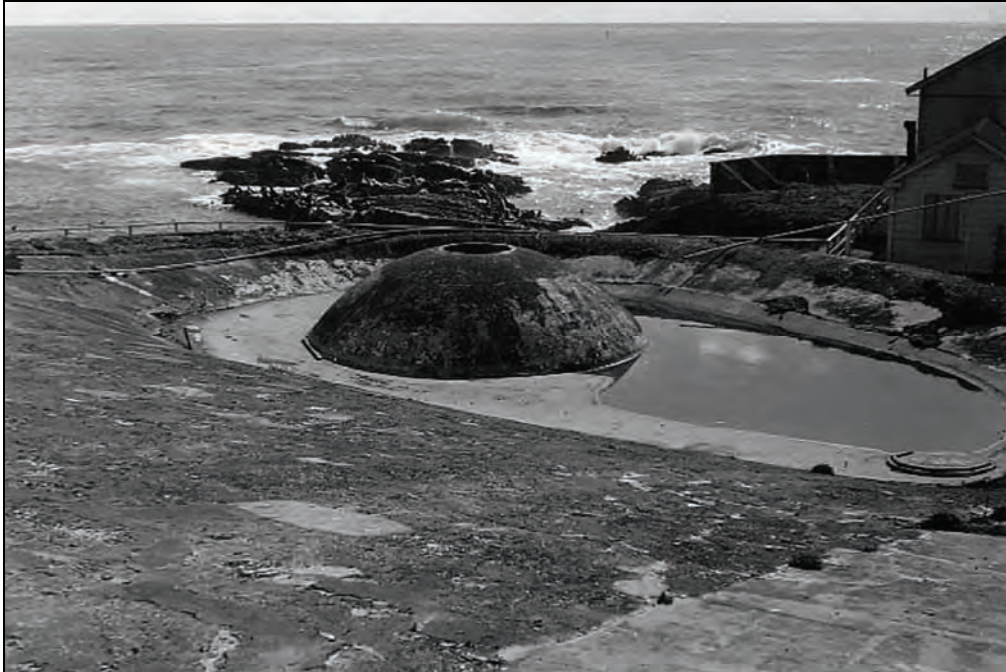
Figure 110. Cistern at the Base of the Water Shed, 1957.

*Fog signal building is visible at right.  
Courtesy of California State Parks.*

Built in the 1870s, the water shed (also referred to as rain shed) consisted of a large cemented area measuring approximately 115 feet by 160 feet. At the base of the water shed was a concrete cistern, which caught and stored the collected water (Figure 110 and Figure 111). This water was then pumped into a large water tank above. From here, it was gravity fed to the dwellings. A wood walkway was installed along the inside edge of the lower portion of the water-shed, likely to provide access to the cistern. The cistern was frequently whitewashed. A hatch provided access to the interior. There were actually two cisterns in place on the island by 1949, one with a 4,000 gallon capacity, and the other 75,000 gallons. The smaller one appeared to be that adjacent to the keeper’s dwelling.

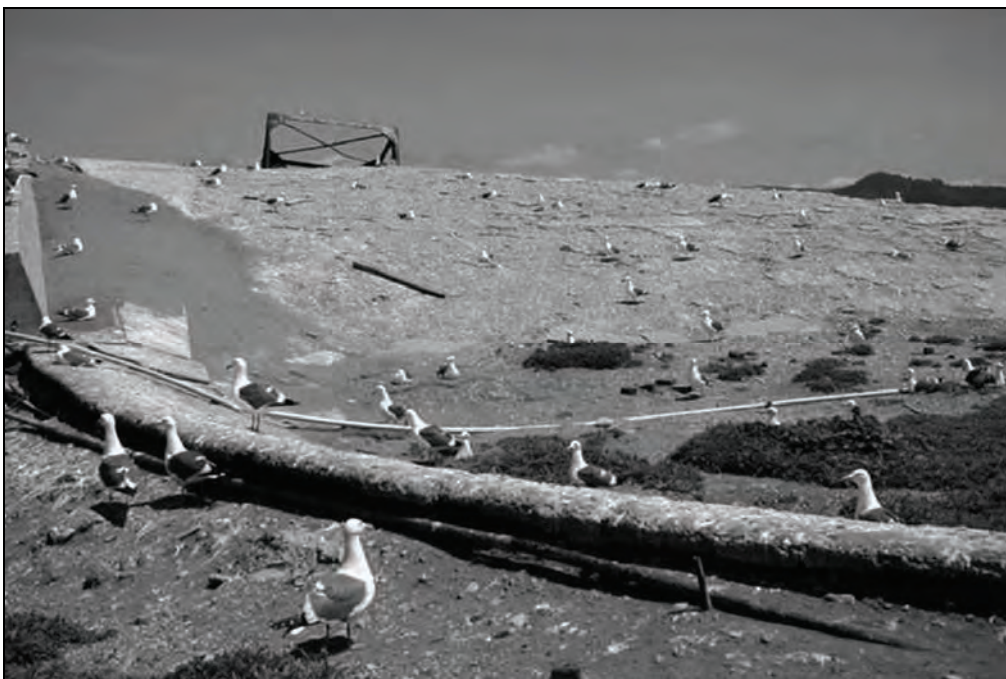
Figure 111. Water Shed looking Northeast, 2005.

*Base of light tower is visible at top of photograph.*

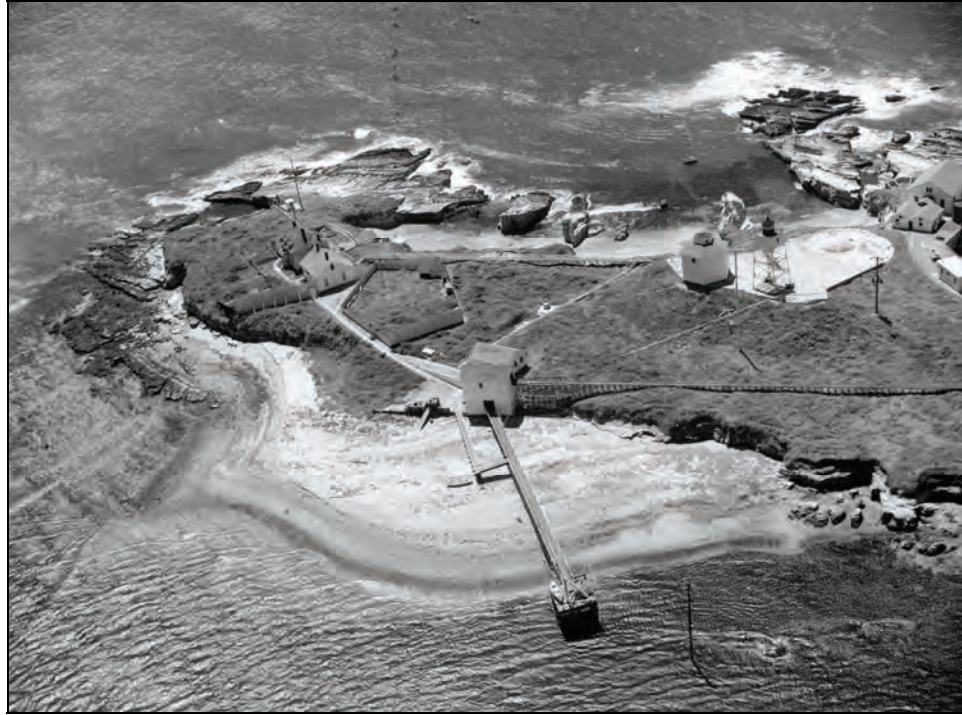
Figure 112. Aerial Photograph of South Portion of Año Nuevo Island, looking West, 1948.

*Note pier and boat house at end.*

This structure, also known as the storehouse or warehouse was built in 1900 (Figure 112 through Figure 115). The building was located at the end of the pier. It measured 18 x 30 feet, and contained two stories, with the lower on the beach and the upper at the level of the tramway. It also contained a hoist. Supplies for the fog signal building were hoisted by block and tackle from the landing to the upper story of the boat house, and from there into a tram car. These cars were pushed by hand along the tramway. It was completely destroyed by fire sometime in the late 1950s.

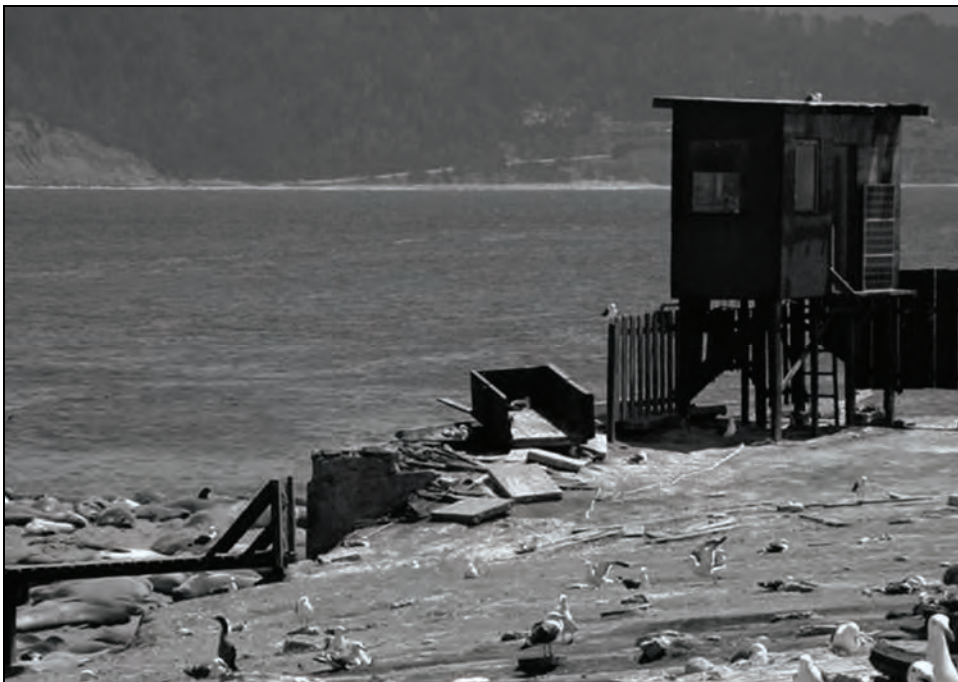
Figure 115. Foundation of Boathouse to left of Modern Blind, 2005.

*Pier is visible at left.*

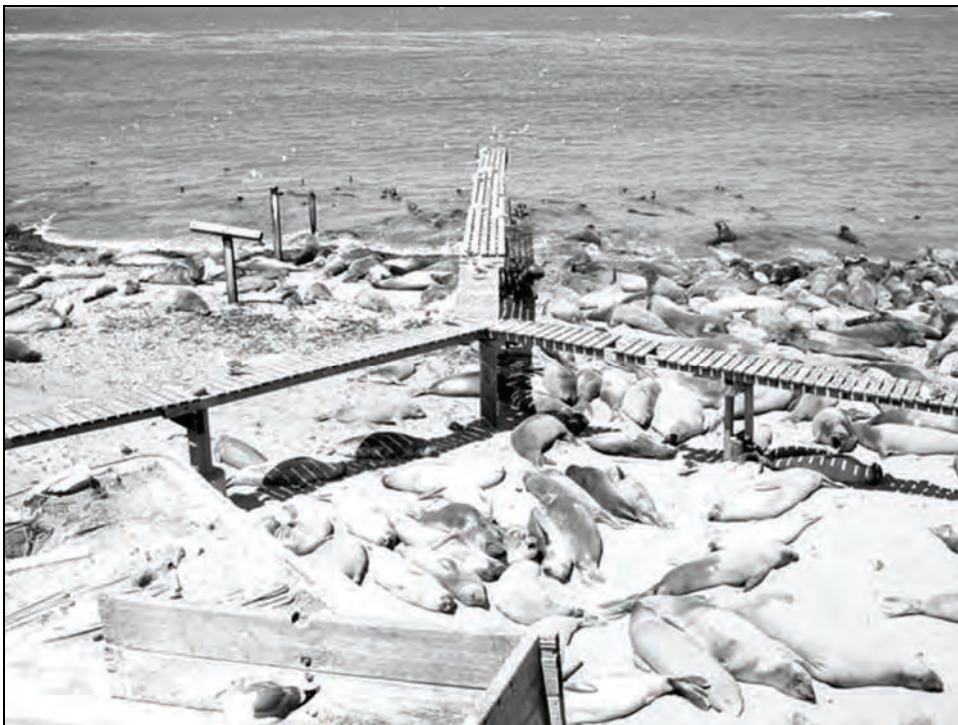
Figure 122. Pier/Wharf, 2005.

*Remains of pier built in 1932 are visible at left.*

A pier or wharf was one of the first elements built on the island in 1872 (Figure 121 and Figure 122). Supplies were provided to the island from this pier and trips to and from the island were made from it. Because of difficult conditions, the pier was frequently repaired. The existing pier appears to be relatively recent, though a section of the pier built in 1932 remains.

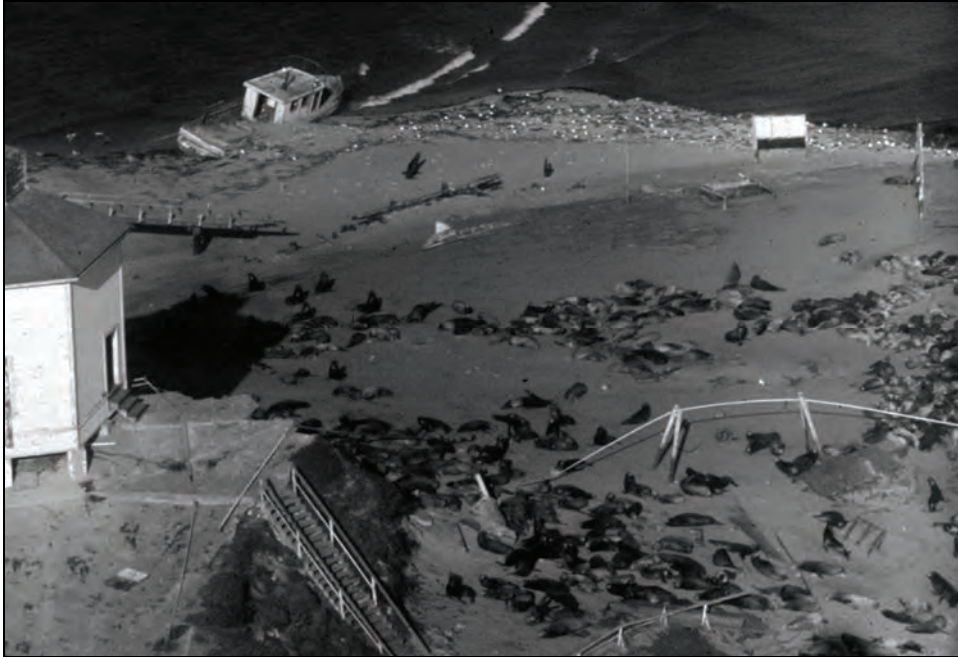
Figure 124. Portion of Water Tank Structure, circa 1961.

*Photograph shows wood stairway leading up to the water tank.  
Courtesy of California State Parks.*

There were several wood walkways connecting buildings (Figure 123 and Figure 124). One portion measured 500 feet long, complete with hand railings. Small trestles were constructed over several gullies on the island for the walkways. The walkways were frequently repaired, being completely rebuilt in 1894. Decking consisted of two inch by twelve inch lumber. Gravel was poured along walking pathways, as well as along the edges of the boardwalk.

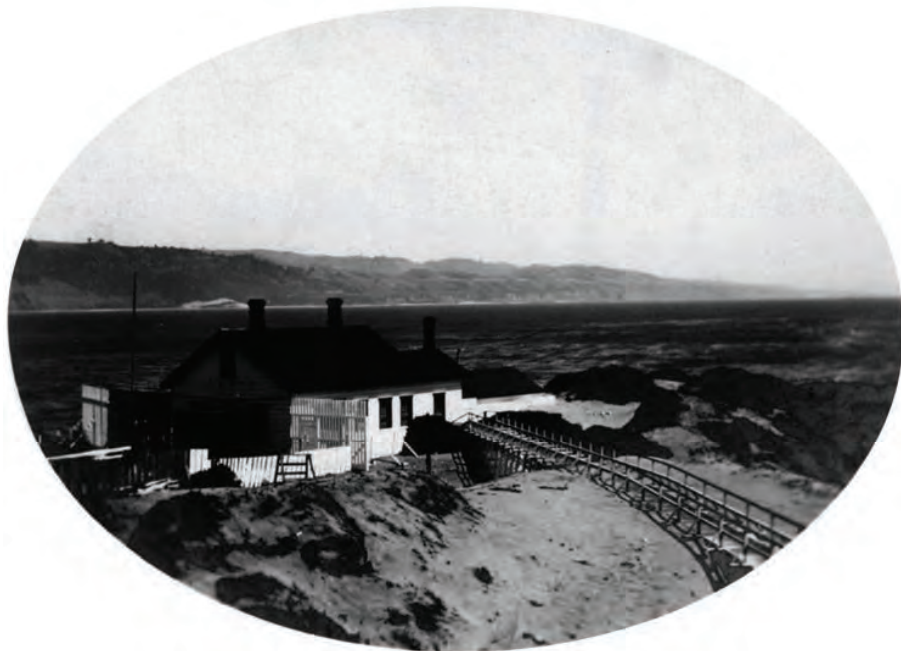
Figure 126. Fog Signal Building looking South, Unknown Date.

*Note tramway at right and fences adjacent to building.  
Courtesy of Department of Special Collections, Stanford University Libraries.*

Built in 1872, the tramway or trestle measured 290 feet in length, and was four feet, four inches wide (Figure 126). It contained steel rails, two inches wide by one half inch thick. Oregon fir planks, measuring two by twelve inches were coated with a crude oil mixture and nailed directly onto four by four inch redwood stringers. The tramway, as with the walkway, required frequent repairs and cleaning. It was also cleared of weeds and sand on a regular basis. In 1894, it was overhauled and repaired, with 675 feet of it renewed with new iron rails. A turntable was also built in order to eliminate the long curve, thereby shortening the track. No trace of this feature remains today. The wood was likely burned or re-used for other purposes.
