HISTORICAL AND ARCHAEOLOGICAL INVESTIGATIONS OF THE CARRIZO CREEK STAGE STATION

Stephen R. Van Wormer

June 30, 2007

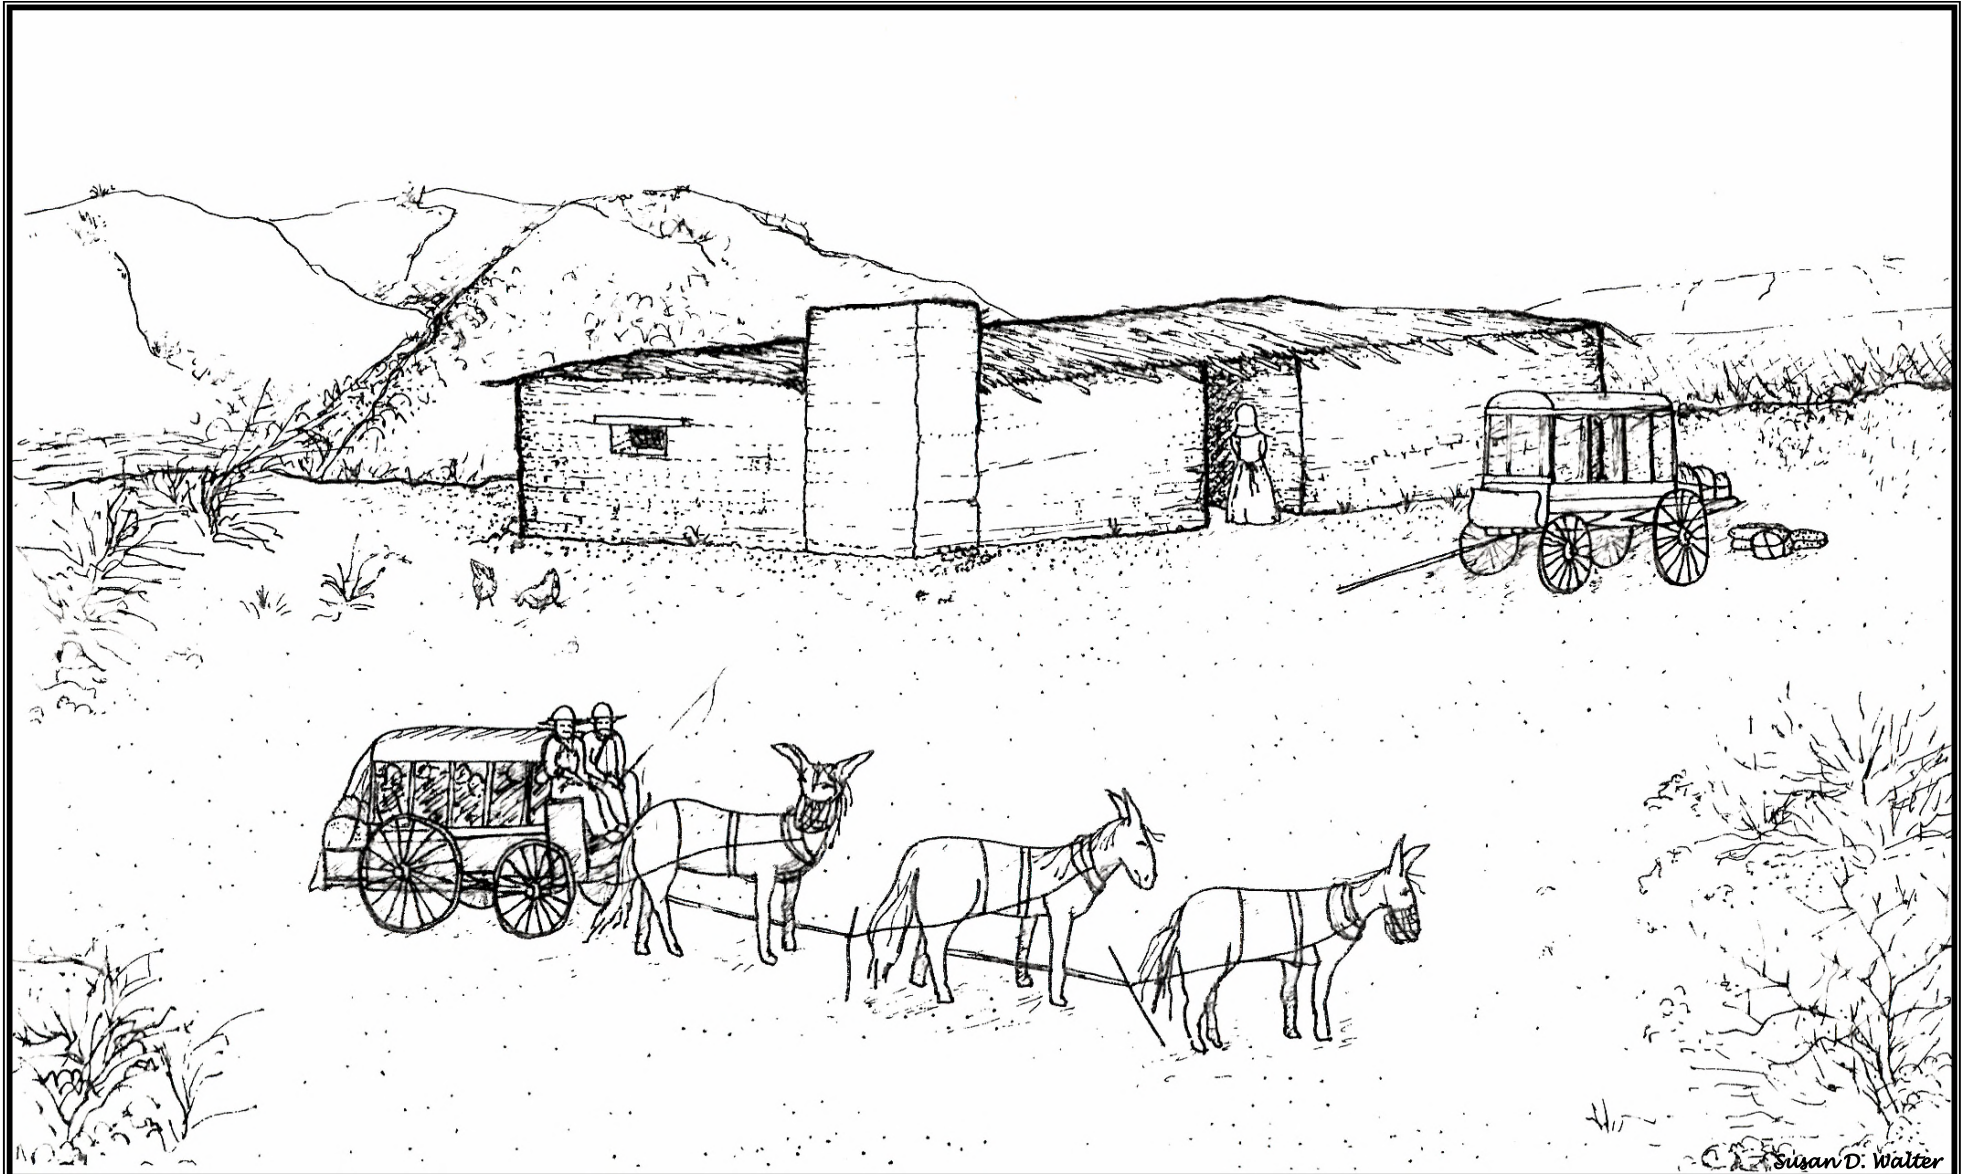
A conceptual sketch of Carrizo Creek Stage Station based on archaeological evidence. The stage from San Diego has arrived and the mules are being unhitched. Fresh teams will be harnessed to the coach at the corner of the building and the passengers will continue to Fort Yuma.

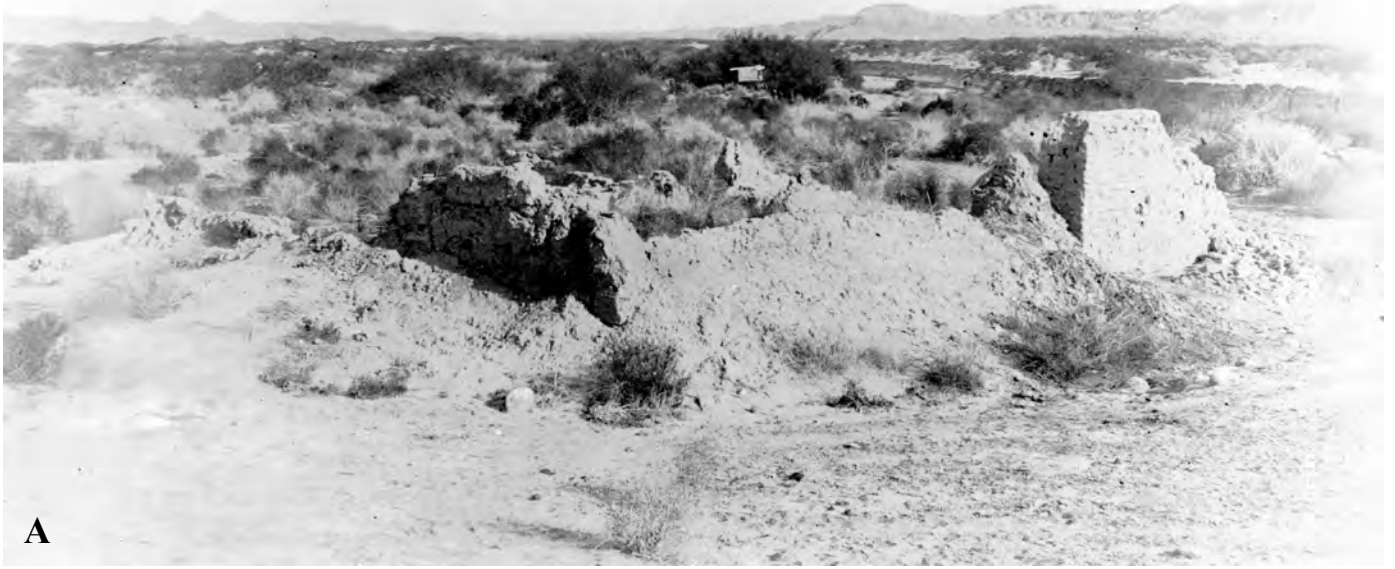
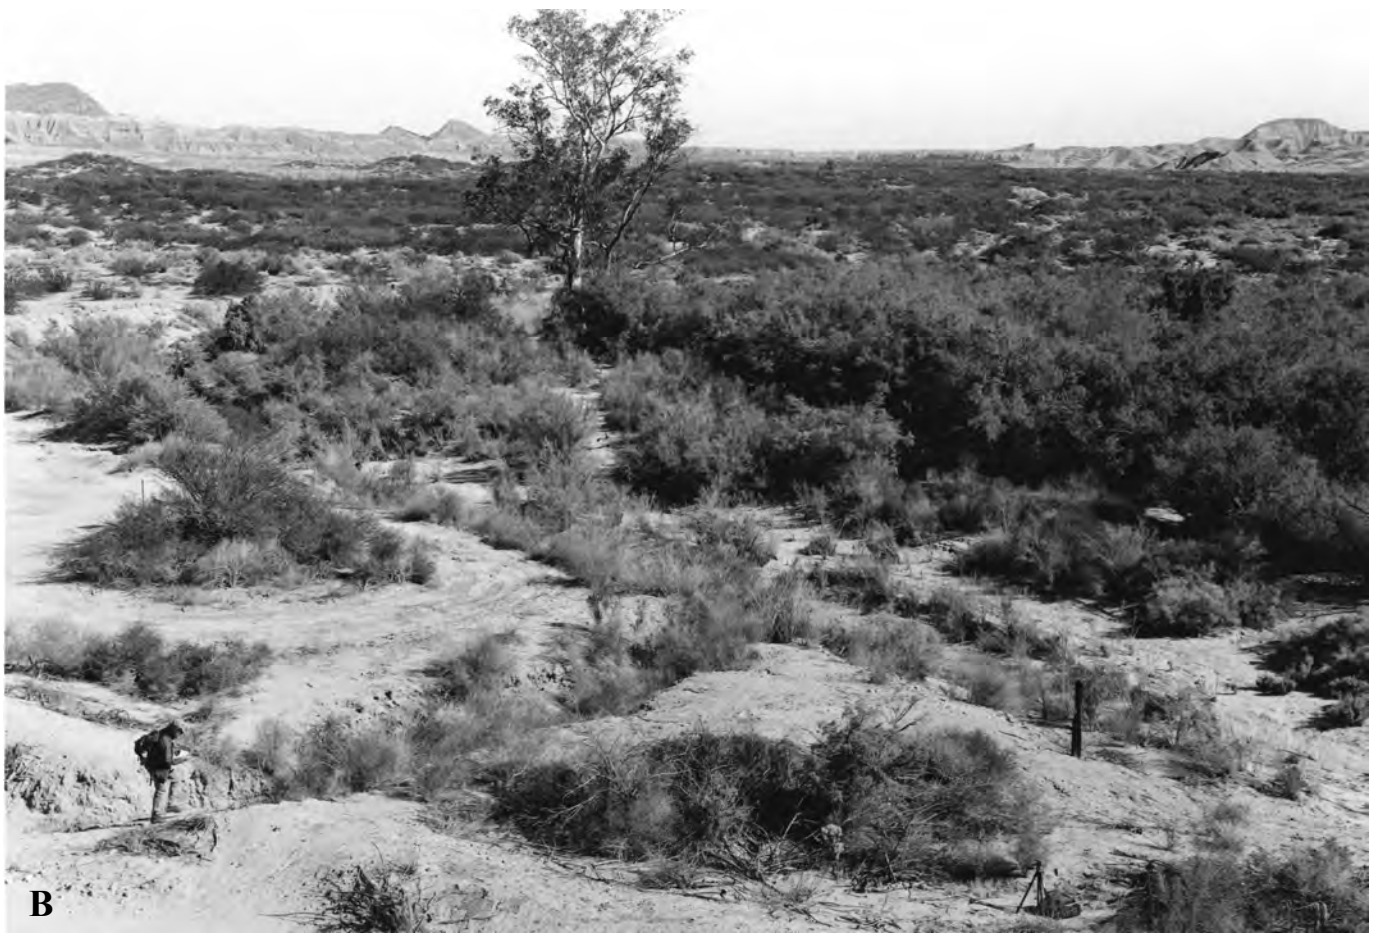
FIGURE 1

A: "Ruins of the old Butterfield Stage Station at Carrizo Creek," late nineteenth century, view to northeast, photograph by Frank Stephens, courtesy of San Diego Historical Society, Booth Photographic Collection
B: Carrizo Stage Station site, 1999, view to northeast, photograph by Christopher Wray

By the 1990s, nearly 130 years since the stage station fell into disuse, the site had suffered greatly from grading and severe erosion and had nearly disappeared from the landscape (Figure 1A & B). With the recognition that if no preservation efforts were undertaken, the site would soon be destroyed, California State Parks' archaeologists began investigations to determine what structures and features remained at the site and what protection measures were necessary for its preservation. In 1999, California State Parks Cultural Resource staff and District Archaeologist Rae Schwaderer recognized the need to archaeologically explore the site and to stabilize whatever features might remain. Funding was dedicated to this task and the research and fieldwork, under the direction of project leaders Sue A. Wade (Associate State Archaeologist) and Stephen R. Van Wormer (State Historian II), began in 2000.
