**2014 Annual Report**  
**Storm Water Management Plan**  
**Carnegie State Vehicular Recreation Area**

**Off-Highway Motor Vehicle Recreation Division**  
**Department of Parks and Recreation**  
**State of California**

**OCTOBER 2014**

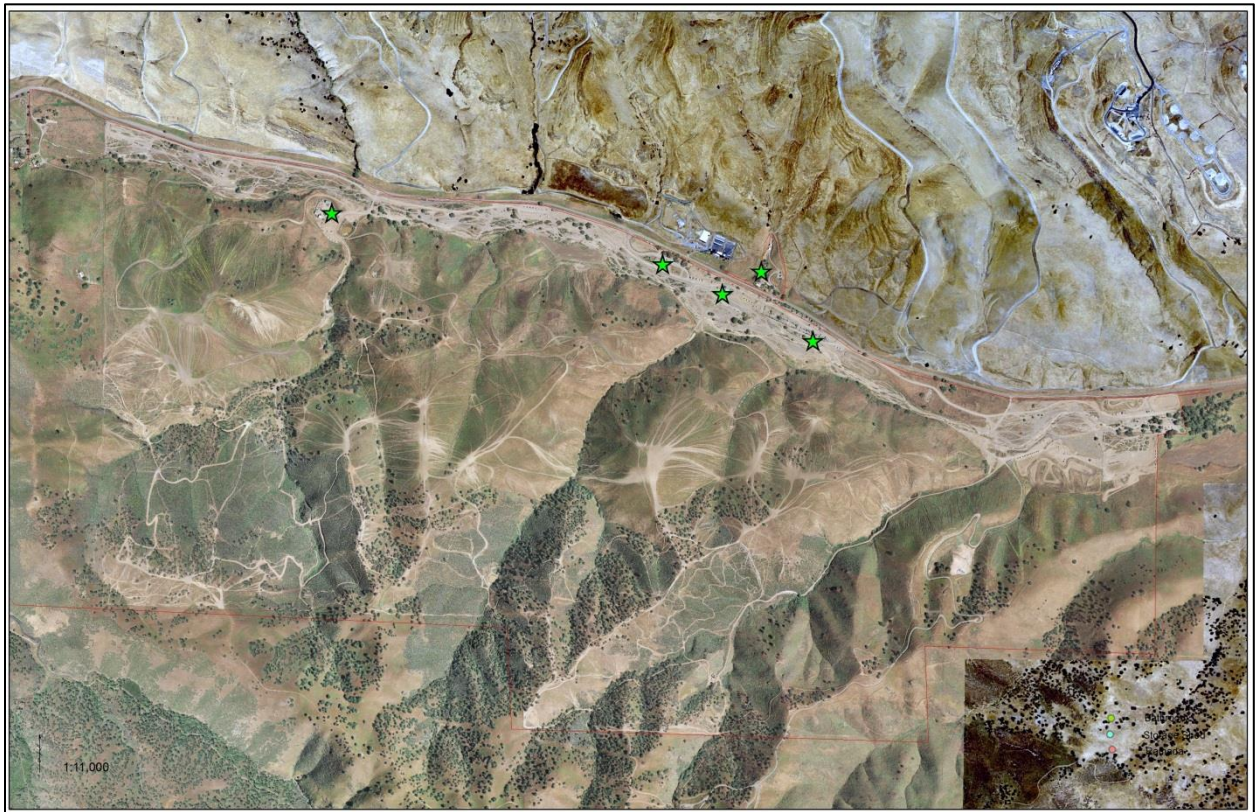
**Map 2. Illicit Discharge Detection and Elimination Program Monitoring Locations.** The locations of the five facilities monitored as part of the illicit discharge detection and elimination program. From left to right: maintenance yard, the ranger station, the store, the water treatment facility, and the campground

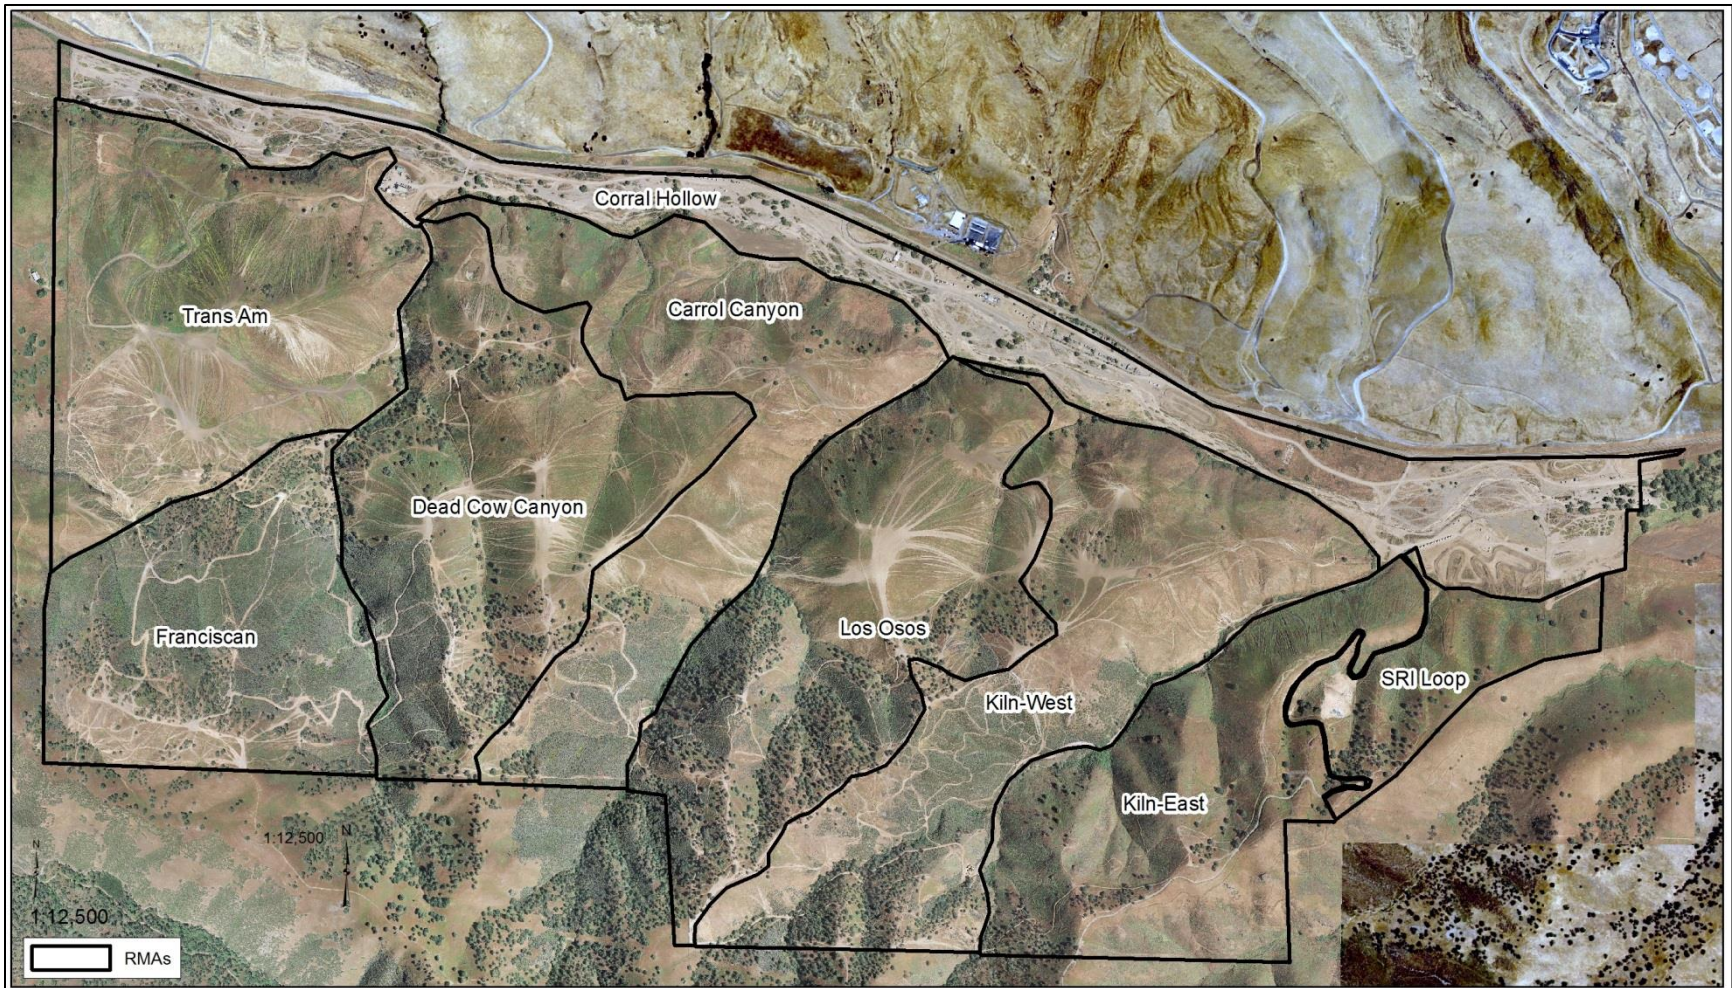
**Map 3. Resource Management Areas.** Corral Hollow, SRI-Loop, and Kiln-East RMAs are completed and open as “trails-only”. Although open, Kiln-West and Los Osos RMAs are currently undergoing rehabilitation efforts.

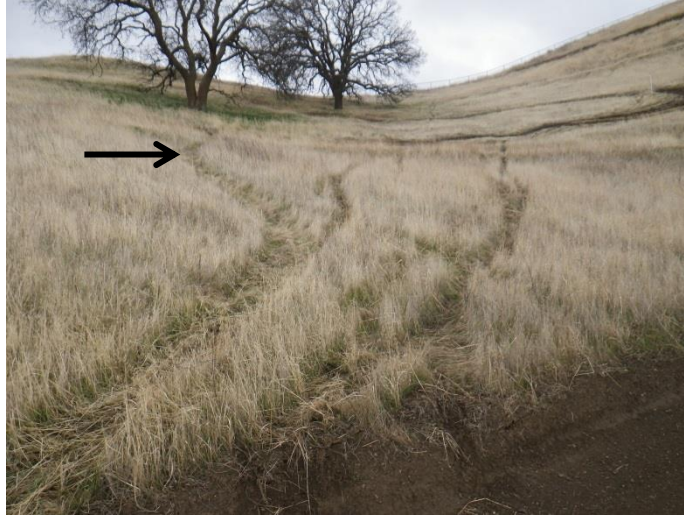
**Figure 4. Kiln-East RMA Off-trail Violation, Feb. 2014.** This RMA was closed for one week due to this violation.

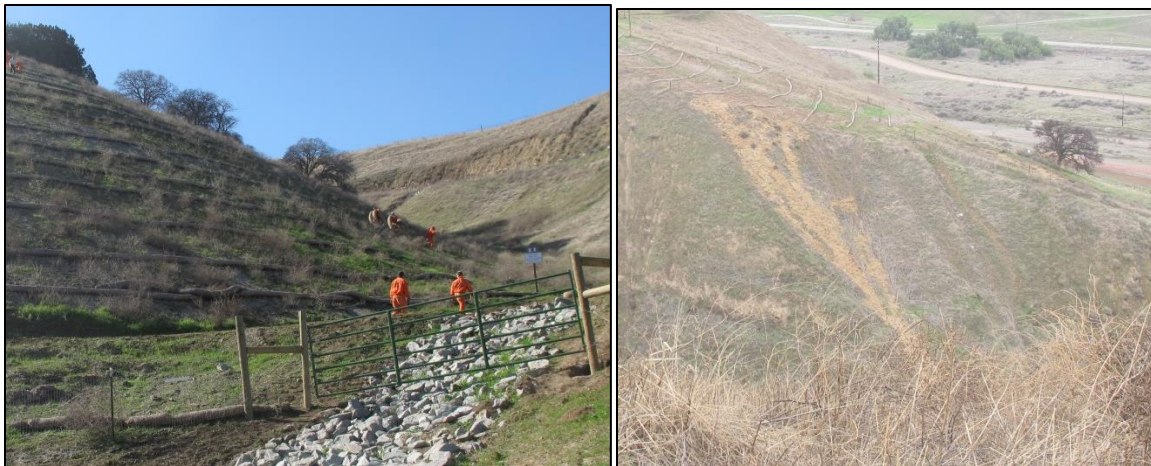
**Figure 5. Off-trail Riding Correction Measure.** Inmate crews are often used to implement corrective measures. Hay is typically spread over the exposed soils to reduce raindrop erosion and also to communicate to visitors that the created trail is not sanctioned.

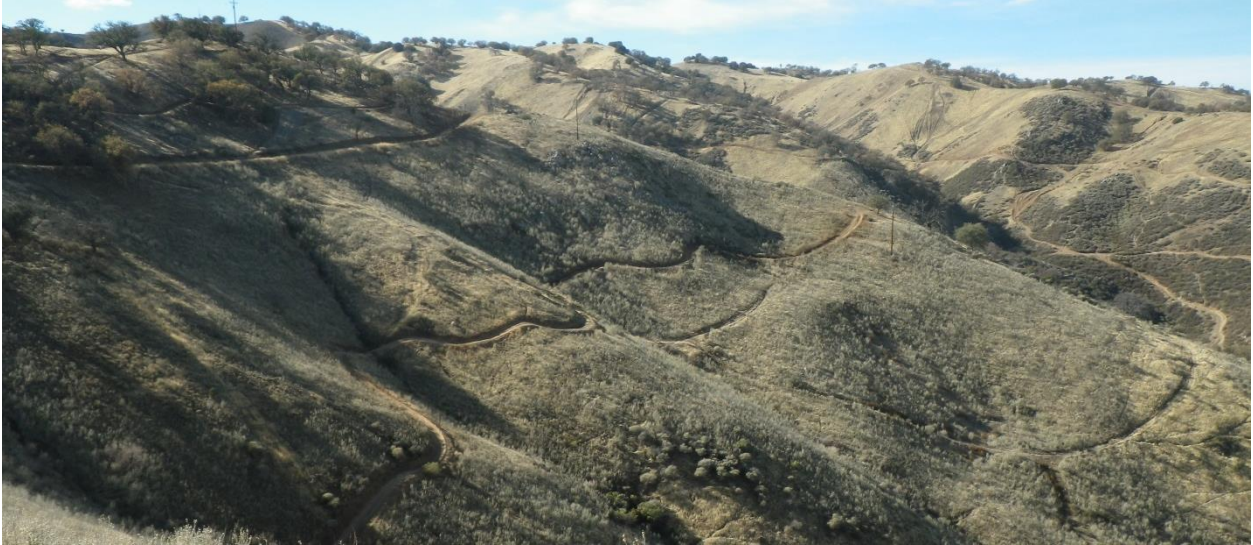
The Kiln-East RMA was re-opened in October of 2011. This RMA has varying topography and more trails (2.96 mi) as compared to the SRI Loop RMA (1.08). Therefore, there was some uncertainty regarding the effectiveness of the RMA model on this larger and more complex trail system. The available monitoring data does suggest a successful beginning as new off-trail activity was minimal and vegetation is re-establishing (see Attachment J). If widespread, unauthorized trail use was occurring then it would be apparent in these landscape level photographs (see Figure 6).

**Figure 6. The Kiln East RMA.** This photo of Kiln East RMA was taken in December 2013 and shows no obvious signs of off-trail riding. Although some off-trail riding did occur, it is limited.

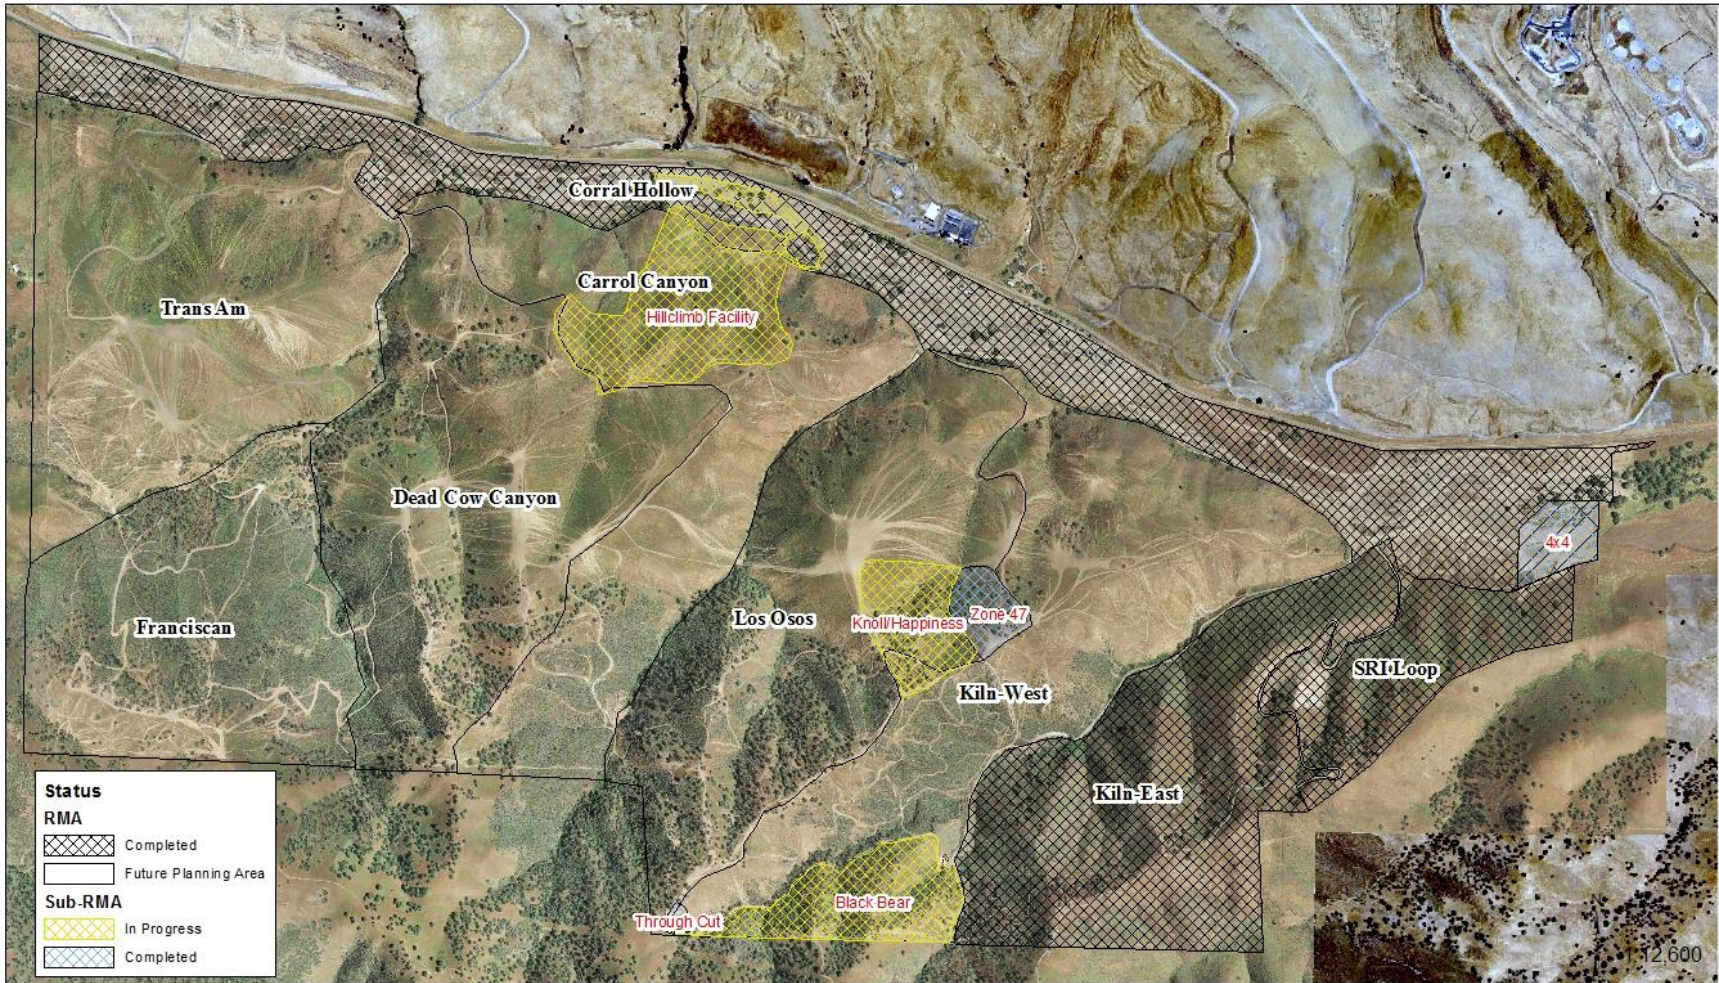
**Map 4. The Status of the RMAs and the Sub-RMAs.** “Completed” means most of the measures are in place. Through monitoring or other means, areas can be improved to protect the natural and cultural environment and provide recreation.

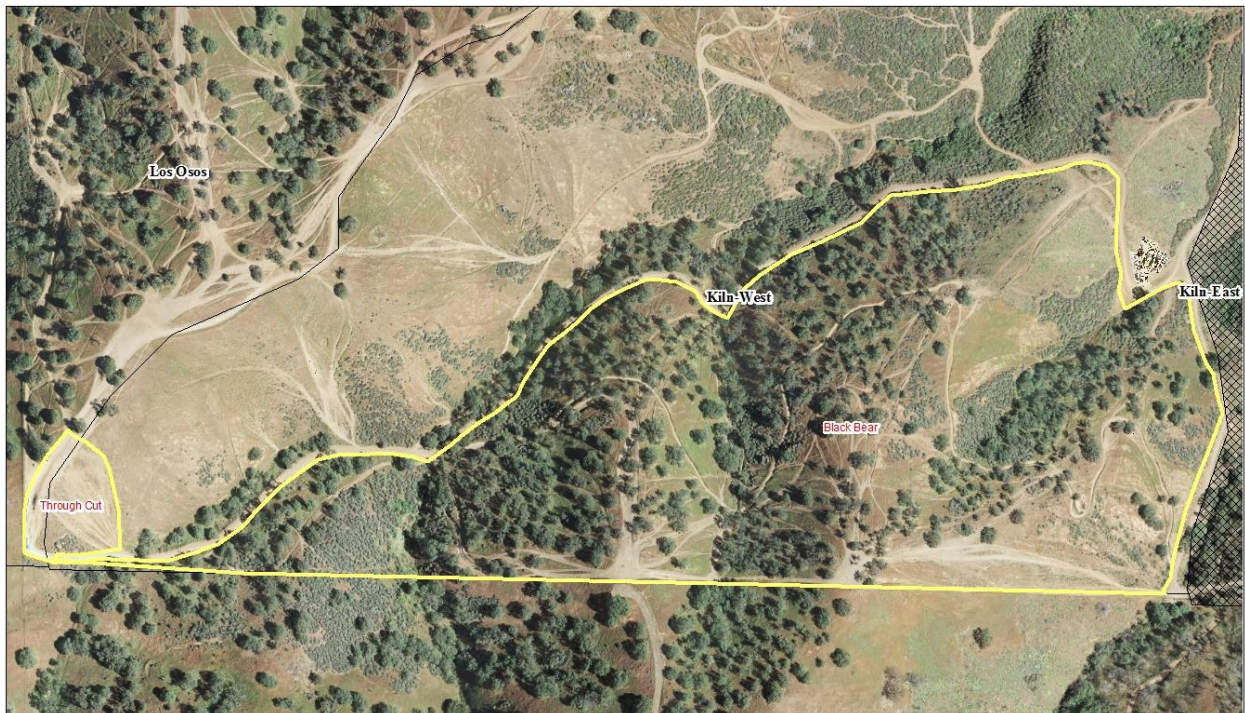
**Map 5. Black Bear and Through Cut Sub-RMAs.** These Sub-RMAs are 27.5 acres (in yellow). Planning and fencing occurred during this reporting cycle. Rehabilitation efforts will occur in the next reporting cycle. Aerial photo is from 2010.

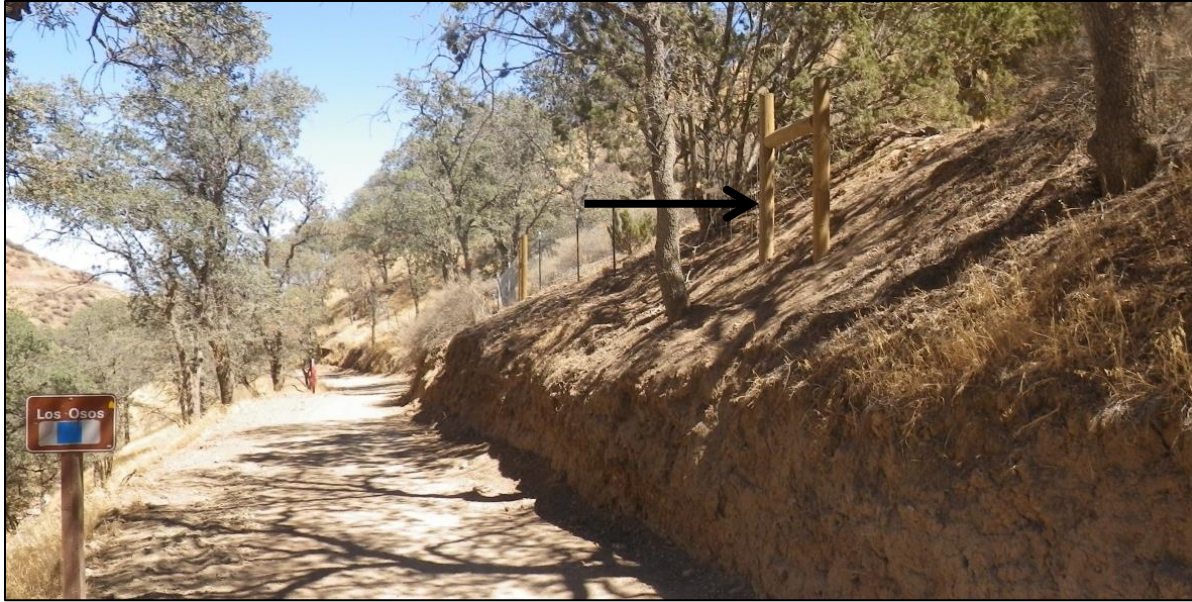
**Figure 7. The Black Bear Sub-RMA.** The perimeter fence (2500') was installed in order to close the area for the rehabilitation work scheduled for the next reporting cycle.

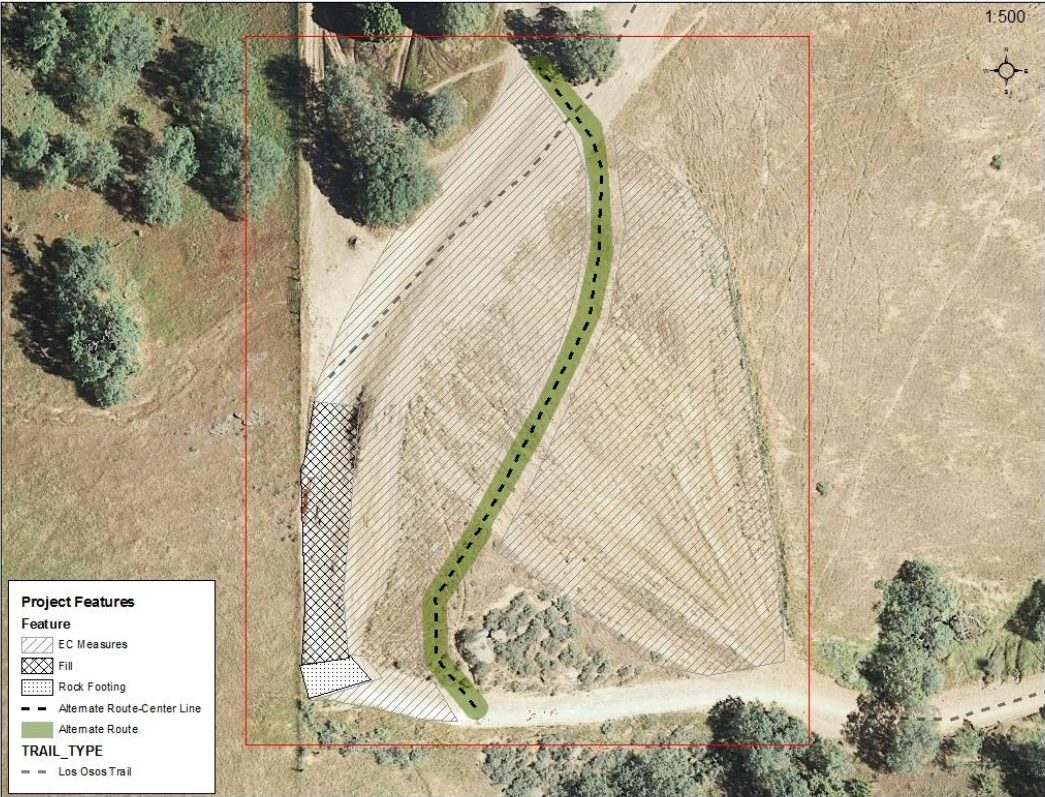
**Map 6. Through-cut.** Improvements included re-aligning the emergency access road, rehabilitating the areas adjacent to the road, and fencing to exclude off-highway vehicle access in the future.

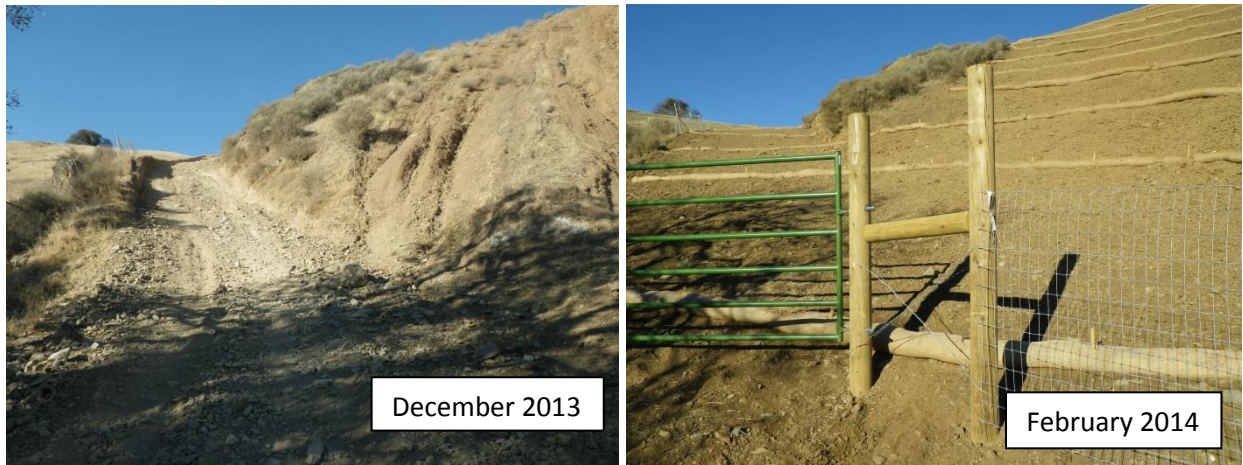
**Figure 8. Rehabilitation of Through Cut.** Area was closed to eliminate off-trail riding, brought up to grade, and restored.

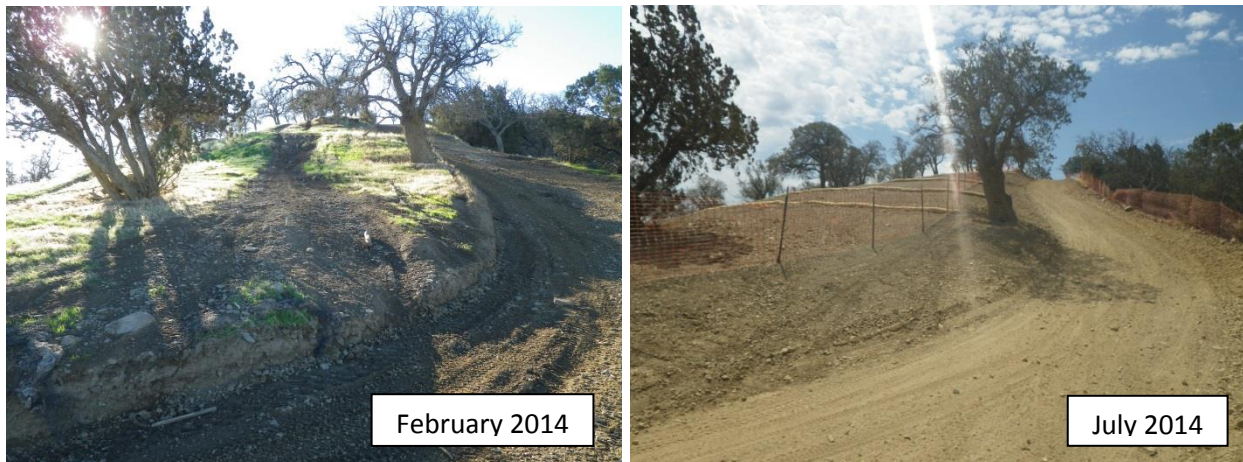
**Figure 9. Rehabilitation Work in Knoll/Happiness.** This shows an area of the Knoll that was closed to eliminate off-trail riding, recontoured, and wattled. Area will be hydroseeded before first rains.

The Los Osos RMA is also undergoing rehabilitation work. The Sub-RMA known as Knoll/Happiness (11 acres) was almost completely rehabilitated during this reporting period (see Map 7). The area was closed, recontoured, fiber rolls were placed, and hydromulching will take place in fall 2014 before the first rains. The Sub-RMA known as Zone 47 (8 acres) was rehabilitated and is currently closed for trail planning (see Map 7). As a result of the work completed in this Sub-RMA, the trail system (approx. 0.80 mi) went from 6 percent to 88 percent green. The CAT is working with the park's management team to identify trail routes to use as part of the official system. A fence was also installed around the perimeter of the area consistent with the RMA strategy. This area was scheduled to open in fall 2013; however, due to drought conditions, vegetation growth was minimal and this area will remain closed until fall 2014 as a result. A project summary can be found in Attachment N.

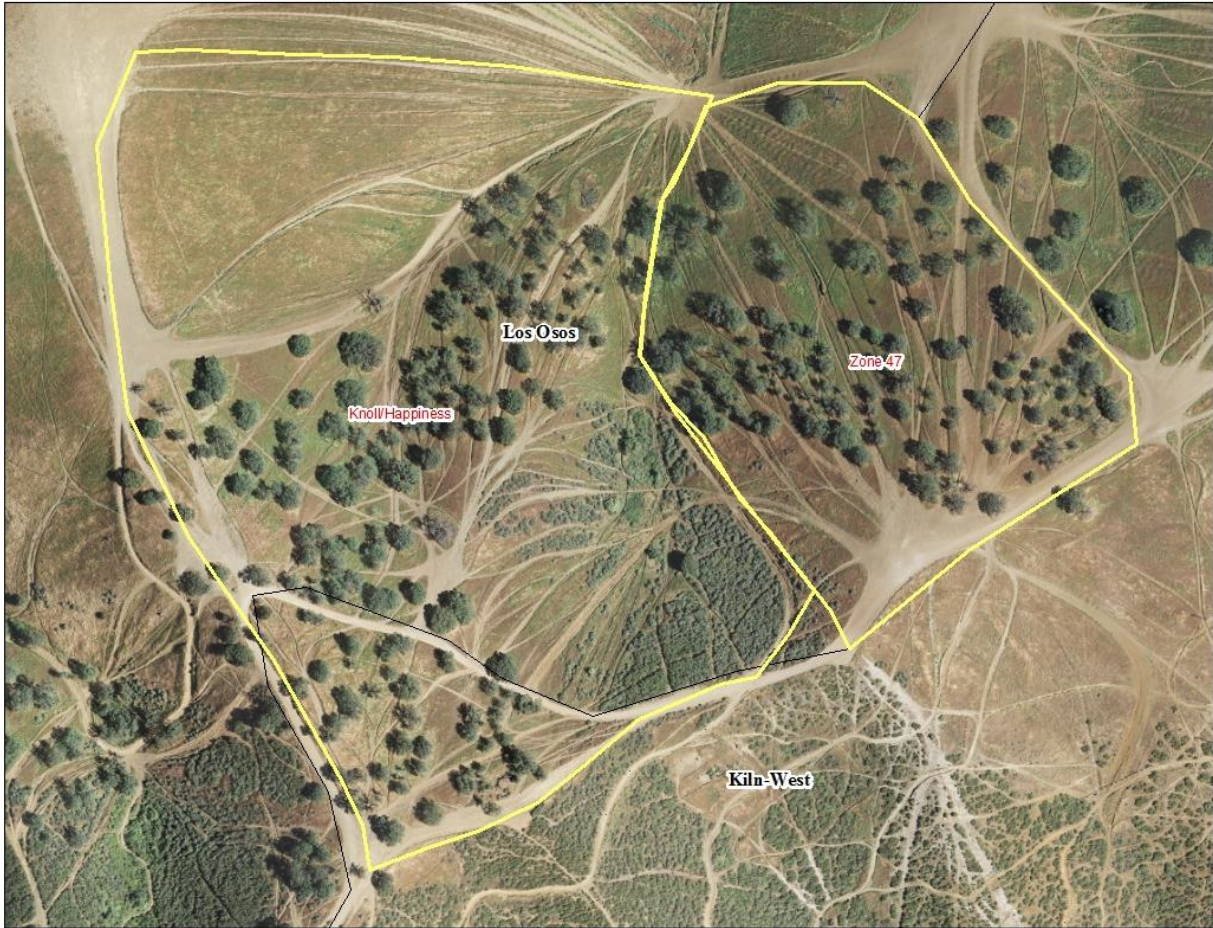
**Map 7. Knoll/Happiness and Zone 47 Sub-RMAs.** These Sub-RMAs constitute 19 acres of rehabilitation within the Los Osos RMA. Zone 47 is complete and Knoll/Happiness is in progress.

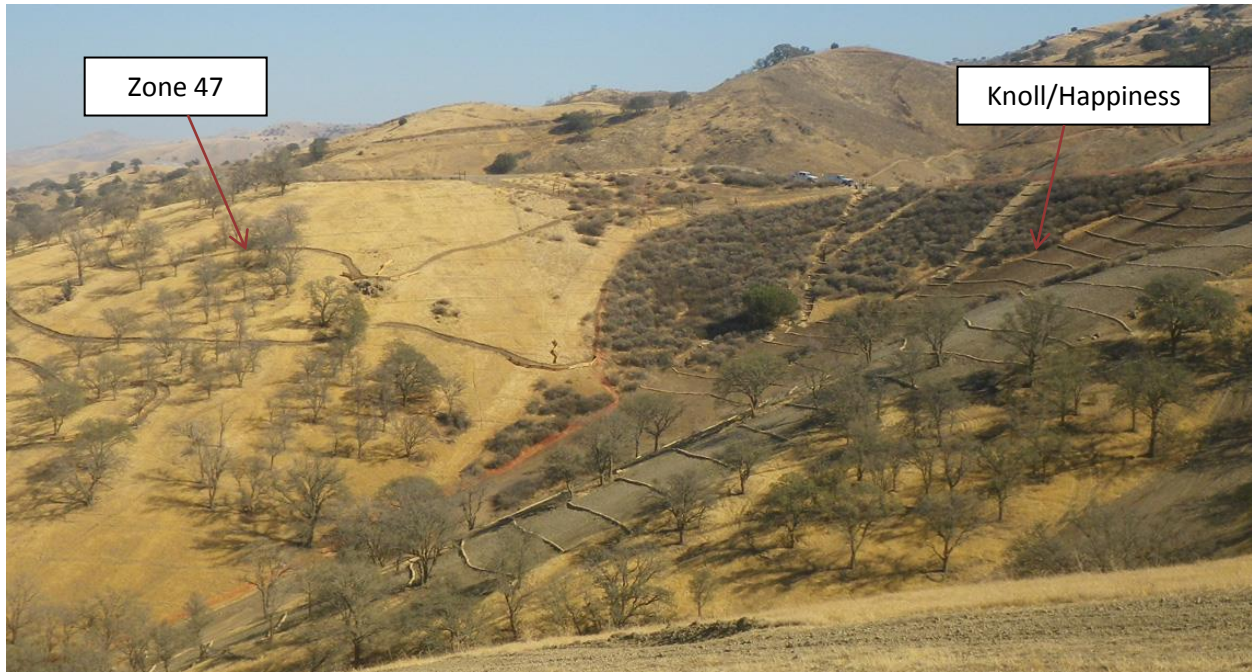
**Figure 10. Los Osos Rehabilitation Progress.** The Zone 47 Sub-RMA was completed during the last reporting cycle and the Knoll/Happiness Sub-RMA took place during this reporting period.

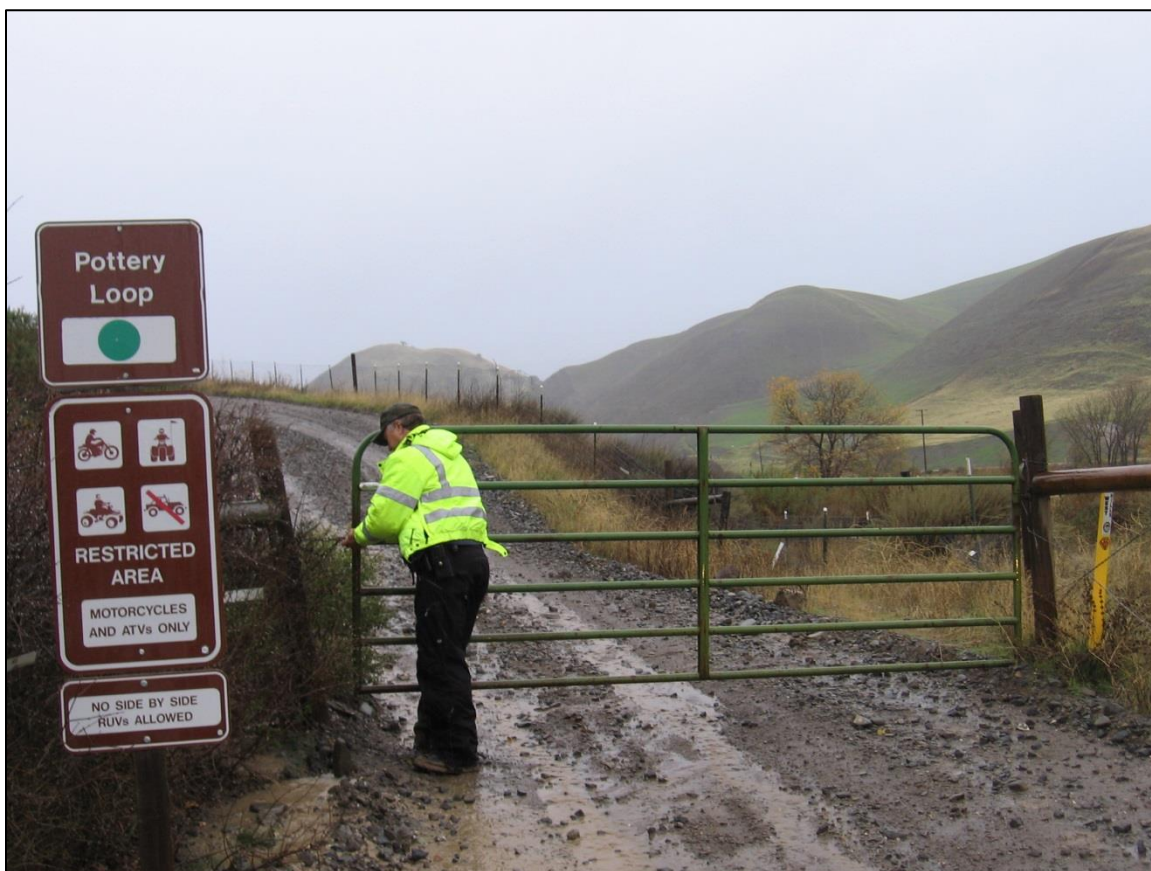
**Figure 11. Wet Weather Closures.** These closures occurred three times this reporting cycle.

Closure Date	Closure Time	Opening Date	Opening Time	Storm Event Precipitation (Inches)
11/20/2013	13:30	11/21/2013	11:30	1.33
12/7/2013	8:00	12/8/2013	8:00	0.36
2/28/2014	8:00	3/2/2014	8:00	0.86

The wet weather closures are currently based on estimates derived from hydrological models. Since conditions can be affected by other factors like wind, temperature, and duration since the last storm, the park is investigating the possible use of soil moisture sensors to assist in the opening and closing of the hills. In March 2013, five locations were identified and soil moisture equipment installed (see Map 9). This equipment consists of Decagon Devices dataloggers and sensors. The information is

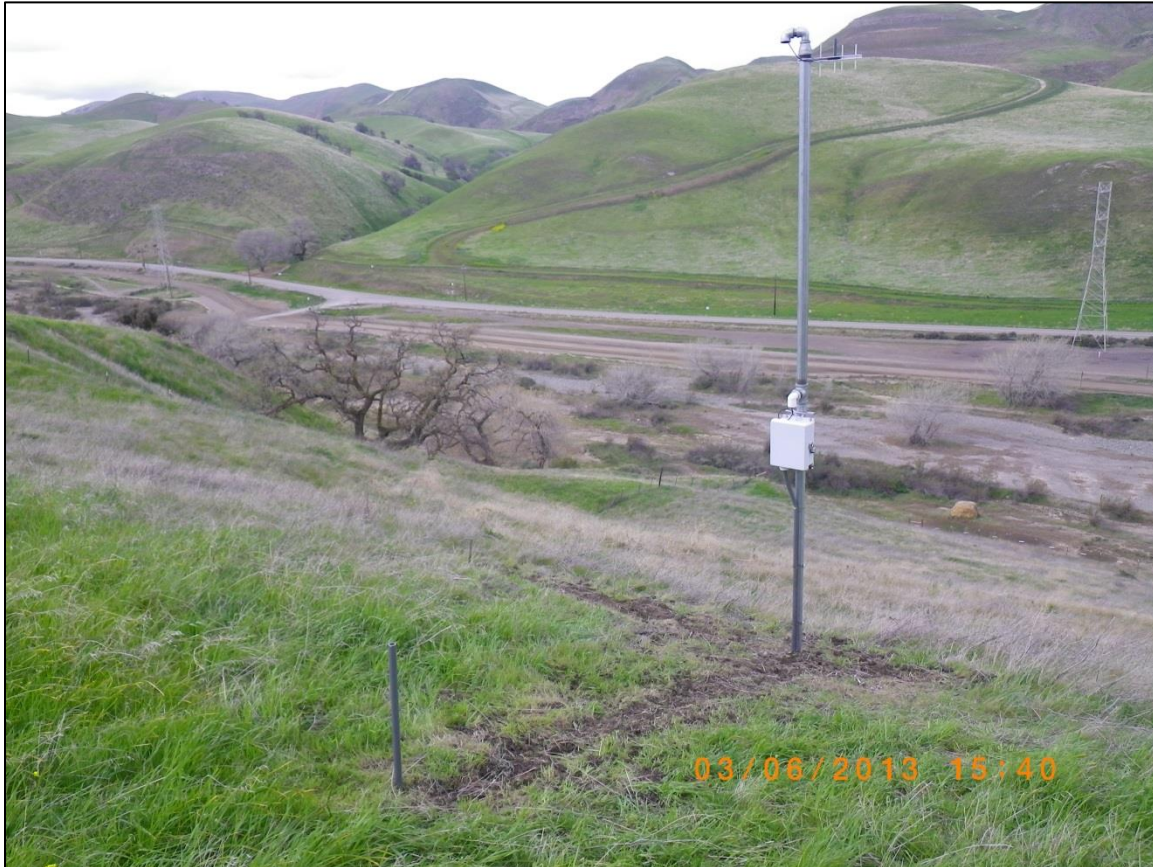
communicated to the base station in the entrance kiosk and software is used to track the measurements. Unfortunately, very little precipitation has occurred since the meters were installed so very little data collection occurred in the 2012/13 and 2013/14 winters. Over the course of the 2014/15 winter, condition assessments will be made and correlated to the soil moisture data. These results will be submitted to the Central Valley Regional Water Quality Control Board (CVRWQCB) for review and to establish soil moisture criteria for opening and closing of the hills.

**Figure 12. Soil Moisture Meter at Site 5.** The meters were installed in March 2013 at five locations.

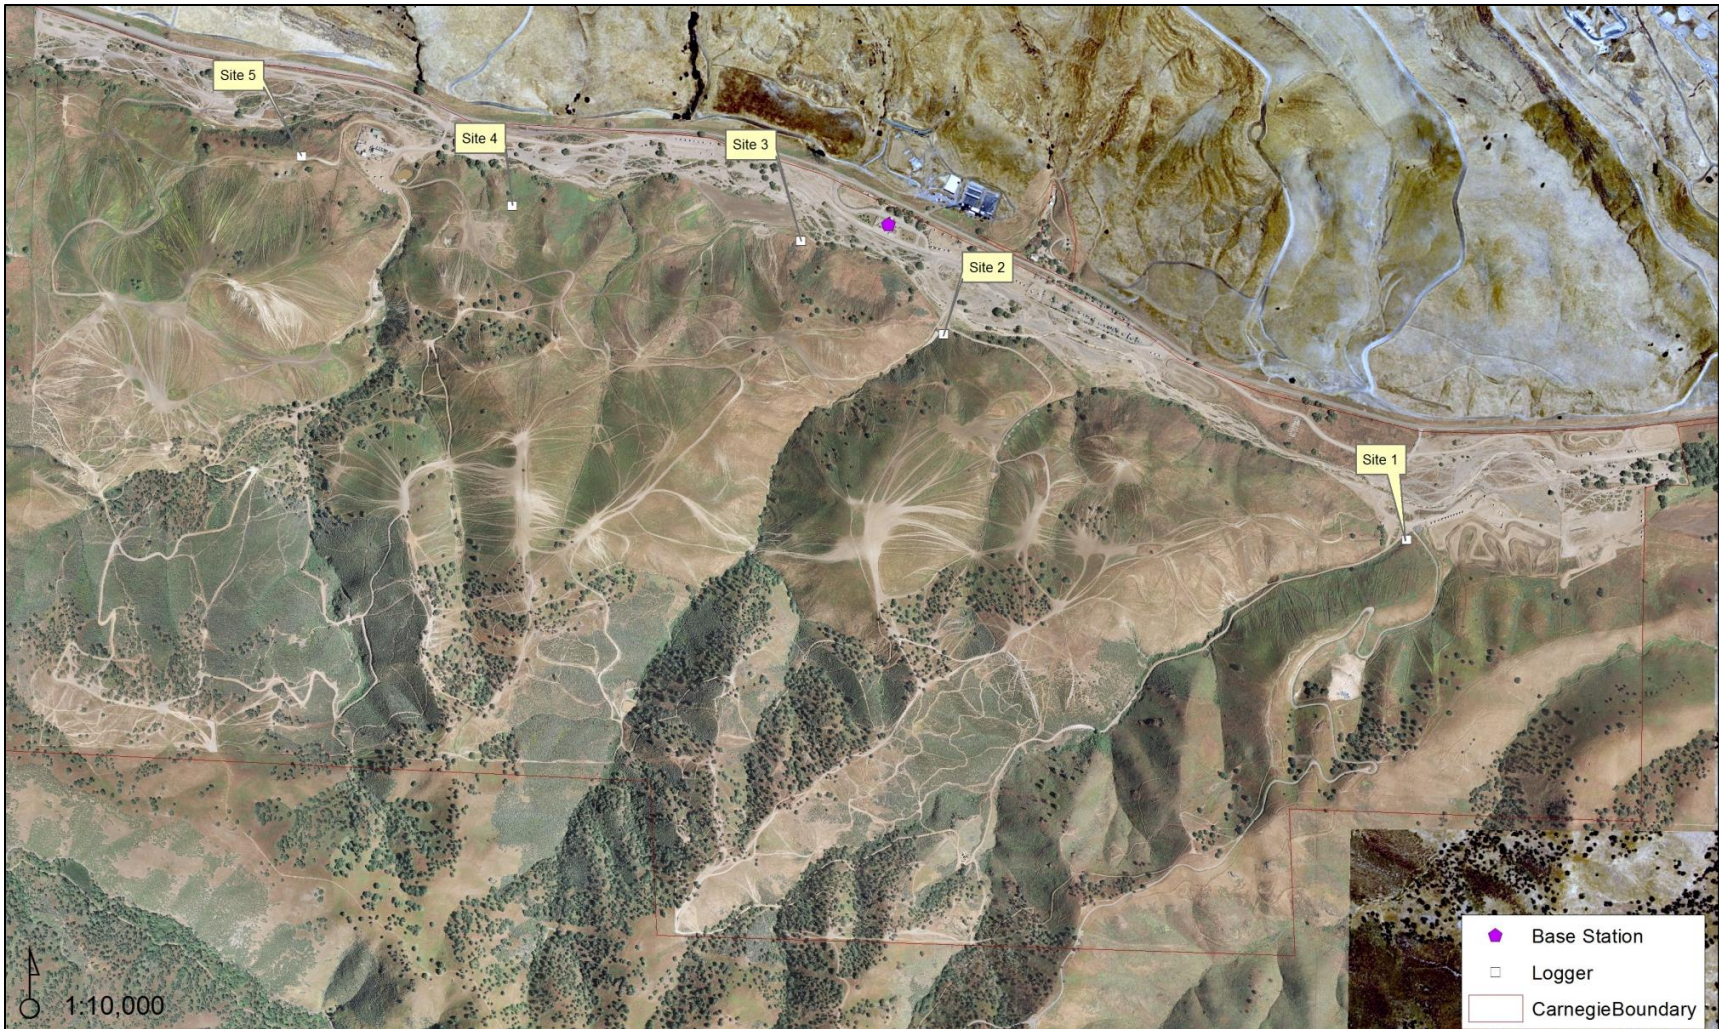
**Map 9. Soil Moisture Meter Locations.** Each site is located closest to a main trail head while maintaining a direct line of communication to the base station. Site 3 is an exception and is set up to measure the soil conditions at the hillclimb facility.

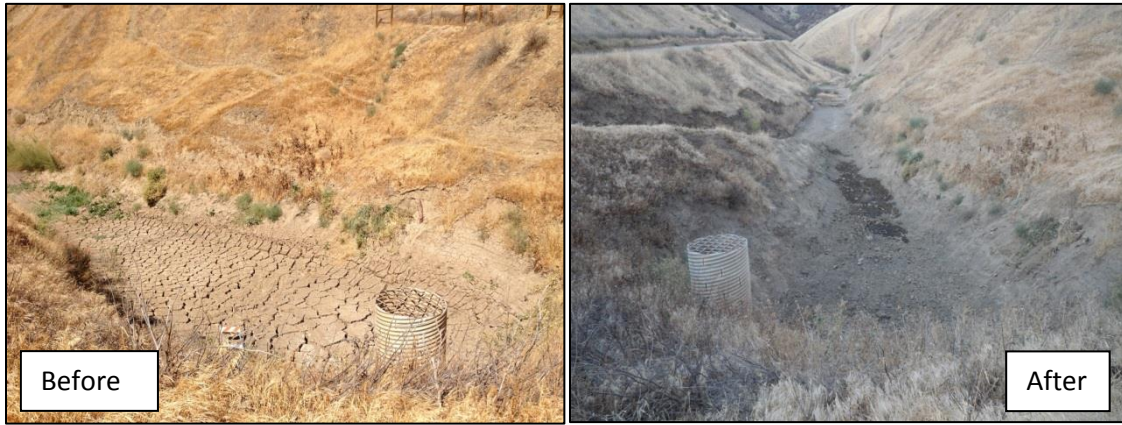
**Figure 14. Kiln Basin Cleanout.**

Sediment removal occurs annually in September. See Figures 14-16 for before and after photos of the cleanout. The sediment from the basins is used for rehabilitation projects (see Figure 17).

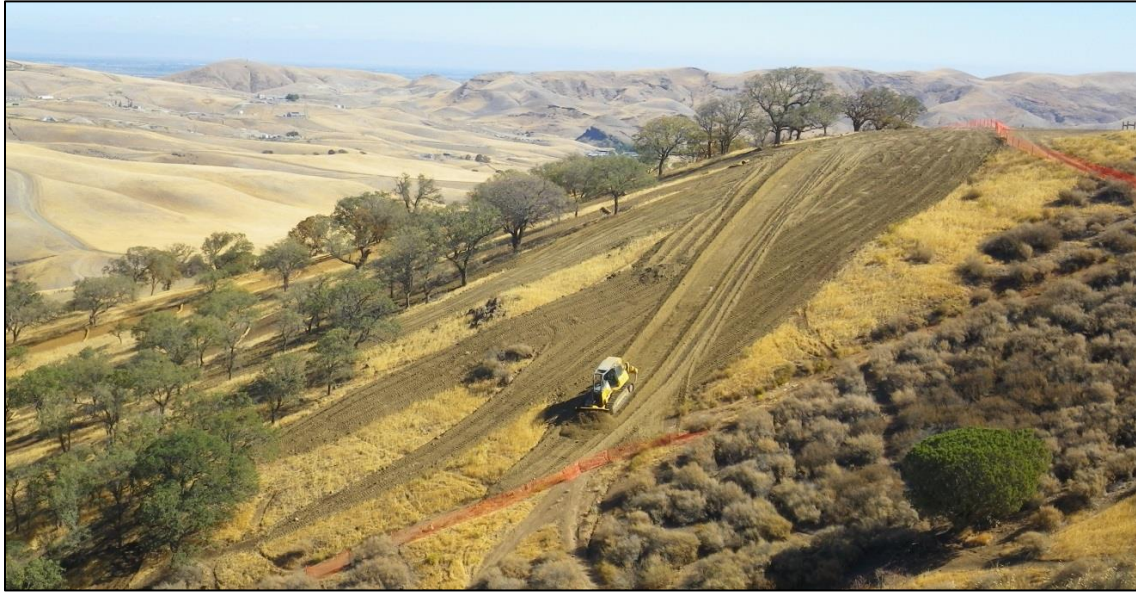
**Figure 17. Sediment Reuse.** The sediment from the basins is used for rehabilitation projects in the park. The photo shows Zone 47 being rehabbed.
