GEOTECHNICAL INVESTIGATION

Bridgeport Covered Bridge Nevada County, California

GEOCON PROJECT NO. S9030-05-41

Subject: GEOTECHNICAL INVESTIGATION
BRIDGEPORT COVERED BRIDGE
SOUTH YUBA RIVER STATE PARK
NEVADA COUNTY, CALIFORNIA

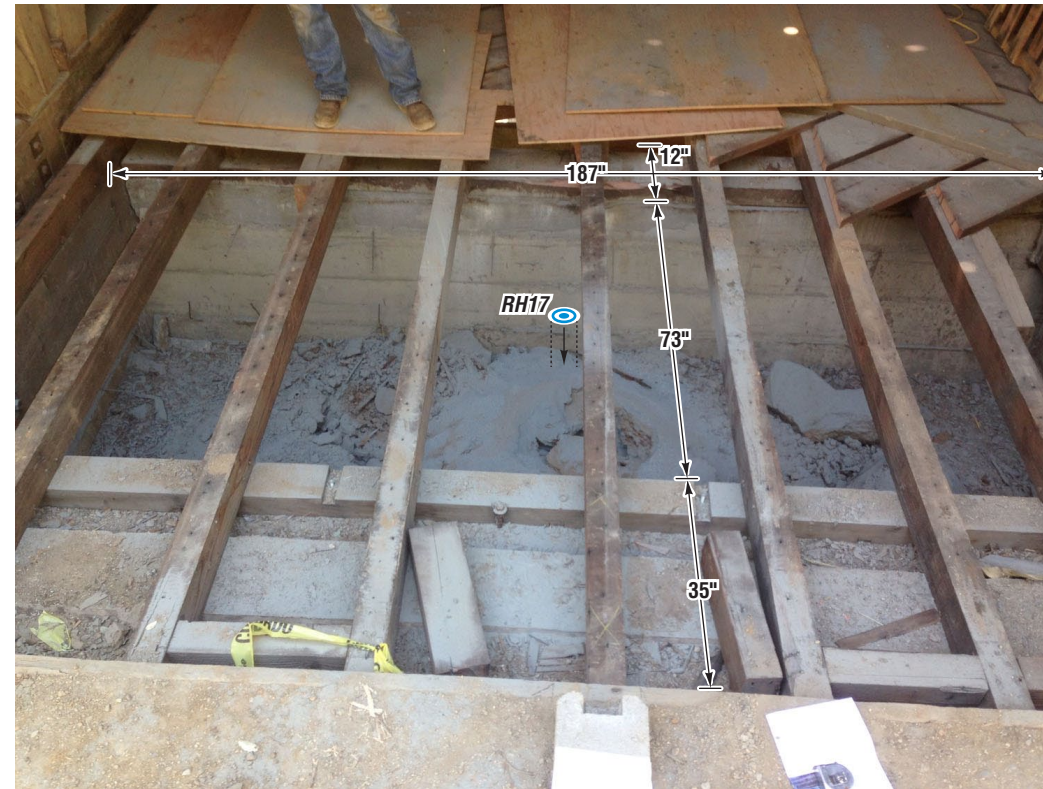
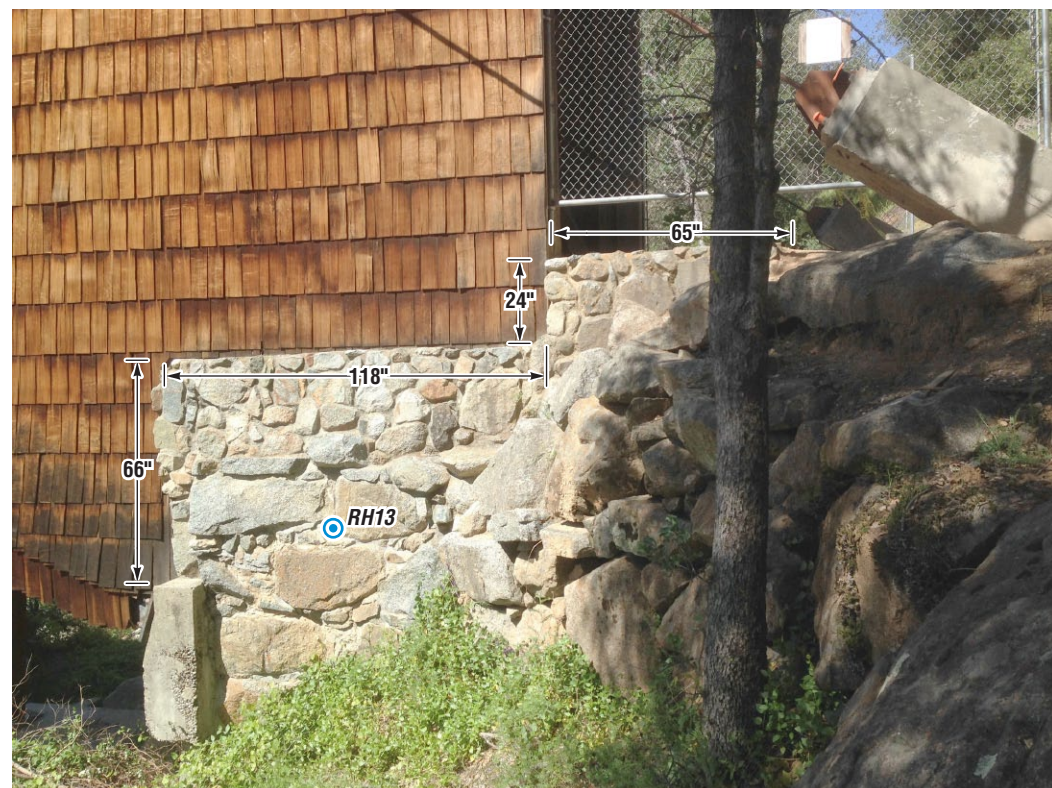
North Abutment Exploration Details

No.	Concrete/Grout Thickness	Behind face composition
Core 2	13"	Core Broke off at Rock at end of core
RH9	2"	Soil to 24"
RH10	3"	Soil to 24"
RH11	3"	Soil/Voids to 24"
RH12	3"	Soil/Voids to rock at 15"
RH13	3"	Soil/Voids and Rocks to 24"
RH14	3"	Soil/Void to 24"
RH17	9"	Rocks and Voids/Soil to 24"
RH22	4"	4-11" Sandy SILT/Voids (dry stacked rock), 11-14" grout/conc., 14" Refusal
RH23	3"	3-12" Soil/Void, 12" grout/conc., 12.5-23" soil/void
RH24	4"	4-23" void (dry stacked rock)
RH25	4"	4-17" Soil/grout/voids, closely spaced stacked rock, refusal at 19" on Rock

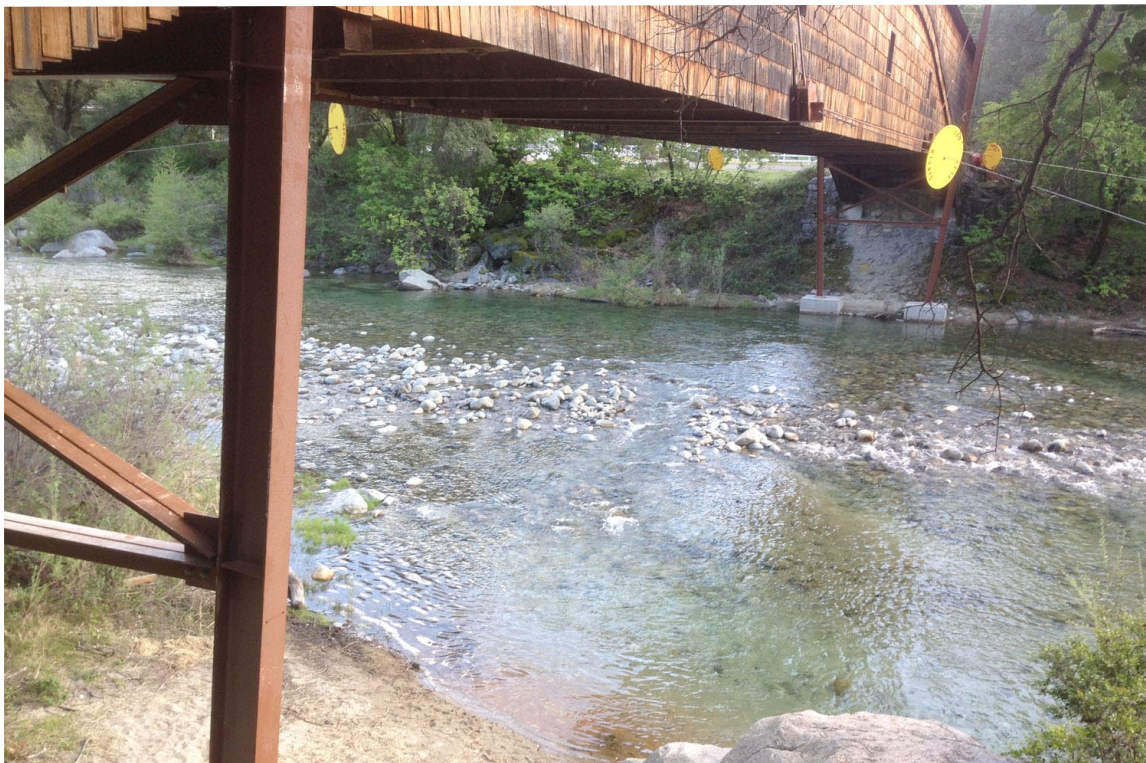
Photo No. 4 Interim stabilization piers

In 2014/2015, interim stabilization measures designed by Buehler & Buehler Structural Engineers (B&B) were constructed. The measures included two interior, structural steel piers (Photo 4) and two tension anchor foundations (Photos 5 and 6) located outside of the South and North Abutments. The approximate locations of the tension anchor foundations (aka "deadman" foundations) are shown on the Site Plan, Figure 2, and Cross-Section A-A', Figure 3.

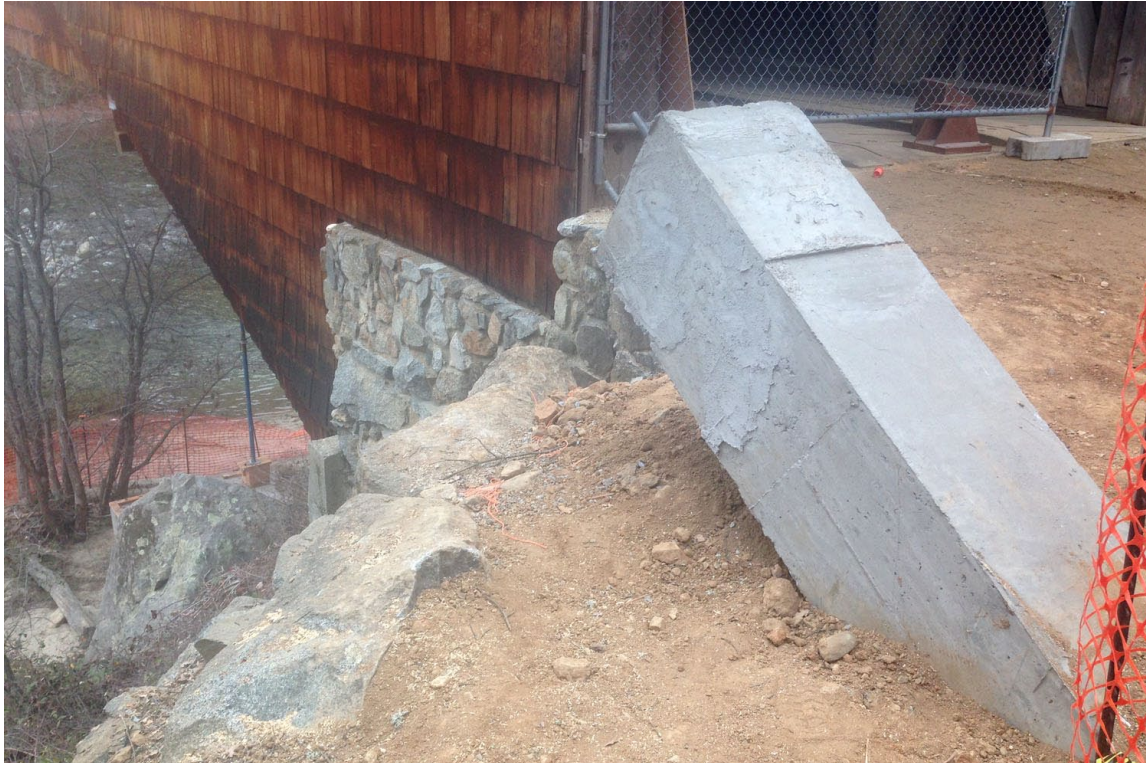
Photo No. 5 Tension anchor for interim stabilization

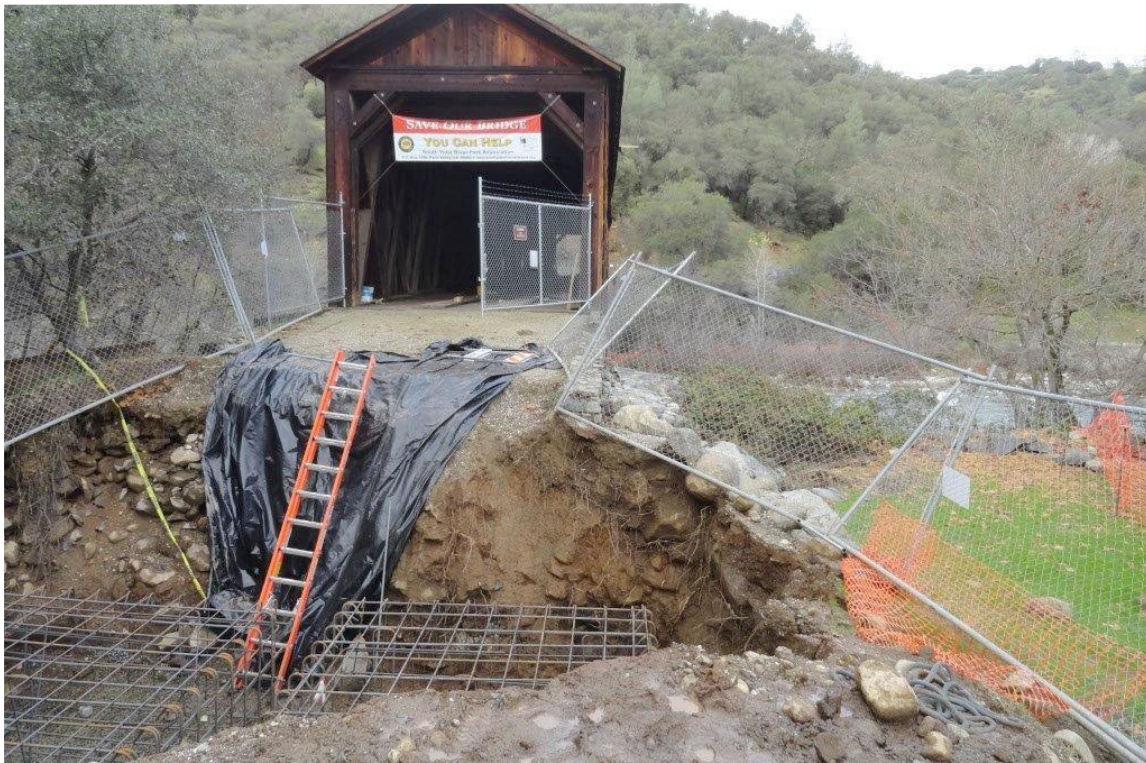
Photo No. 6 South tension anchor footing

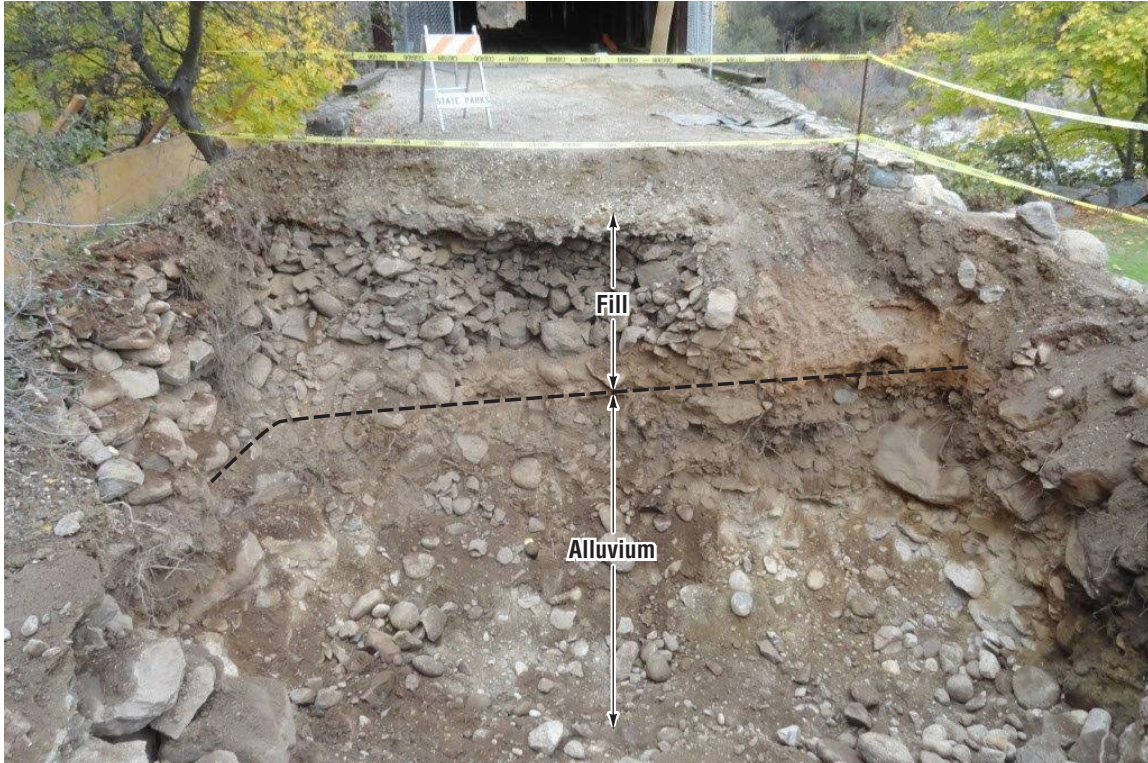
Photo No. 7 Typical subsurface conditions – south abutment area

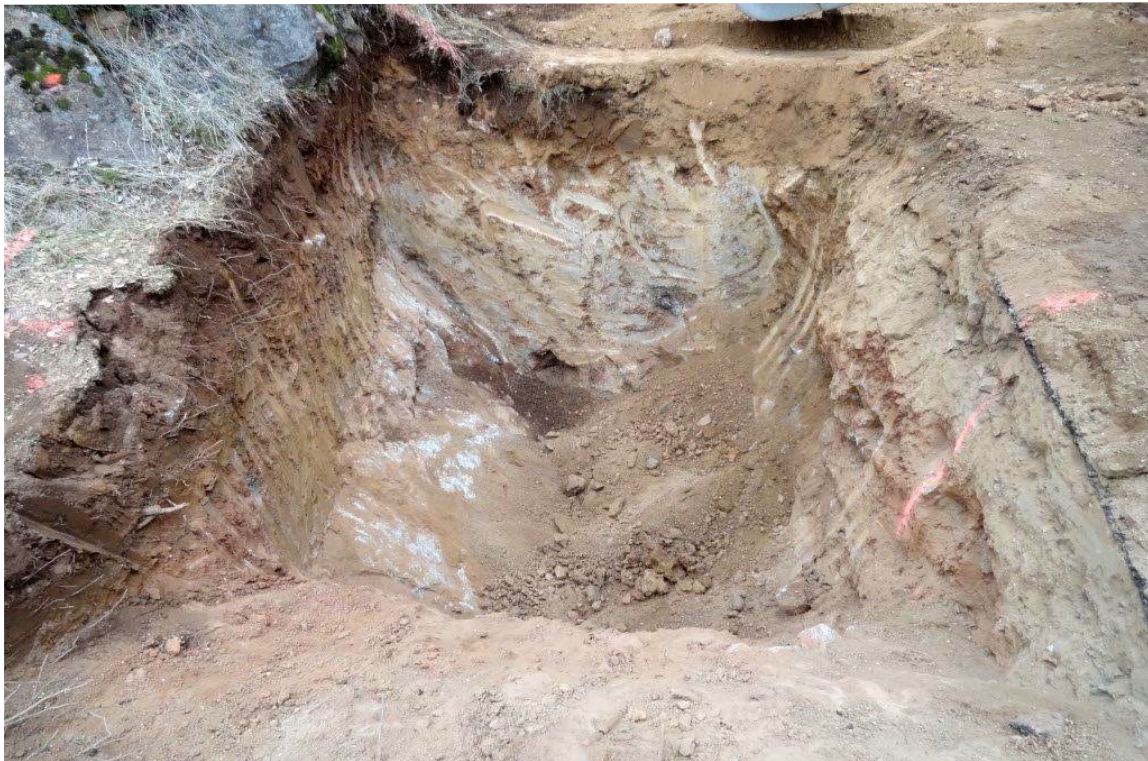
Photo No. 8 Typical subsurface conditions – north abutment area

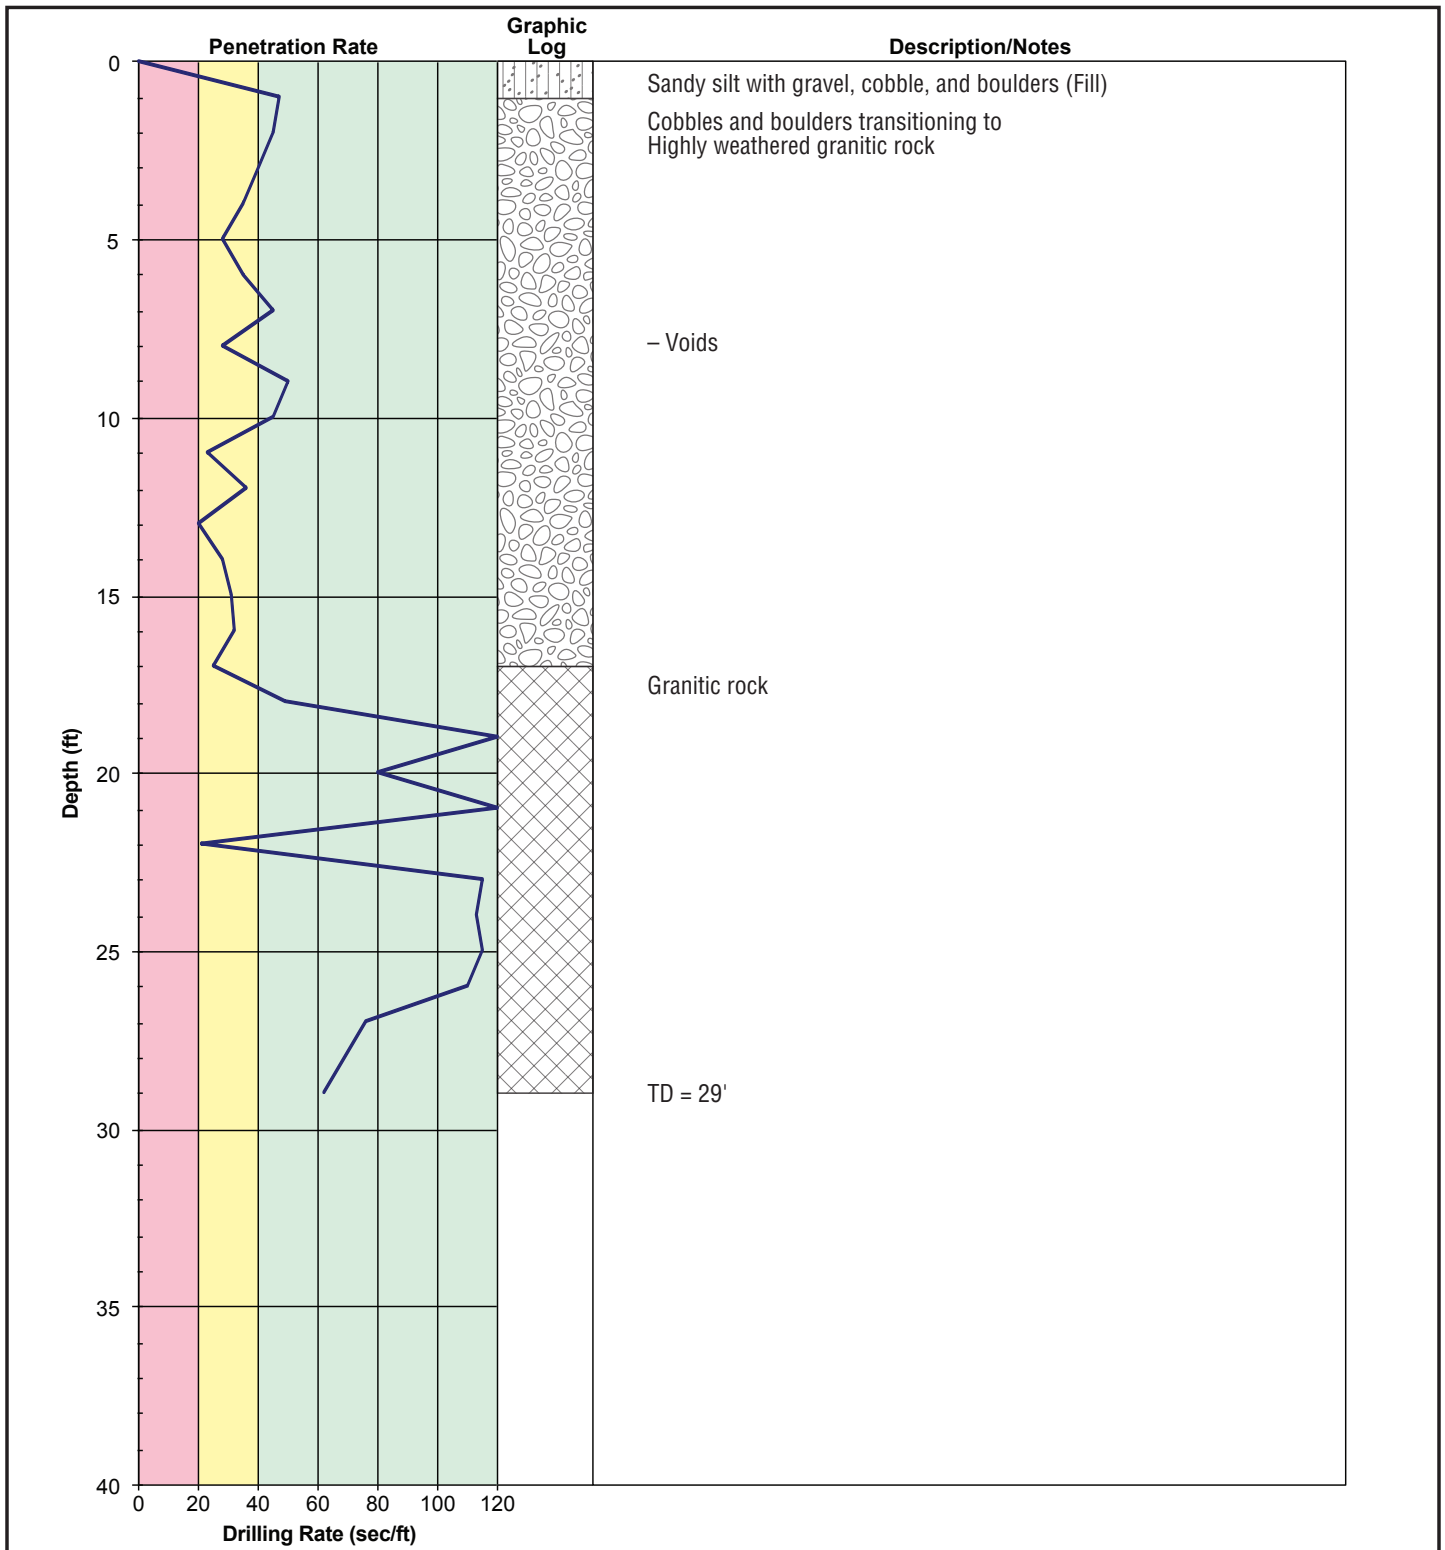
Figure A9

Estimated Subsurface Condition

- 0 - 20 sec/ft – Soil/Loose Cobble/FILL
- 20 - 40 sec/ft – Boulders/Highly Weathered Rock
- > 40 sec/ft – Bedrock

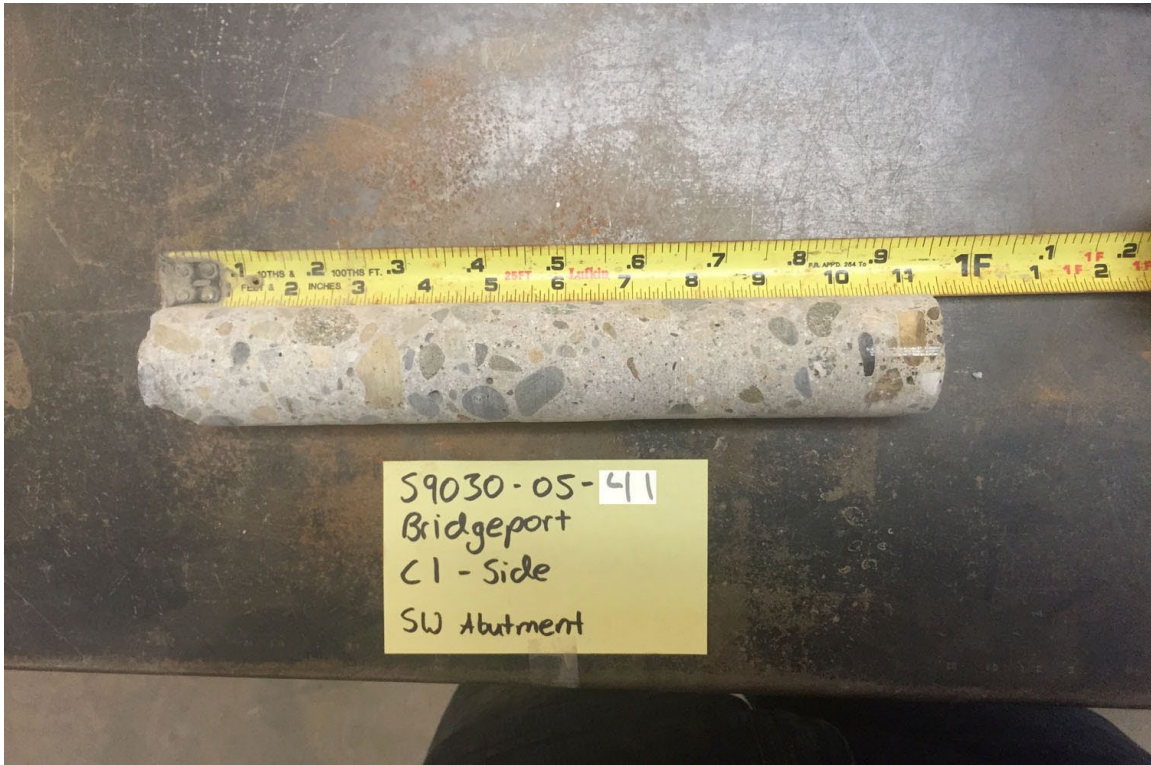
Photo C1 Core C1 – south abutment arch seat

- Visually examined and photographed the cores to evaluate (qualitatively) concrete condition. Performed laboratory compression tests on the concrete cores to determine compressive strength.
