Año Nuevo Island Light Station

*Documentation of the Light Station Complex
Año Nuevo Island,
Año Nuevo State Reserve, San Mateo County, California*

June 2005

Matt C. Bischoff
Historian II
California State Parks
Northern Service Center
Sacramento, CA

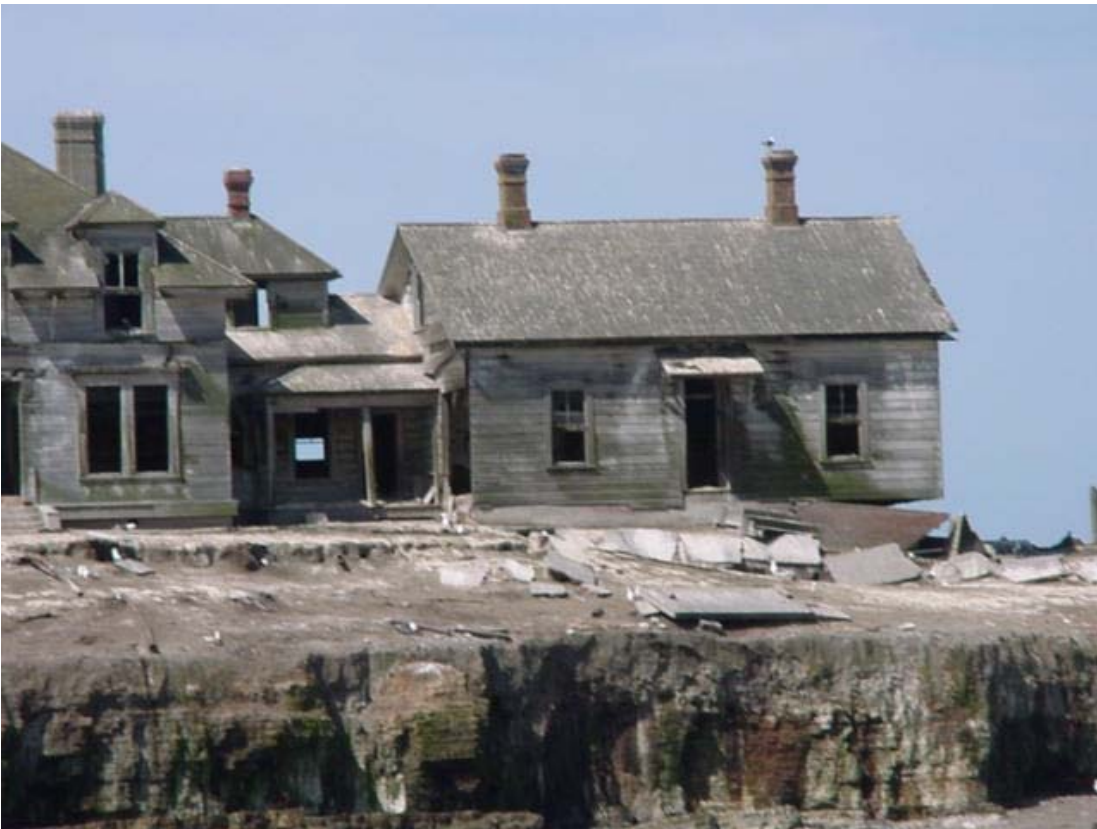
The foundation has been seriously undermined by erosion of the adjacent beach. The building is in danger of collapse as a result.

Figure 42. Keeper's dwelling, original portion on right, 1906 addition on left, 2005.

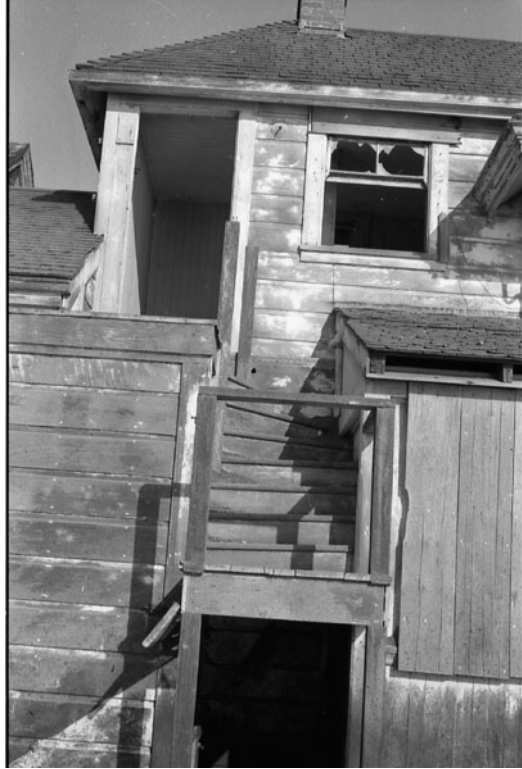
Figure 48. Rear of Keeper's dwelling (1906 addition), stairway to landing, west side, 1982. This stairway was added sometime later judging by previous figure. Catalog #24738, California State Parks, Archaeology Laboratory, West Sacramento.

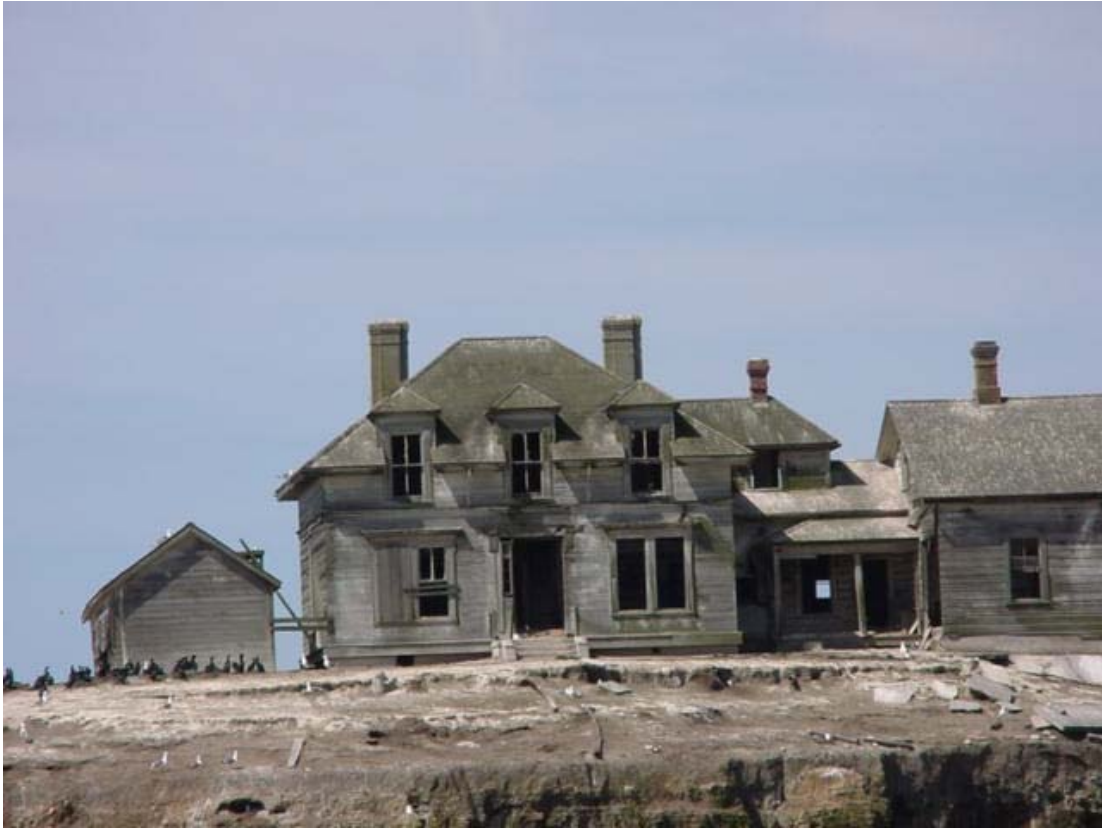
Figure 52. Keeper's dwelling, 1906 addition, 2005.

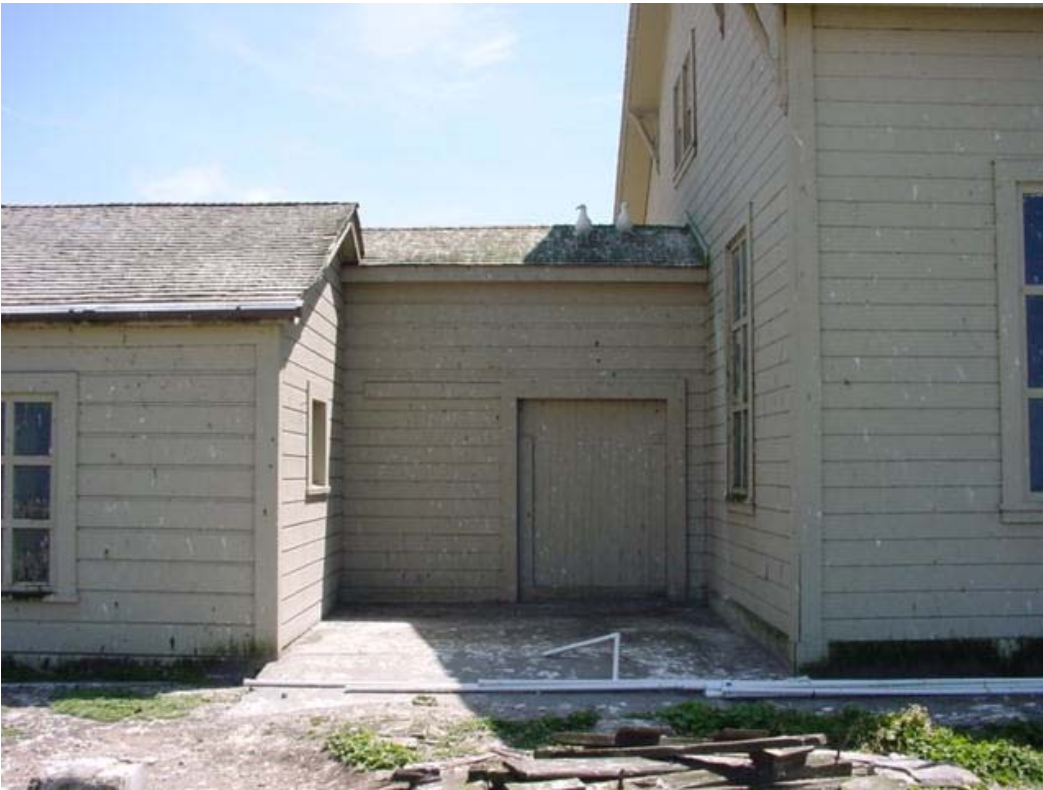
Figure 68. Fog signal building: gallery connecting 1881 portion at left and newer (1899) building at right, 2005.

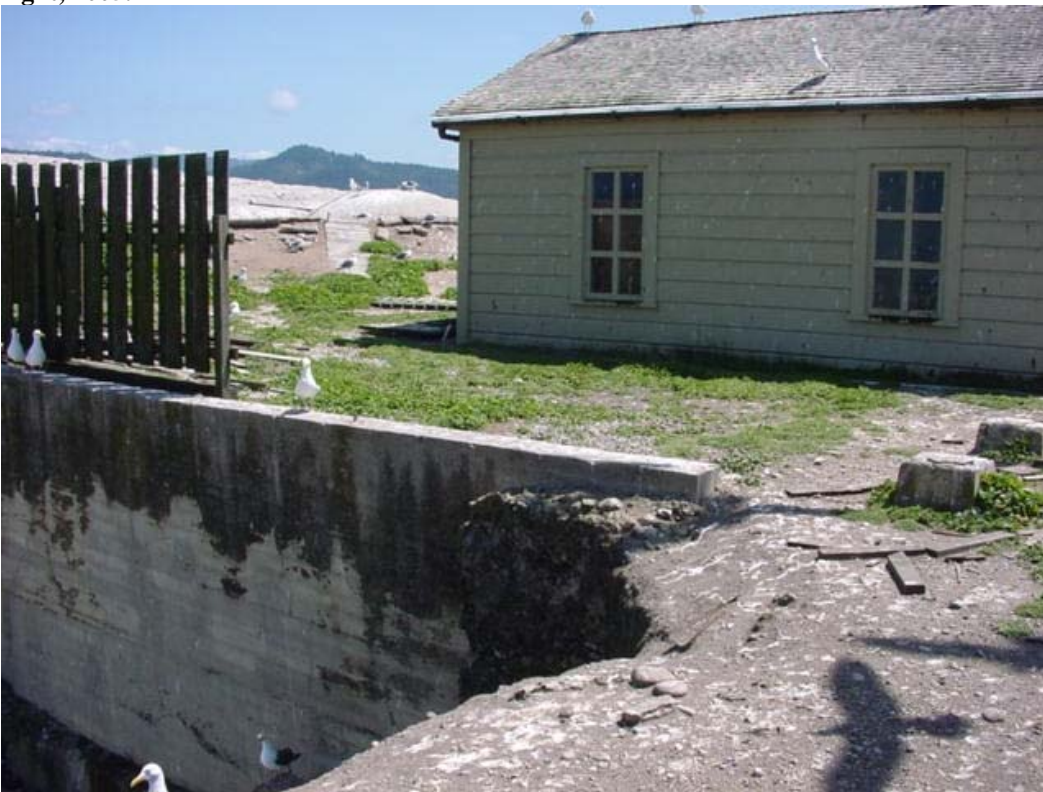
Figure 69. Retaining wall adjacent to 1881 section of fog signal building, looking west, 2005.

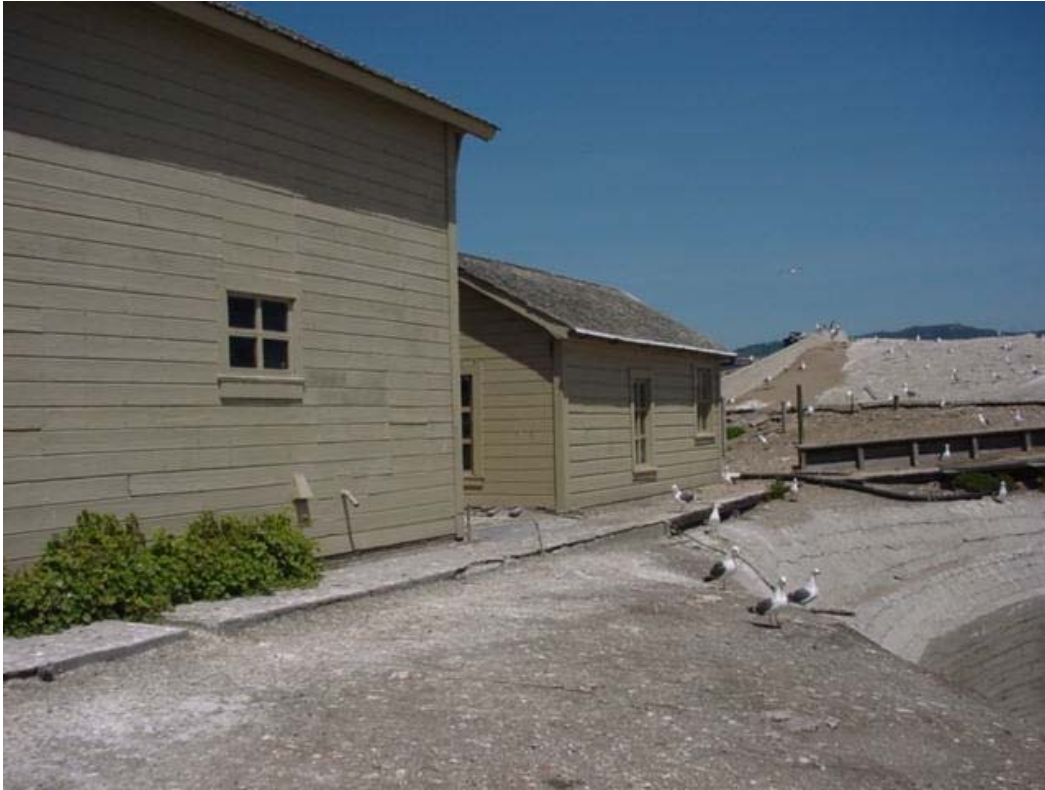
Figure 70. Fog signal building looking north, 2005. Note concrete retaining wall at right, and remains of wood walkway.

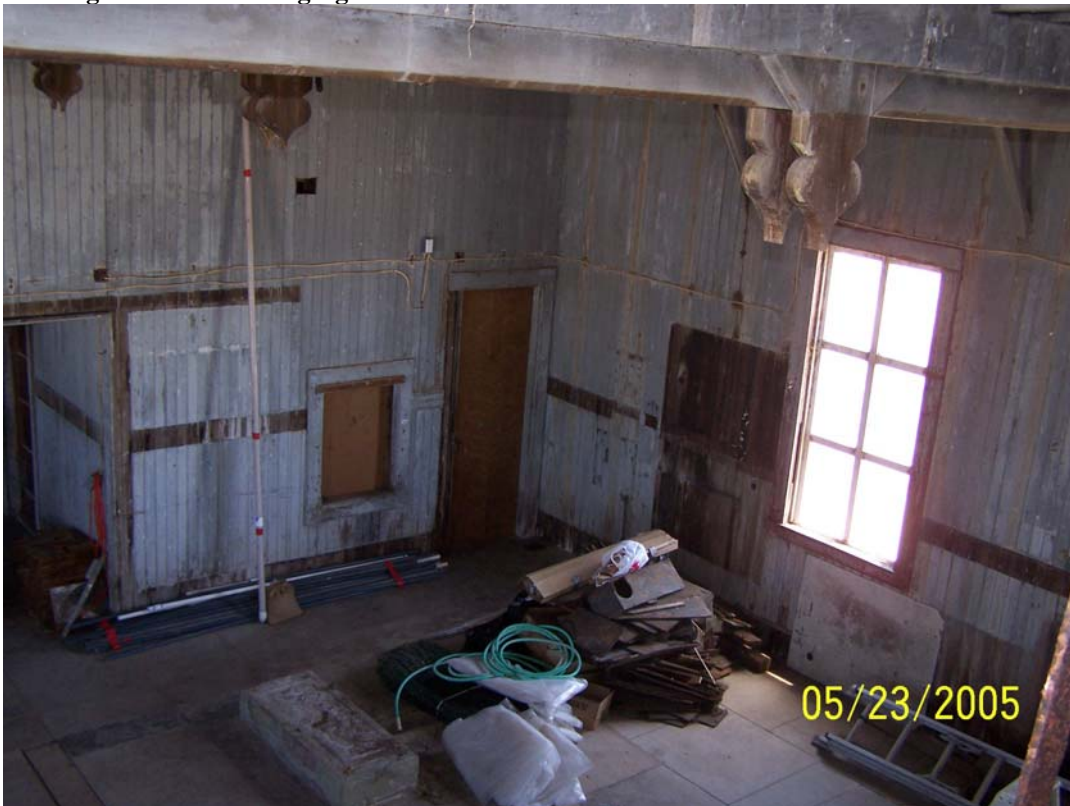
Figure 75. Interior of fog signal building, 1899 portion, showing door into Room 8, 2005. Note foundations for boilers and other equipment.

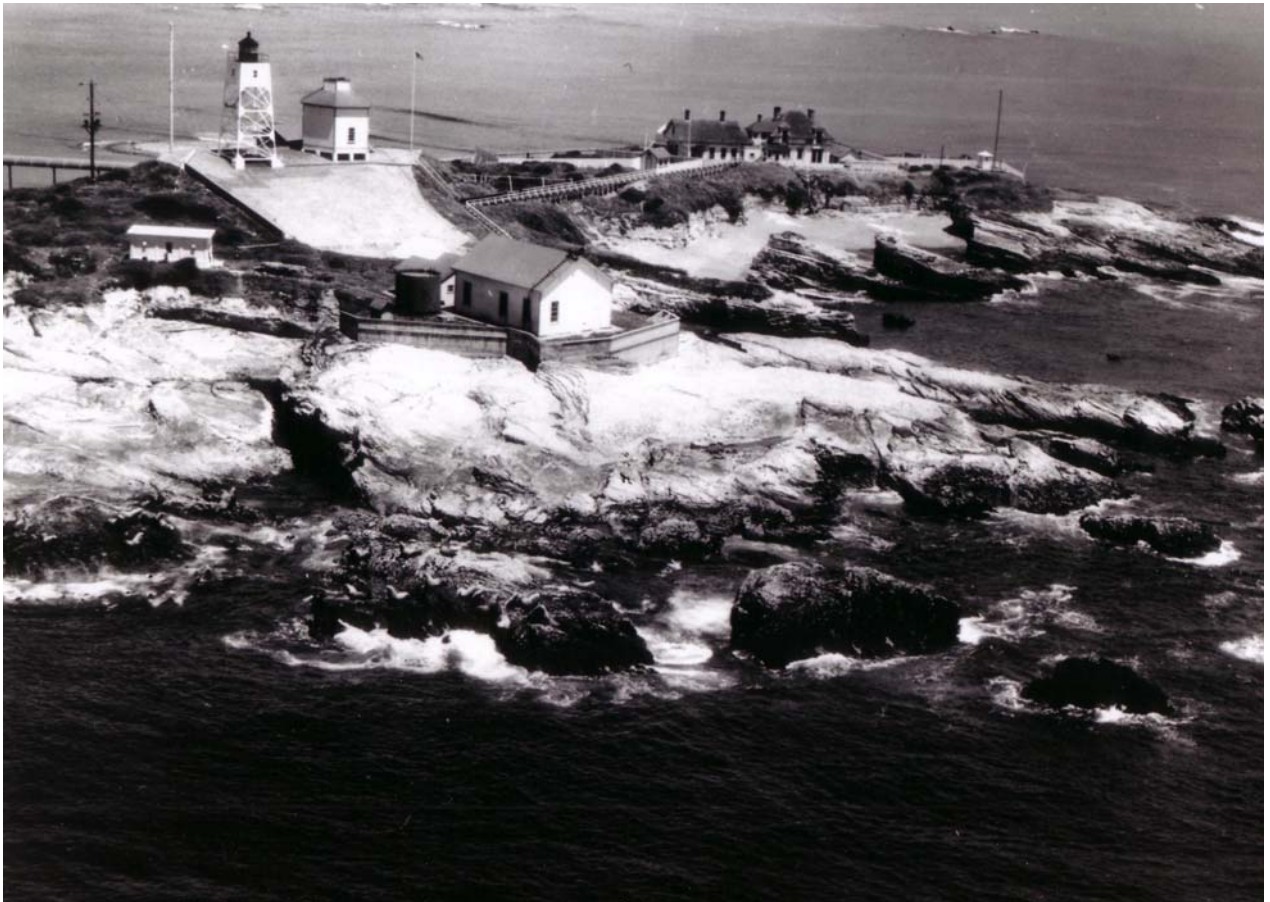
Figure 78. Overview of light station with light tower visible at left, 1953. U.S. Coast Guard photograph, U.S. Coast Guard Historian's Office, Washington, D.C. Note fog whistles are missing from gable end of fog signal building (replaced by automated system)

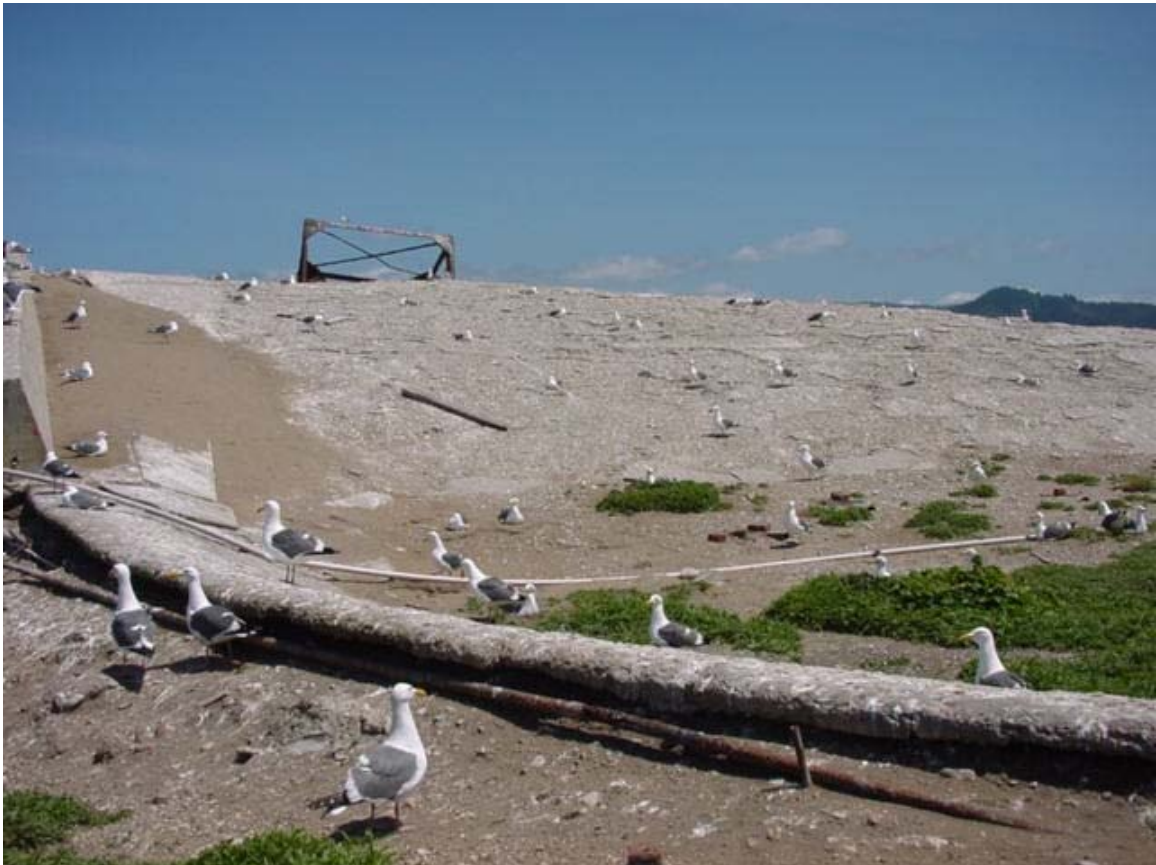
Figure 91. Water-shed looking northeast, 2005. Base of light tower is visible at top of photograph.

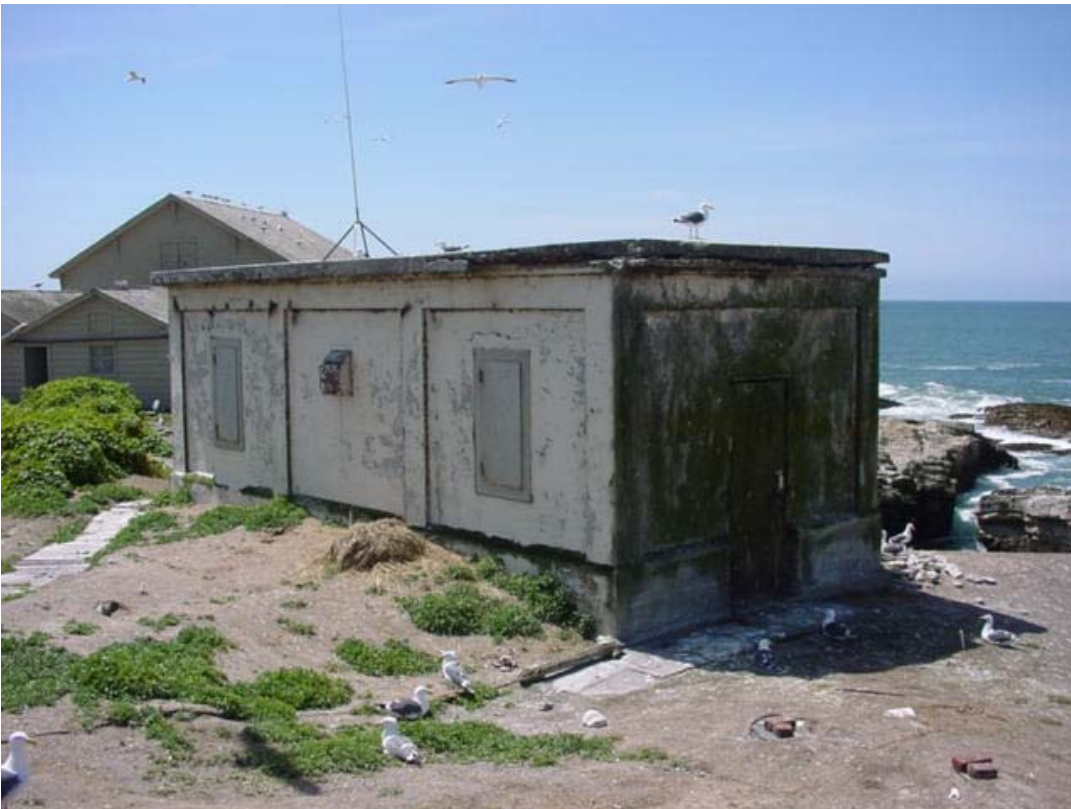
This concrete structure measured 13' x 27,' and was connected to the boat house by the tramway. It was apparently built in 1908. Though plans for the building could not be located, it appears to be similar to those constructed at other locations during this same period. At Point Conception, for example, the concrete and steel oil house measured 26' x 14,' was built upon concrete piers and a 5 1/2" thick concrete slab floor. A single steel door consisting of a 3/16" plate with two 2 1/2" riveted hinges provided access into the front of the structure. Four windows (two on each side) were also in place. The fuel storage building at Ano Nuevo building began to deteriorate soon after the Coast Guard abandoned the station, and concrete began spalling off of the reinforcing rods. Cement patches have been applied to many places on the building. Several types of doors and

window coverings have been installed on the building over the years of its operation. The building continues to deteriorate rapidly, particularly on the roof, where spalling is a major problem.

Figure 97. Fuel Storage/paint locker building, looking southwest, 2005.

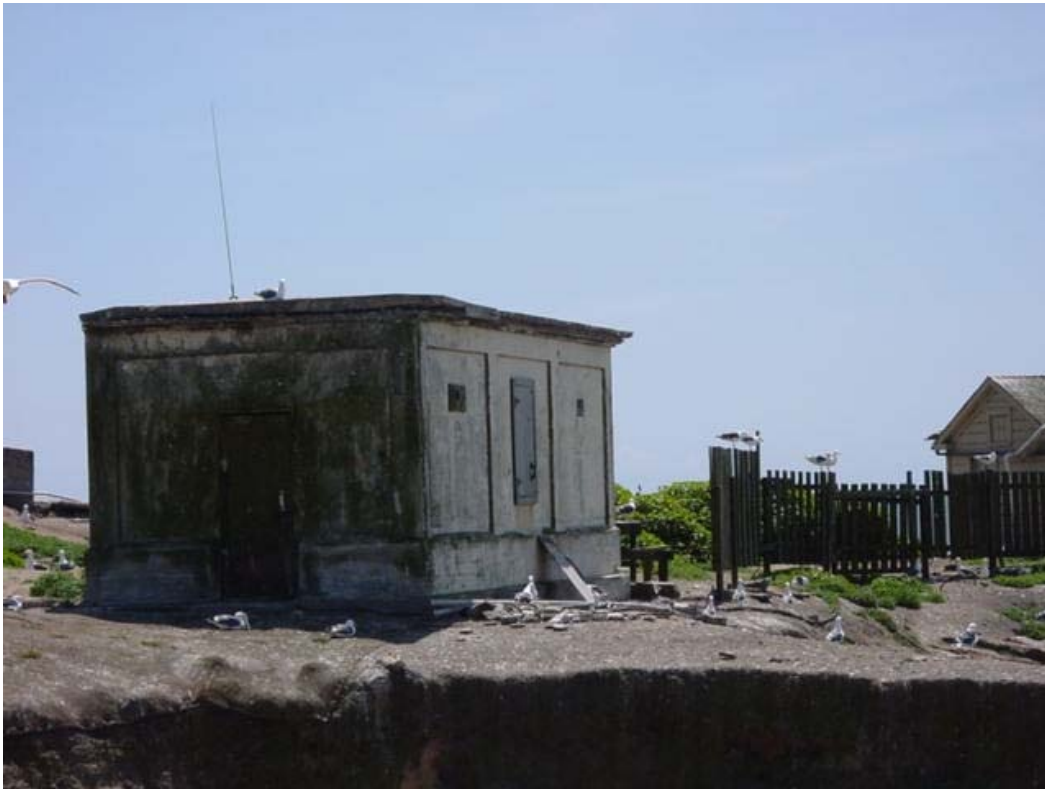
Figure 98. Fuel Storage/paint locker building, looking southeast, 2005.

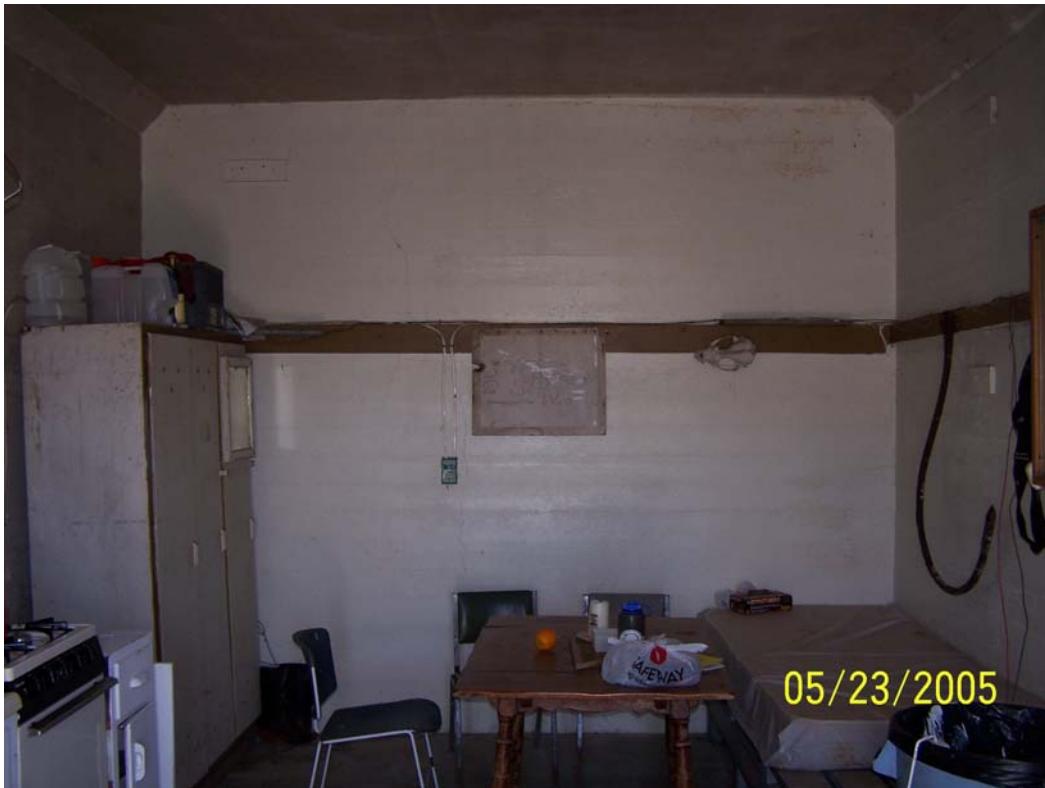
Figure 99. Interior of fuel storage/paint locker building, 2005.

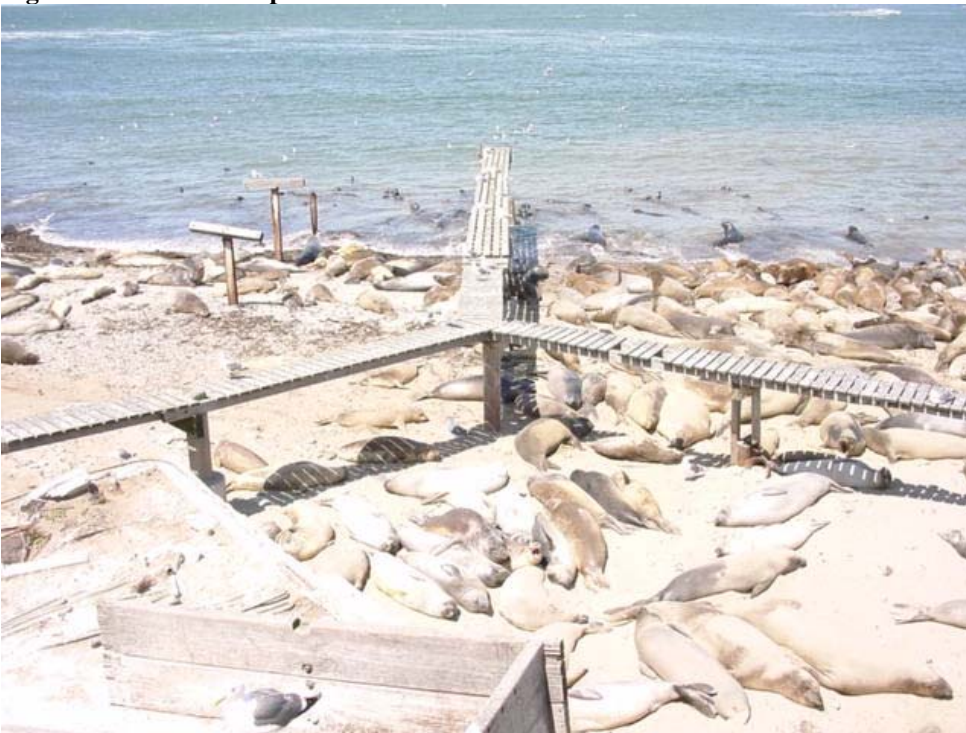
A pier or wharf was one of the first elements built on the island in 1872. Supplies were provided to the island from this pier and trips to and from the island were made from it. Because of difficult condition, the pier was frequently repaired. The existing pier appears to be relatively recent, though a section of the pier built in 1932 remains.

Figure 102. Pier/wharf, 2005. Remains of pier built in 1932 is visible at left.
