# National Register of Historic Places Registration Form

Historic name: Montecito Ranch House

Street & number: 1080 Montecito Way

City or town: Ramona State: California County: San Diego

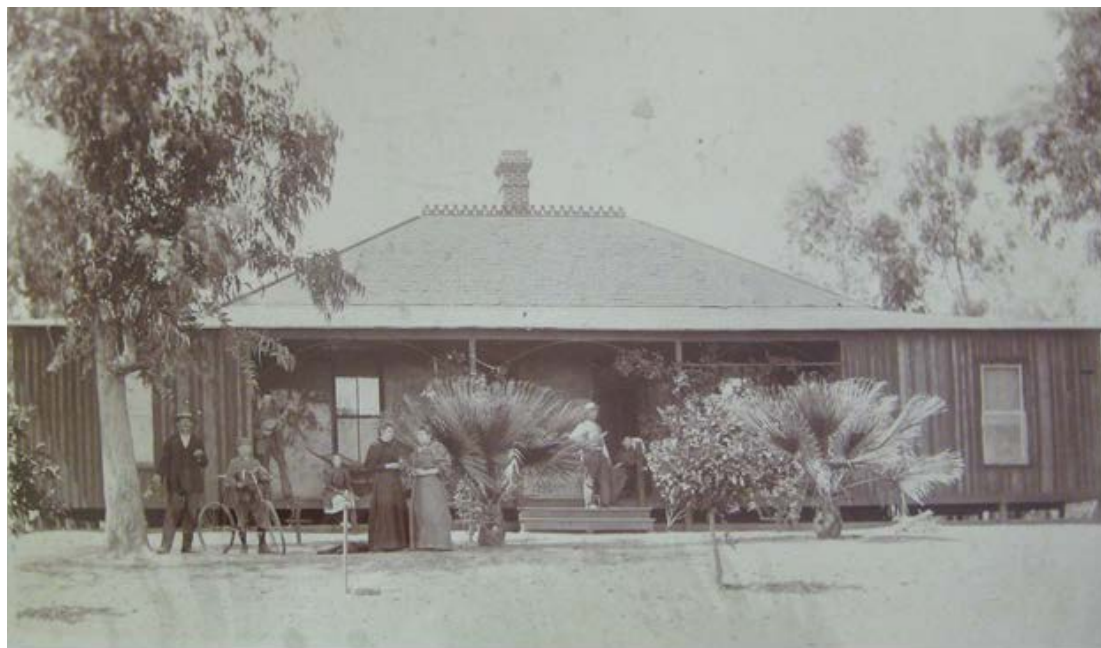
**Figure 1.** Montecito Ranch House south façade circa 1897. Porch had a wood framed floor and the top of the porch roof aligned with the bottom edge of the main roof's eaves. Also note the arched detail between the porch posts. Wood-framed additions were added at the southeast and southwest corners of the porch with vertical wood siding (camera facing north). *Photo courtesy of the Guy B. Woodward Museum, Ramona.*

caretaker's house (**Figure 1**). Its builder could have been Augustus Barnett, a Ramona forefather (Carrico, 2011) or Theophile Verlaque, architect builder of the first Ramona home (National Register-listed Verlaque House). The building is larger than most found on a ranch from that period and is built with thick adobe brick with tall windows and tall ceilings giving it a grand feel. A long driveway leads up to the ranch house with sparse landscaping and a few prominent old trees. The rural desert landscape is typical in the inland mountain-rimmed Santa Maria Valley 36 miles from San Diego and 20 miles southeast of Escondido. Large rock outcroppings can be seen on surrounding hills and even slopes just a few hundred yards from the home.

Various additions have been added on the porch starting early in the building's history. A circa 1897 photograph (**Figure 1**) shows what appear to be the first porch additions on the southeast and southwest corners of the porch; these additions no longer exist. Subsequent additions on the southwest and northwest corners provided bathrooms and a laundry room. The bathroom at the southwest corner of the porch appears to have been added sometime between the 1920s and the 1950s. This estimate is based on the pink and burgundy tile wainscot. The tile detail and tile style are consistent with prevalent architectural detailing from the 1920s to 1950s. The bathroom and laundry room addition on the northwest side porch appears to be more recent. The fixtures and finishes in the laundry room and bathroom do not reflect the historical character of the ranch.

the 1897 photo (**Figure 1**) while the kitchen chimney is not visible due to the angle of the photograph. Both brick chimneys appear to be in fair condition although some loose bricks and a large crack are visible on the main chimney.

**Prior to 1897:** Early porch enclosure at the southwest and southeast corners of the building. The wood framed rooms are visible in the historic photograph dated 1897 (**Figure 1**). The additions have wood-framed walls with tall 1/1 double-hung wood windows and vertical wood siding.

Earliest known photograph of the Montecito Ranch House is dated 1897 (**Figure 1**). The photo shows the south façade of the house. Wood-framed walls can be seen on the southwest and southeast corners of the porch.

- 1 of 21 View of the Montecito Ranch House site from the main gate entrance looking up the hill (camera facing north)
- 2 of 21 View of south façade and porch of ranch house which replicates similar view as Figure 1 (camera facing north)

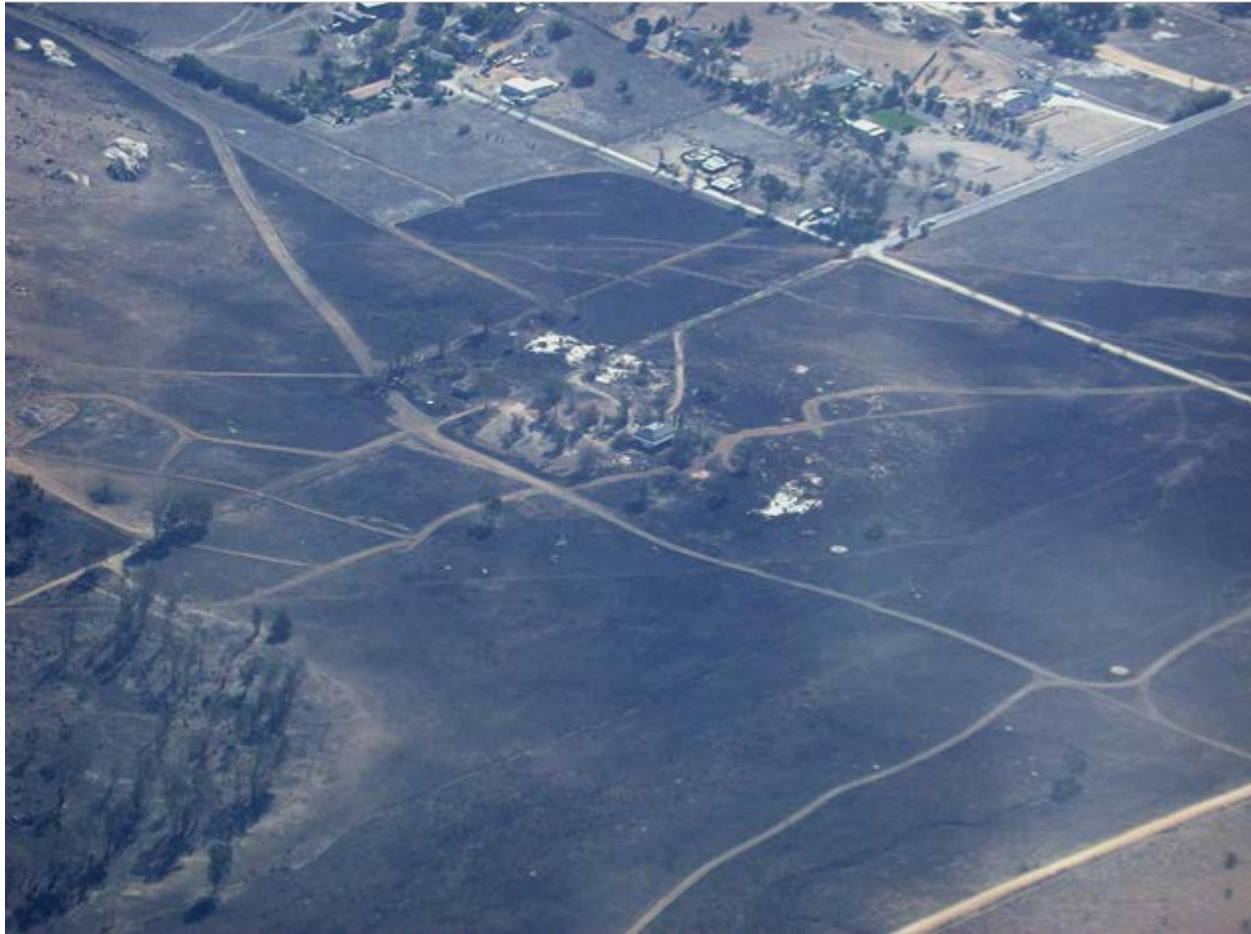
**Figure 3.** Aerial photo of Montecito Ranch after 2007 wildfire. The land and trees around the building were burned, and the ranch house and barn were saved through heroic efforts (camera facing southeast). *Photo courtesy of the Coons Collection.*
