National Register of Historic Places Registration Form

1.	Name of Property Historic name: Mountain House Historic District DRAFT					
	Other names/site number: Mountain House Ranch; Mountain House Meadow; Mountain Home; Mountain House Resort; Trinomial (No. CA-BUT-3148H); Primary No. (04-003148) Name of related multiple property listing: (Enter "N/A" if property is not part of a multiple property listing N/A					
	(Enter 14/A if property is not part of a muniple property fishing 14/A

2.	Location Street & number: 13465 Oroville-Quincy Highway City or town: Mountain House State: California County: Butte County					
	Not For Publication: Vicinity:

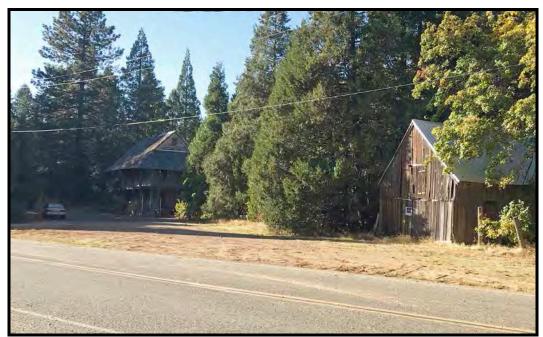
Photo 1. Exterior view, Mountain House Historic District, Overview, looking southwest (Photo by Corri Jimenez).

The Beckwourth Trail/Oroville-Quincy Highway (1851; 1855) passes by four contributing resources in the Mountain House Historic District (see **Figure 2, Photo 1**). The segment within the historic district is the original road alignment and is set on a curved north-south axis with an entrance and exit on the north side of the realigned California State Route 162, a modern asphalt two-lane road. The segment is about 25 feet wide, approximately 850 feet long, and passes by the hotel, grocery store/post office, and a barn—all contemporary to the early transportation history. The segment's roadbed material varies from predominantly being dirt to having patches of macadam, a ballast material, which is fixed in the dirt. Macadam as a historic paving material was best used during the turn of the 19th century. Sometime in the 1980s, the road was bypassed by the newer road. This segment of the Beckwourth Trail/Oroville-Quincy Highway is a contributing resource to the Mountain House Historic District.

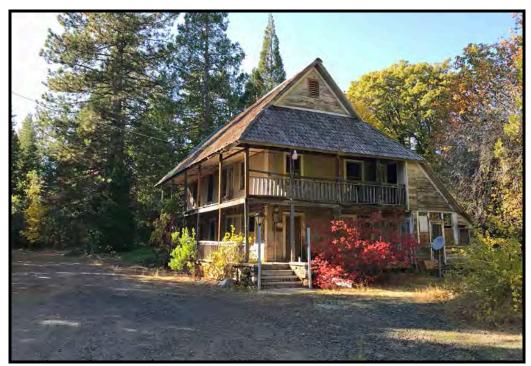
Photo 2. Exterior view, Mountain House Historic District, Hotel, looking northwest (Photo by Corri Jimenez).

that wraps around the east elevation. The east, west, and south elevations of the hotel's exterior walls are all clad with 3-inch wide clapboards (see **Photo 2** and **Photo 3**).

The hotel's roof slopes to the north and is steeply pitched as a catslide, a roof design best seen on New England saltbox buildings and atypical to California, especially rural Butte County. The hotel's unique roof design is visible on both its east and west ends, and has an office space on the east end and a commercial refrigerator space on the west. The hotel's roof has standing seam metal on the northern slope while historic wood shingles cover the southern slope.

On the south elevation, the hotel is divided into five bays and a two-story porch that extends out from the elevation approximately 4-foot wide. In the 1860s, the hotel had six bays, and by the 1890s, it was more than eight bays with grapevines growing on it; the hotel was shortened to its current five bays sometime between 1920-1940 by removing the east end (see **Figures 7-10, 12**). At this time, the porch was continued around the west side of the building under a pent roof. The porch is in fair condition and has been reconstructed or modified a few times over the years. Grapes, nevertheless, still grow on the trellis of the front porch. Two single-leaf wood doors are located on the south elevation, and a third door is located on the east elevation. Most of the windows on the south, west, and east elevations are 1/1 double-hung wood windows with a lamb's tongue detail. Two wood windows on the west elevation's second floor are wider, and it is believed were added sometime in the 1950s.

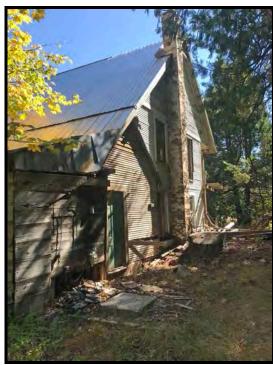
Photo 3. Exterior view, Mountain House Historic District, Hotel, looking southeast (left); **Photo 4.** Interior view, Mountain House Historic District, Hotel, looking west (right) (Photo by Corri Jimenez).

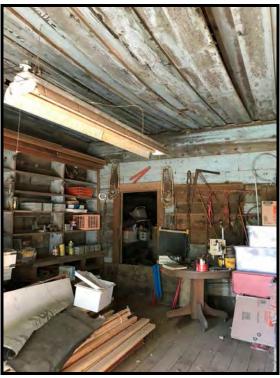
Photo 7. Interior view, Mountain House Historic District, Grocery Store/Post Office, looking northeast (Photo by Corri Jimenez).

The interior of the store/post office is divided into two large rooms laterally on a north-south axis. A root cellar, or cold storage space, is accessible from the rear and located under the front room's floorboards. The celling is lined with board-and-batten boards that are notched around the vertical board-and-batten walls. On the east and west walls, the south (front) room has 8-foot high shelves with drawers for selling goods. The shelves have an ornate top and constructed of 1-inch thick boards. The walls and ceiling in this front room are painted turquoise, or "Prussian Blue," which is contemporary to the 1860s (see **Photo 7**).³

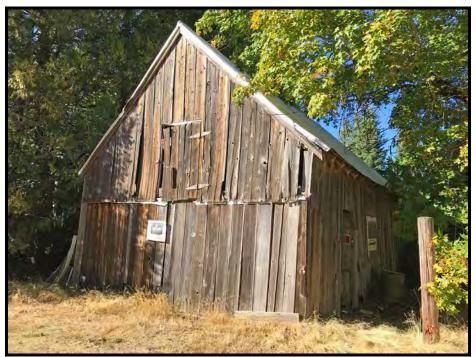
Photo 8. Exterior view, Mountain House Historic District, Barn, looking northeast (Photo by Corri Jimenez).

The barn (c.1865) is approximately 10 feet east of the store/post office and set on a north-south axis on the historic segment of the Beckwourth Trail/Oroville-Quincy Highway (see **Figure 2**, **Photo 8**). The barn is 20 feet wide and 30 feet long. The building is constructed of hand-hewn bents that are joined by mortise-and-tenon construction and tied by hewn beams. Metal modern brackets are attached to the joints of the bents as additional support. The ends of the bents are set on fieldstones. The barn is covered with vertical wood boards and a hinged double door on the front. The barn's roof is gabled with peeled logs as rafters that are visible along the eave. The roof is covered with corrugated sheet metal and wood skip-sheathing and shingles are visible.

The barn's interior has an office located in the northeast corner and ceiling boards separate a loft space. On the south wall, sliding-glass aluminum windows were added in the 1950s, which is the only alteration to the barn. The barn is contributing resource to the Mountain House Historic District.

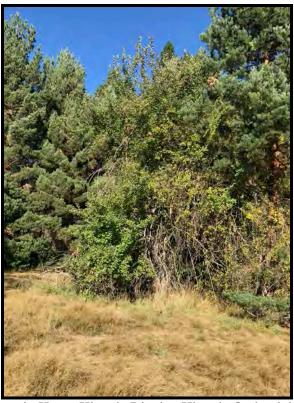
Photo 9. Exterior view, Mountain House Historic District, Historic Orchard, looking north (Photo by Corri Jimenez).

In 1893, the orchard was expanded and historic newspaper articles specifically define 50 varieties of apple trees, which included Sweet Bough, Early Harvest, Gravenstein, Northern Spy, and Ben Davis trees. During the writing of the nomination, many apple trees were fruit bearing, and were 15 to 30 foot height with a healthy diameter around 6-12 inches (see **Photo 9**). The

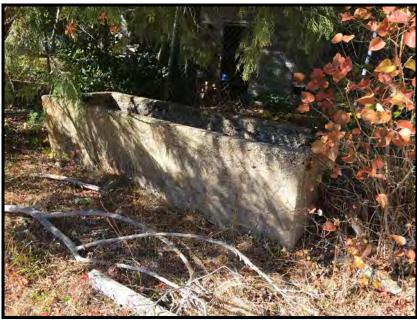
Photo 10. Exterior view, Mountain House Historic District, Water Trough, looking north (Photo by Corri Jimenez).

The water trough for horses (c.1944) is constructed of board-formed, cast concrete that has a pebble aggregate (see **Figure 2**, **Photo 10**). The structure is approximately 5 feet long, 2 feet wide, and about 3 feet high and is east of the hotel approximately 30 feet. The water trough is a contributing resource to the Mountain House Historic District.

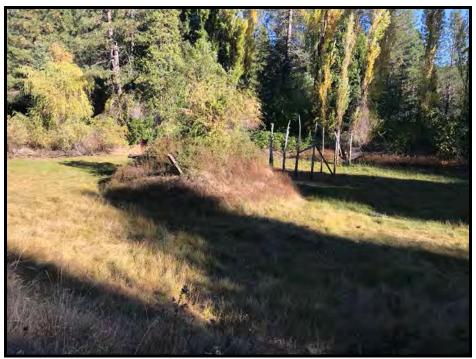
Photo 12. Exterior view, Mountain House Historic District, Fish Pond and dock, looking southeast (Photo by Corri Jimenez).

On the south side of California State Route 162, there are three fish ponds (c.1944) adjacent to the historic orchard (see **Figure 2**). The larger fish ponds range in size from 20 to 30 feet in diameter and are about 5-10 feet deep. A fingerling pond is smaller in diameter and has a stone-lined brim. The largest pond has a wooden boat dock on the east side that is in poor condition (see **Photo 12**). All the ponds were dry during the time of writing the nomination. The fish ponds are contributing resources to the Mountain House Historic District.
