National Register of Historic Places Registration Form

Historic name: Scarlett Ranch

Other names/site number: Scarlett-McGrath Ranch

Street & number: 5011 West Gonzalez Road

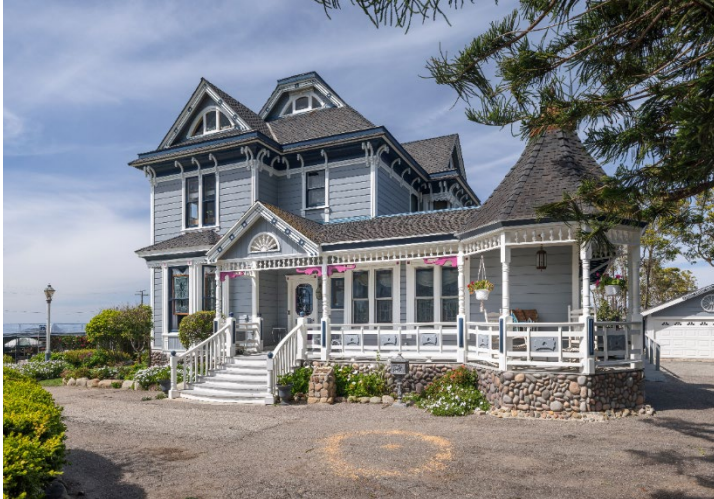
Map Reference No.	Brief Physical Description	Resource Count	Representative Photograph
Contributing Resources			
1	<p>Queen Anne Style Farmhouse (Map Reference No. 1)</p> <p>This building is described in detail in the <i>Narrative Description-Contributing Resources</i> section of the nomination form. It was constructed during the period of significance and retains sufficient integrity to convey significance.</p>	1 Contributing Building

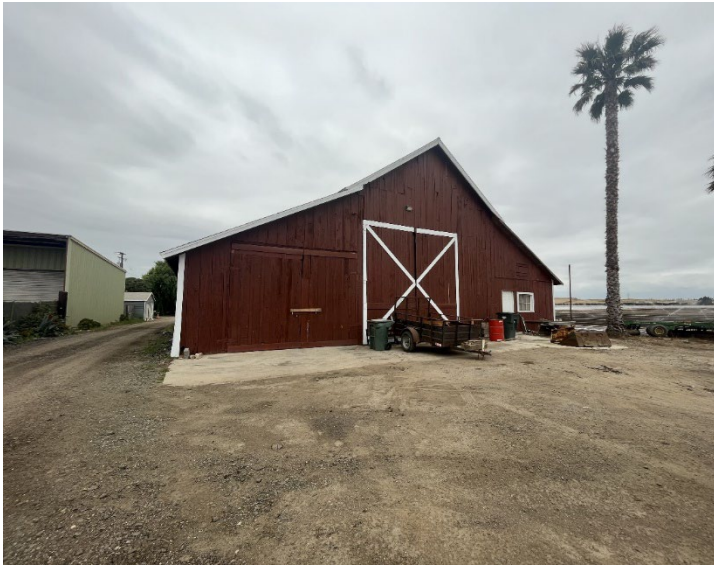
<p>North Elevation</p>

<p>South Elevation</p>
2	<p>Barn (Map Reference No. 2)</p> <p>This building is described in detail in the <i>Narrative Description-Contributing Resources</i> section of the nomination form. It was constructed during the period of significance and retains sufficient integrity to convey significance.</p>	1 Contributing Building

Sited approximately 260 feet east of the farmhouse is a one and a half story barn that was constructed between 1929 and 1934 (UCSB var.) (see photograph CA_Ventura County_Scarlett Ranch_0014; see additional photographs included in the Resource Count Table under Map Reference Number 2). The utilitarian structure features a rectangular footprint and sits on a concrete foundation. It is clad in (recently) painted red vertical board and batten siding and is topped with a gabled roof clad in composition shingles. Boarded over windows and doors line its east elevation, while the west elevation features just one door opening. Both gable (north and south) end elevations feature large barn door openings in addition to other window and door openings.

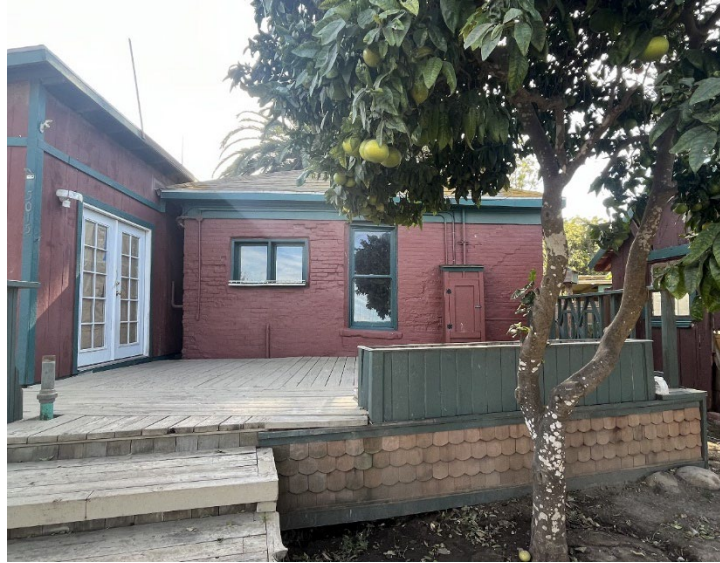
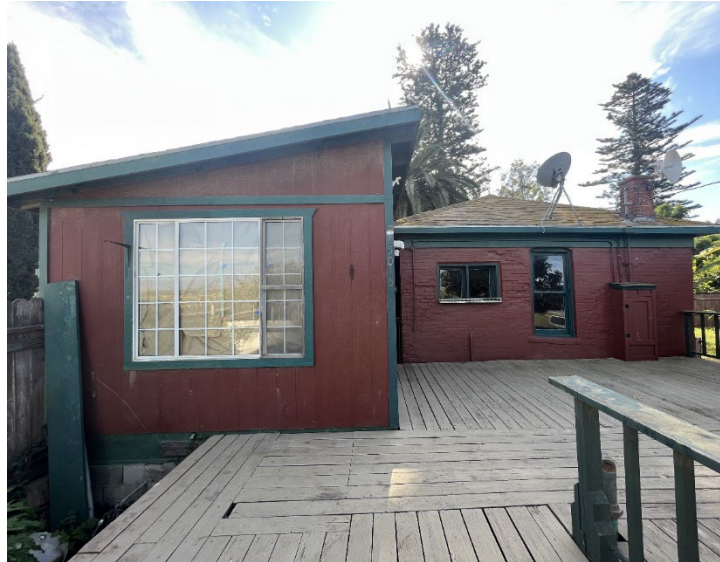
This building is described in detail in the *Narrative Description-Contributing Resources* section of the nomination form. It was constructed during the period of significance and retains sufficient integrity to convey significance.

North Elevation

North Elevation with Addition More Visible

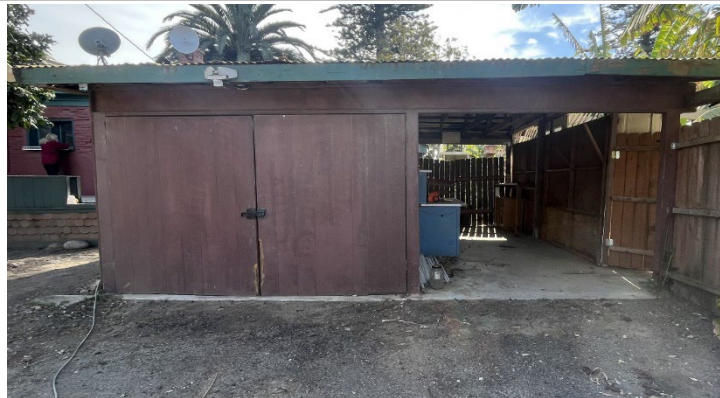
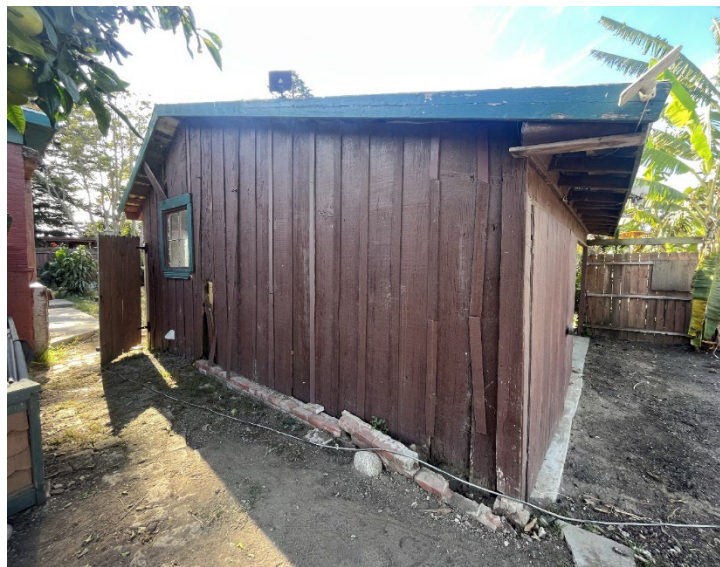
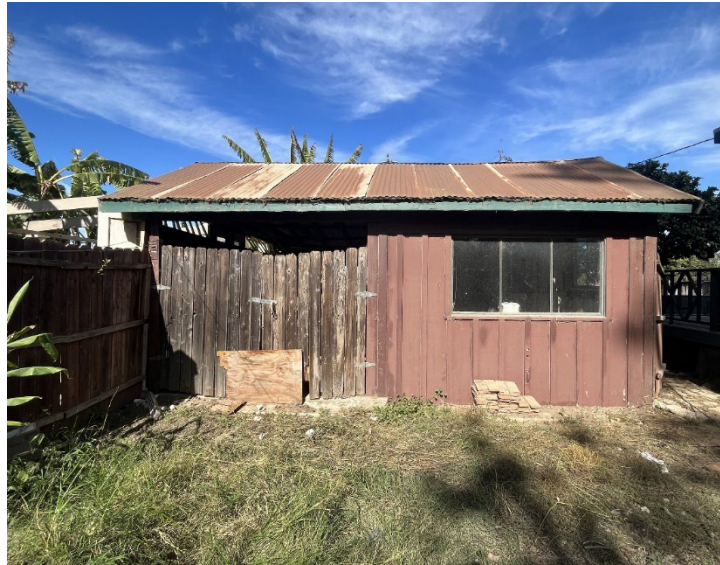
North Elevation

4	<p>Former Tractor Shed (Map Reference No. 4)</p> <p>This building is described in detail in the <i>Narrative Description-Contributing Resources</i> section of the nomination form. It was constructed during the period of significance and retains sufficient integrity to convey significance.</p>	1 Contributing Building
---	--	-------------------------

Sited approximately 120 feet northeast of the farmhouse, just west of the above-described tank house, is a single-story, rectangular planned building that appears to have functioned historically as a tractor shed, currently in use as a garage (see photographs CA_Ventura County_Scarlett Ranch_0013 [at right]; see additional photographs included in the Resource Count Table under Map Reference Number 4). Due to its size and location, and the quality of available aerial photographs, the building has not been definitively dated, although its form, detailing, and materials suggest it was constructed around the turn of the century. The utilitarian structure is topped with a side gabled roof clad in corrugated metal panels. Its south and east elevations feature original vertical wood board and batten siding, while siding on the west elevation is not original. The north elevation is entirely occupied by two large door openings; while openings appear original, one door has been removed entirely and the other has been reconstructed in recent decades. What appears to be an original, four lite fixed window sash is present on the east elevation; there is an additional window on the south elevation that appears non-original.

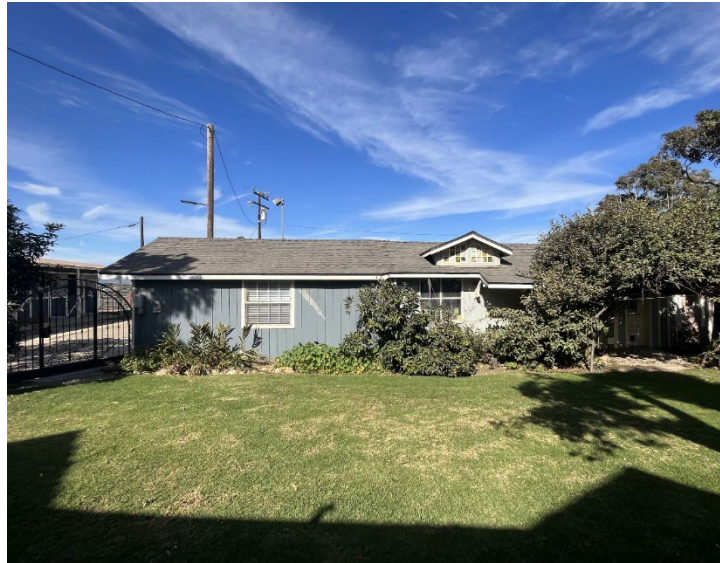
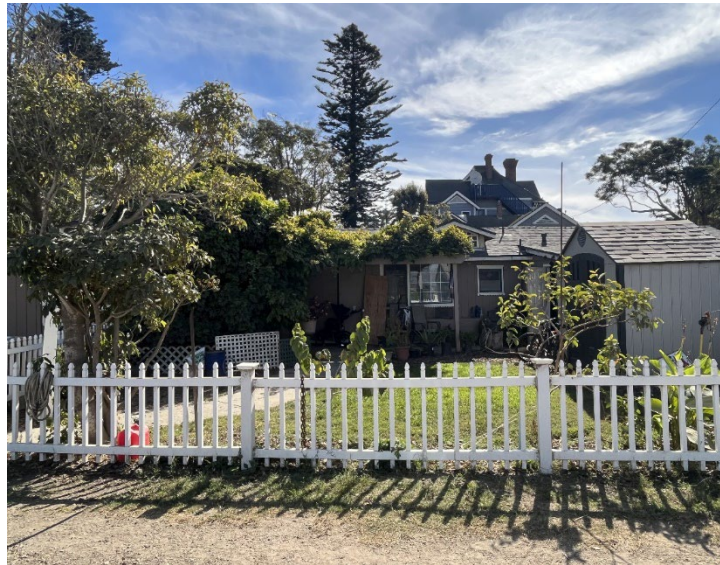
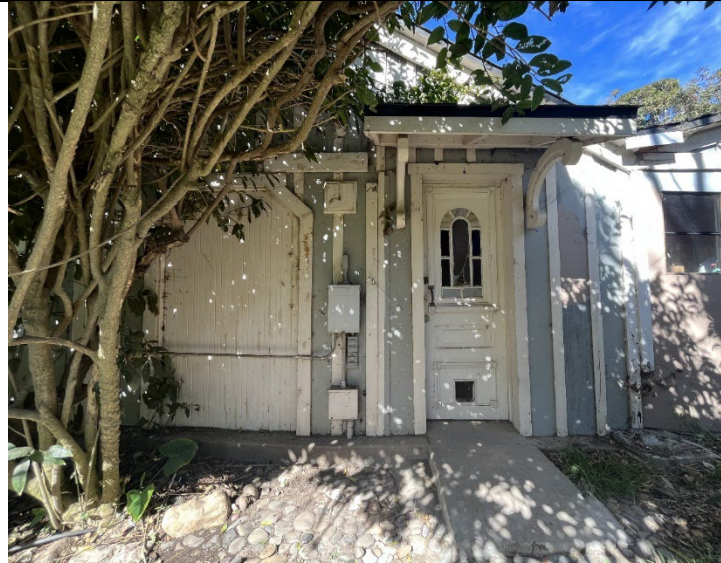
5	Former Residence (Map Reference No. 5)	1 Noncontributing Building
---	---	----------------------------

This building is described in detail in the *Narrative Description-Noncontributing Resources, Historic Period* section of the nomination form. Portions of the buildings were constructed during the period of significance. However, it does not retain sufficient integrity to convey significance.

Close up of Entry on South Elevation (note turn of the century detailing)

Located approximately 40 feet north of the previously described farmhouse is an irregularly planned, single story building most recently used as a residence that is currently not in use (see photograph CA_Ventura County_Scarlett Ranch_0016 [at top center]; see additional photographs included in the Resource Count Table under Map Reference Number 5). A small portion of the building appears to date to the turn of the century. As such it was constructed during the period of significance. However, it was originally an outbuilding (garage and woodshed; based on a review of historic period photographs) and was later modified to serve as a residence. While the building's original date of construction is expressed in minor details such as a bracketed overhang over a south elevation entry, it has been highly modified with several additions and the replacement of much of its historic fabric in recent decades such that it does not possess sufficient integrity to convey its significance. While the Former Residence may possess a significant association with the pioneering settlement and early agricultural development of the western Oxnard Plain, it does not possess sufficient integrity to convey that association. It therefore does not contribute to the property's significance.

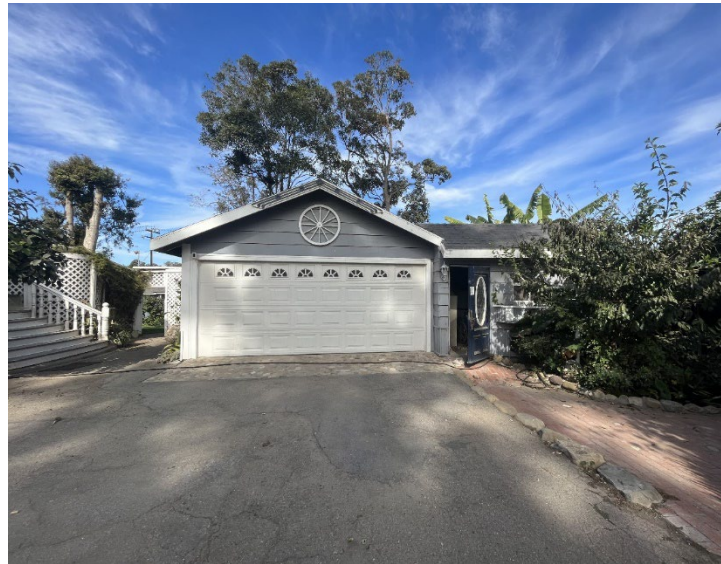
South Elevation

This building is described in detail in the *Narrative Description-Noncontributing Resources, Post Historic Period* section of the nomination form. It was constructed outside the period of significance and possesses no historical associations. It does not contribute to the property's significance.

Located approximately 20 feet east of the northeast (rear) corner of the previously described farmhouse is a single-story, roughly L-planned garage (See photograph included in the Resource Count Table under Map Reference Number 6). Due to its size and location, and the quality of available aerial photographs, the building has not been definitively dated, although its form, detailing, and materials suggest it is contemporary and was constructed in the latter half of the 20th century. The building integrates minimal ranch style elements and features applied Victorian detailing but does not embody any particular architectural style. It is topped with an intersecting gabled roof clad in composition shingles; walls are clad in various forms of wood siding. The building was constructed outside the period of significance and does not possess any significant historical associations. It therefore does not contribute to the property's significance.

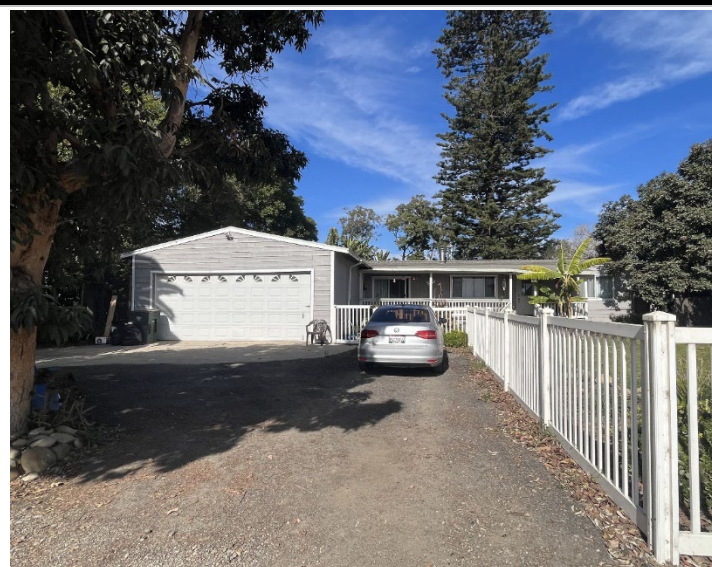
South Elevation

7 **Contemporary Residence (Map Reference No. 7)**
 This building is described in detail in the *Narrative Description-Noncontributing Resources, Post Historic Period* section of the nomination form. It was constructed outside the period of significance and possesses no historical associations. It does not contribute to the property's significance.

Located approximately 80 feet southeast of the farmhouse is a single-story L-planned residence with attached garage that was constructed, based on a review of aerial photographs, following 1967 (See photograph included in the Resource Count Table under Map Reference Number 7). The residence does not embody any particular architectural style; its form suggests that it is a double wide mobile home, to which a garage has been added. Siding throughout is variously wood board and paneling; windows and doors are variously vinyl and metal. The building was

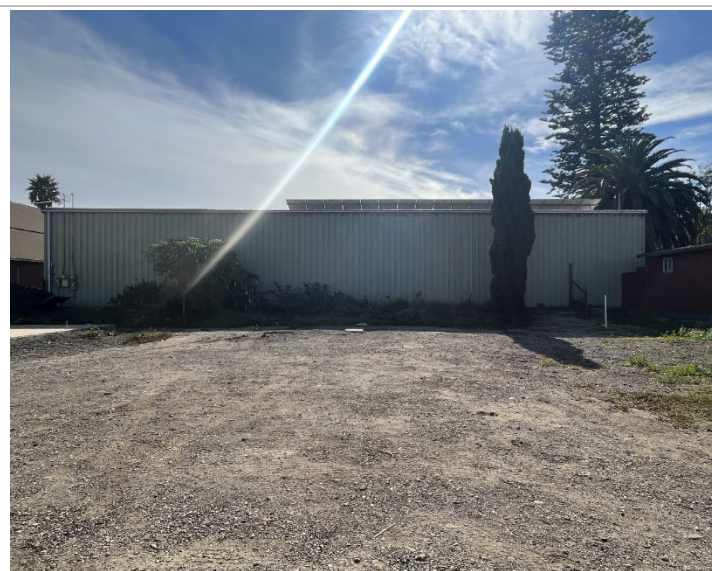
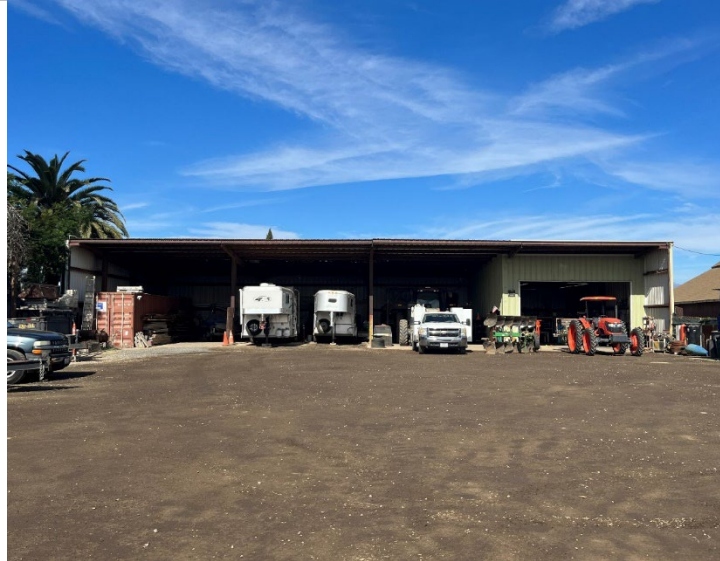
North Elevation

8 **Contemporary Equipment Storage Building (Map Reference No. 8)**
 This building is described in detail in the *Narrative Description-Noncontributing Resources, Post Historic Period* section of the nomination form. It was constructed outside the period of significance and possesses no historical associations. It does not contribute to the property's significance.

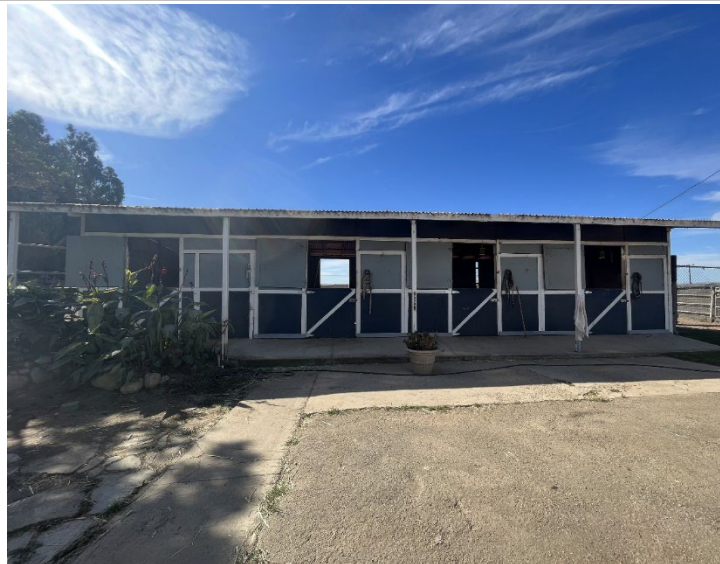
East Elevation

This building is described in detail in the *Narrative Description-Noncontributing Resources, Post Historic Period* section of the nomination form. It was constructed outside the period of significance and possesses no historical associations. It does not contribute to the property's significance.

Located approximately 40 feet northwest of the farmhouse, is a single-story building containing four horse stables that appear based on design and materials to have been added to the property in the latter half of the 20th century (See photograph included in the Resource Count Table under Map Reference Number 9). The rectangular planned building is of utilitarian construction featuring a concrete slab foundation and plywood sheathed walls. It is topped with a shed roof clad in corrugated metal panels. A narrow overhang supported with wood posts extends over the building's primary (east) elevation, which is lined with four stable doors. The building was constructed outside the period of significance and does not possess any significant historical associations. It therefore does not contribute to the property's significance.

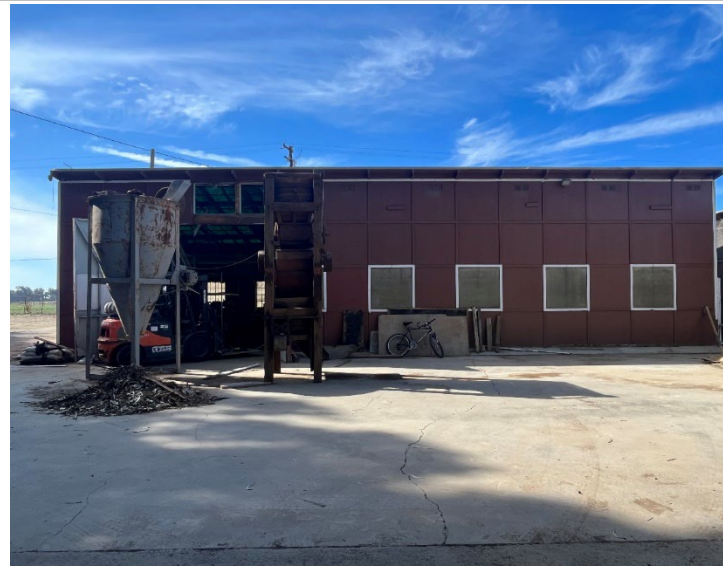
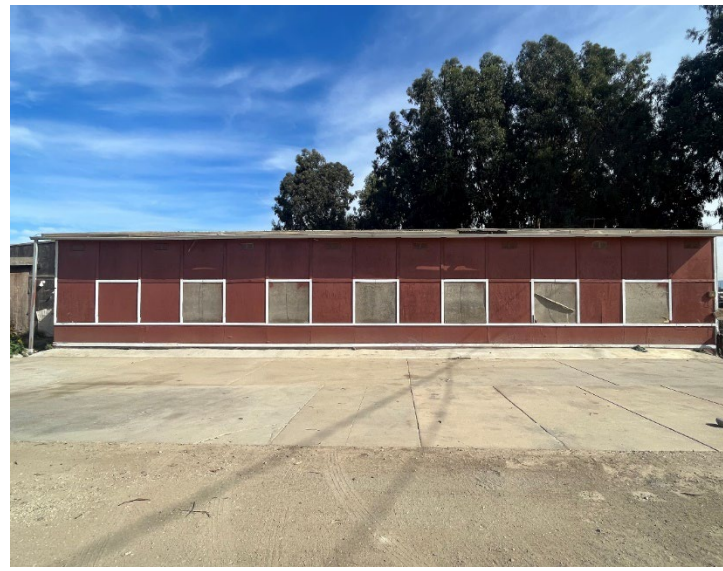
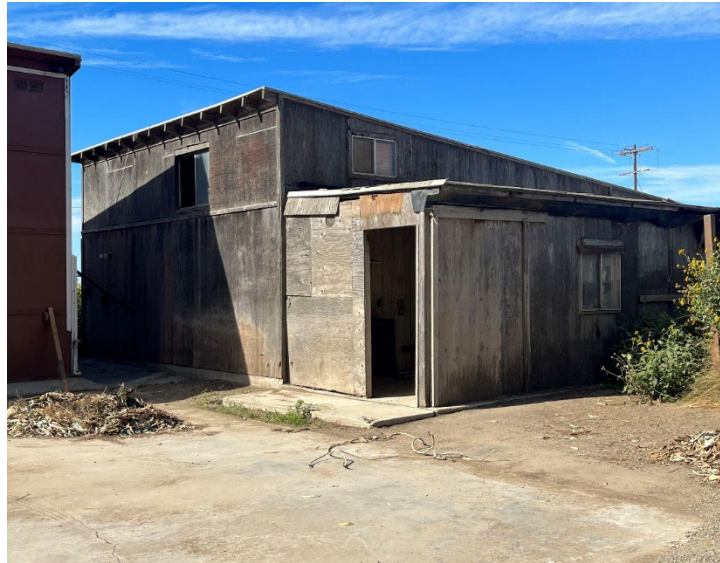
Two Utilitarian Storage Buildings (Map Reference No. 10 and 11)

These buildings are described in detail in the *Narrative Description-Noncontributing Resources, Post Historic Period* section of the nomination form. They were constructed outside the period of significance and possess no historical associations. They do not contribute to the property's significance.

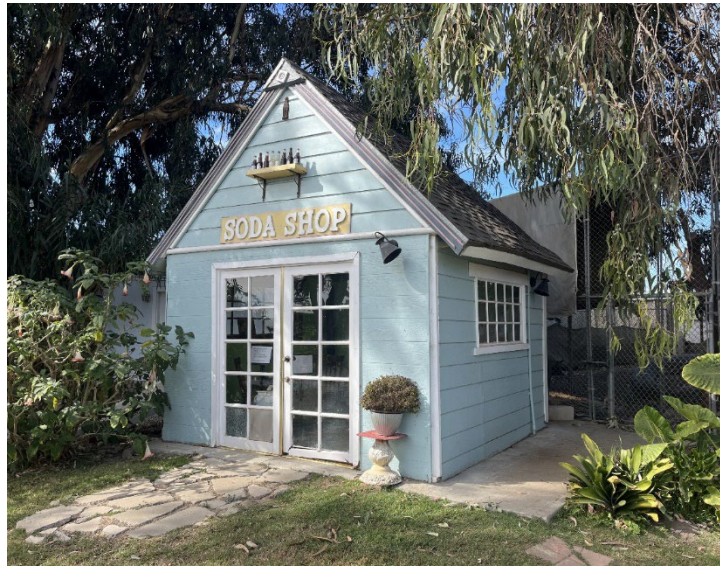
North and East Elevations

This building is described in detail in the *Narrative Description- Noncontributing Resources, Post Historic Period* section of the nomination form. It was constructed outside the period of significance and possesses no historical associations. It does not contribute to the property's significance.

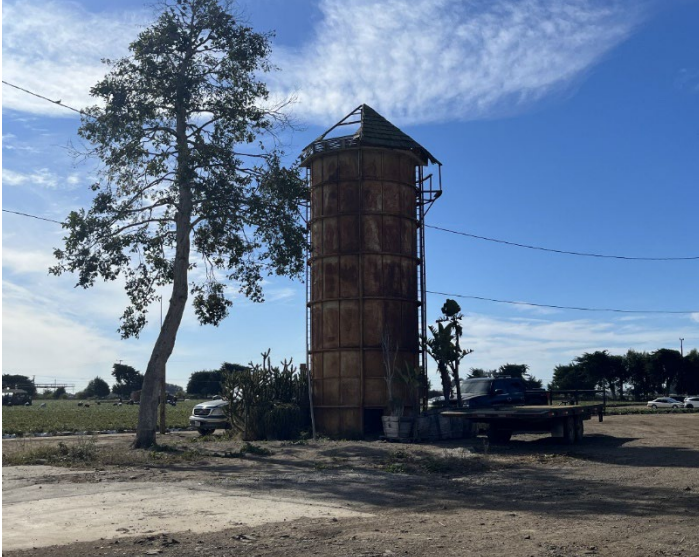
Map Reference No.	Brief Physical Description	Resource Count	Representative Photograph
13	<p>Water Tower (Map Reference No. 13)</p> <p>This structure is described in detail in the <i>Narrative Description-Noncontributing Resources, Post Historic Period</i> section of the nomination form. It was constructed outside the period of significance and possesses no historical associations. It does not contribute to the property's significance.</p>	1 Noncontributing Structure

Located approximately 95 feet southwest of the barn previously described is a water tower structure that, according to a review of aerial imagery, was added to the property following 1947(See photograph included in the Resource Count Table under Map Reference Number 13). The round, approximately 20-foot-tall structure is constructed of metal and features two ladders along its length. It is topped with a wood framed and shingles pyramidal roof which is partially deteriorated. It was constructed outside the period of significance and does not possess any significant historical associations. Therefore, it does not contribute to the property's significance.

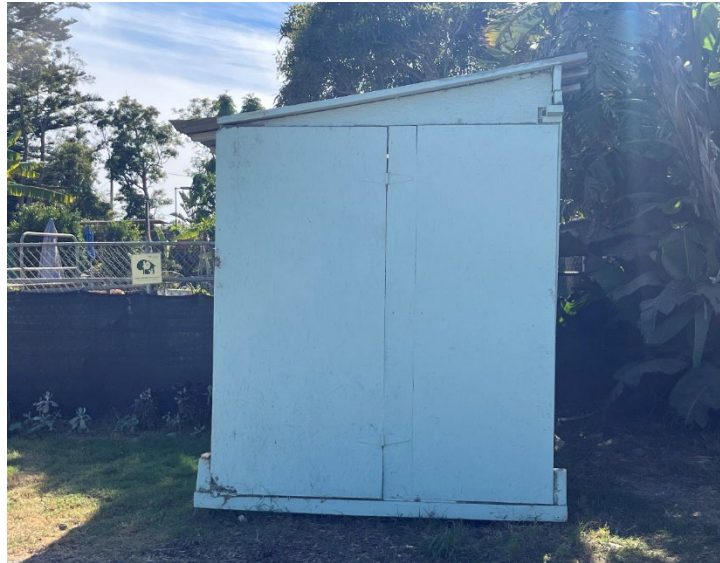
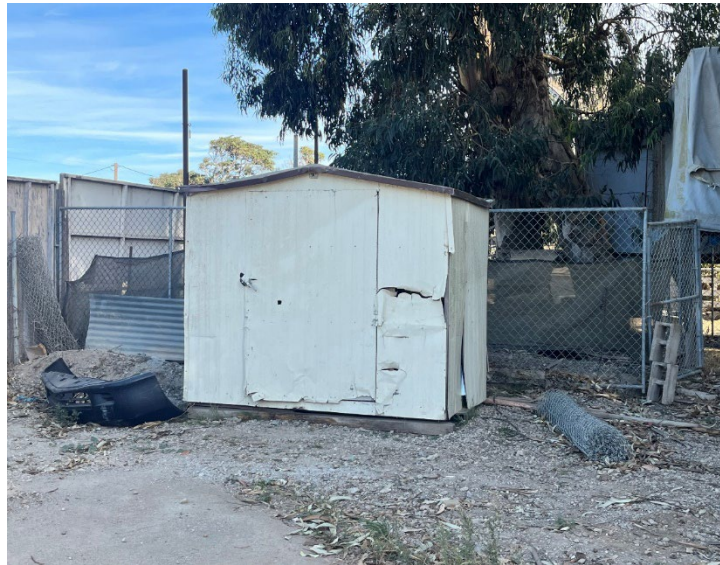
Contemporary Nondescript Structures

These structures are described in detail in the *Narrative Description-Noncontributing Resources, Post Historic Period* section of the nomination form. They are scattered throughout the property and were constructed outside the period of significance and possess no historical associations. Therefore, they do not contribute to the property's significance. Examples of these structures are included in this table, at right.

In addition to those noted above, the subject property features a number of structures scattered throughout (See photographs included in the Resource Count Table under Map Reference Number N/A). These structures are architecturally nondescript and utilitarian in nature; they date from the post historic period. Representative photographs of such structures are included in the Resource Count Table included in Section 11 (Section 11 page 20) of this nomination. These structures were constructed outside the period of significance and do not possess any significant historical associations. Therefore, they do not contribute to the property's significance, and they are not included in the Resources count, as presented in Section 5 of this nomination. They are not individually identified in the Sketch Map included in Section 11 (Section 11 page 3) of this nomination.
