# National Register of Historic Places Registration Form

historic name Bald Eagle Ranch House

street & number 511 Crawford Road

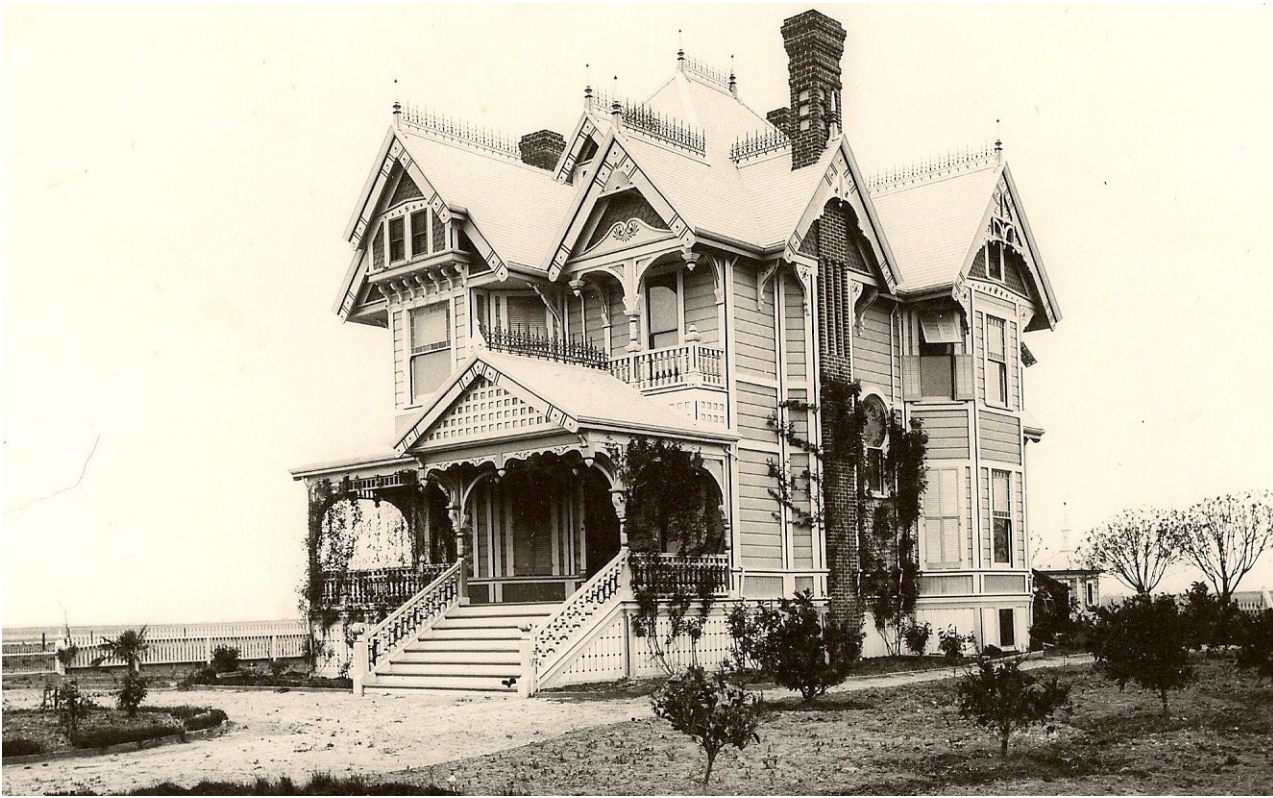
**Figure 1:** Historical photograph of the Bald Eagle Ranch House taken sometime after construction in 1893.

A feeling of age is expressed in the landscape and setting of the Bald Eagle Ranch House. This can be seen by again comparing Figure 1 and Photograph 001. In its original setting, photographs show that the house sits in a tree-less, flat area of the ranch; vegetation is sparse. But current photographs show tall, old trees and mature shrubbery, expressing an atmosphere of age and solidity. Together with its current large front lawn, curved driveway, and front water fountain statue, the setting of the Bald Eagle Ranch House expresses its historic character through both nature and architecture. Although the historic Bald Eagle Ranch operation is gone, the house still stands, a Victorian Queen Anne farmhouse that has been surrounded by fields and orchards for the last 120 years. The Bald Eagle Ranch House has retained its integrity in feeling and association, and as can be seen by comparing Figure 1 and Photograph 001, it looks very much the way it did in the 1890s. In its exterior and interior details, in both design and materials and workmanship, the Bald Eagle Ranch House is very much a product of its time and place. It is and has always been a gracious, grand place to live.

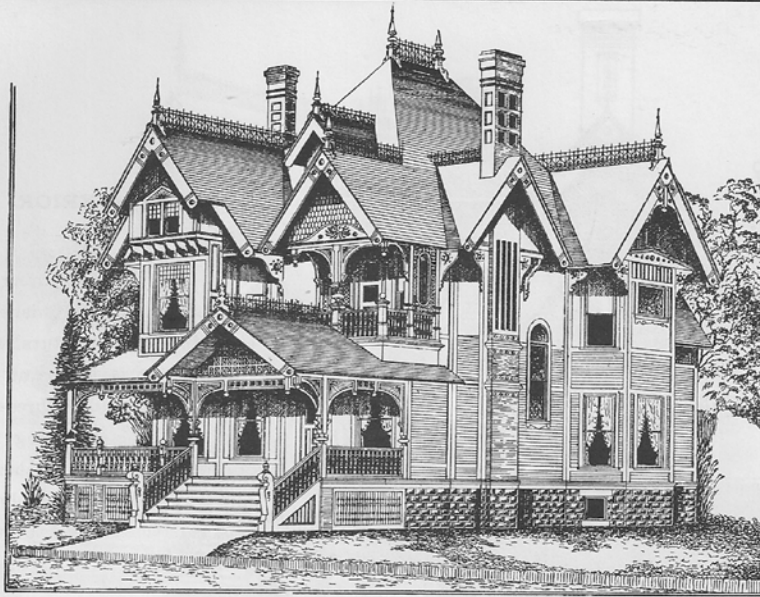
DESIGN No. 36.

PERSPECTIVE VIEW.

The Bald Eagle Ranch House was built according to mail-order architectural plans supplied by George F. Barber, and the Late Victorian Queen Anne style house follows Design No. 36.<sup>1</sup> (See Figures 3 and 4 for drawings, complete description, and floor plans of Design No. 36 from this catalog.) Work began on the house in 1891, and construction finished in 1893.

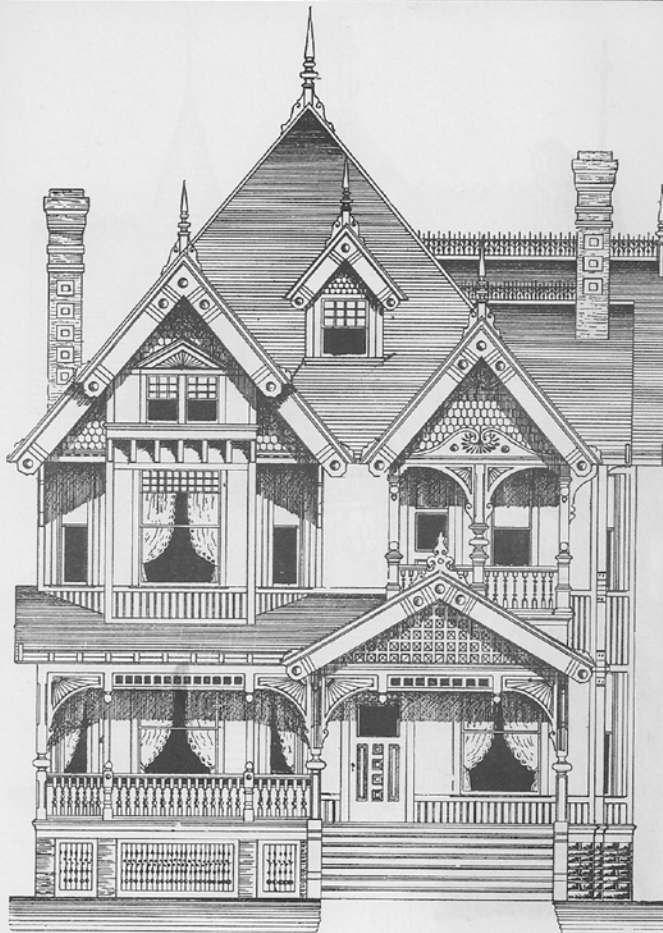
**DESIGN No. 36.**

FRONT VIEW.

The entire building, up to cornice, is weatherboarded; gables and roof shingled. Foundation of stone. Outside blinds. Painting, three-coat work.

The hall, parlor, dining and bed rooms are finished in oak or other desirable hardwood; all the rest is finished in pine or poplar, for painting. Plastering, three-coat work, hard finish. Plumbing consists of sink and pump in kitchen, bath tub and bowl, with supply and waste pipe connections, and gas throughout.

FIRST-FLOOR PLAN.

SECOND-FLOOR PLAN.

**Figure 4:** "Design No. 36" from Barber's *Cottage Souvenir No. 2*. The house is almost identical to this front view and follows the floor plan closely.

The house follows the Barber First Floor and Second Floor plans for Design No. 36 with some changes. (See Figures 3 and 4 for the floor plans.) The main entry is through the porch (labeled piazza on the plan) on the south side of the house. According to the plan, the front entrance opened into a vestibule next to a nook which had seating on two sides and an arch entry, and both of these small rooms originally opened onto the sitting hall; however, it is not known if this was originally followed in the construction of this house. Currently the front door opens directly onto the sitting hall. As seen in the plan, the sitting hall opens west into the parlor, and north is a hallway with a north door to the bedroom. At the present time this hall is shorter and goes just to the base of the second floor stairs. The plan shows a west door to the dining room from this hallway, but this does not exist. From the parlor directly north is the dining room separated by pocket doors. West from the dining room is a sun porch, added onto the house early. According to the plan, a china closet was situated on the north wall of the dining room, but it exists on the west wall.

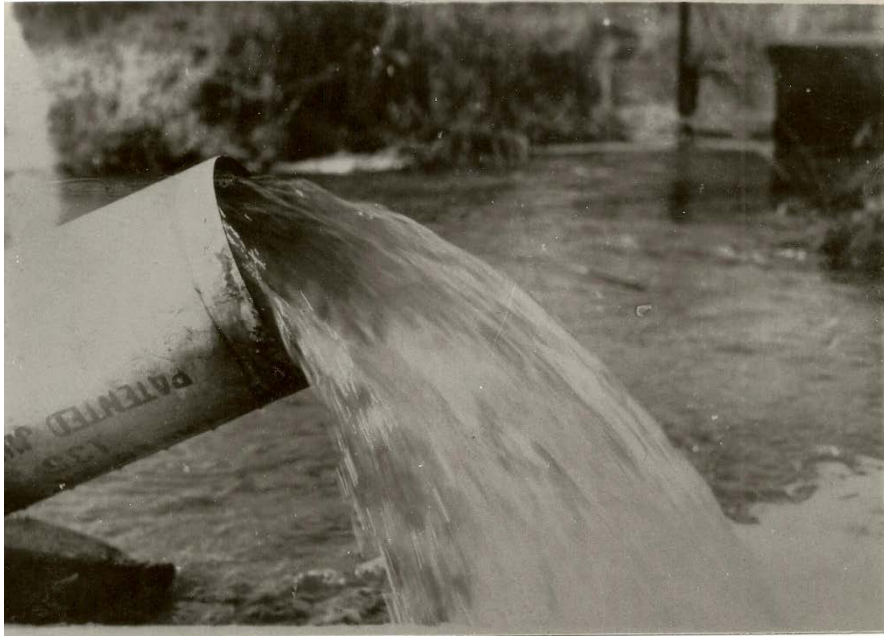
**Figure 6:** Historical photograph of irrigation water coming to the Bald Eagle Ranch.
