**United States Department of the Interior**  
**National Park Service**  
**National Register of Historic Places Registration Form**

Historic name: Fort Ord Station Veterinary Hospital

OTHER/WWII mobilization Series 700 construction

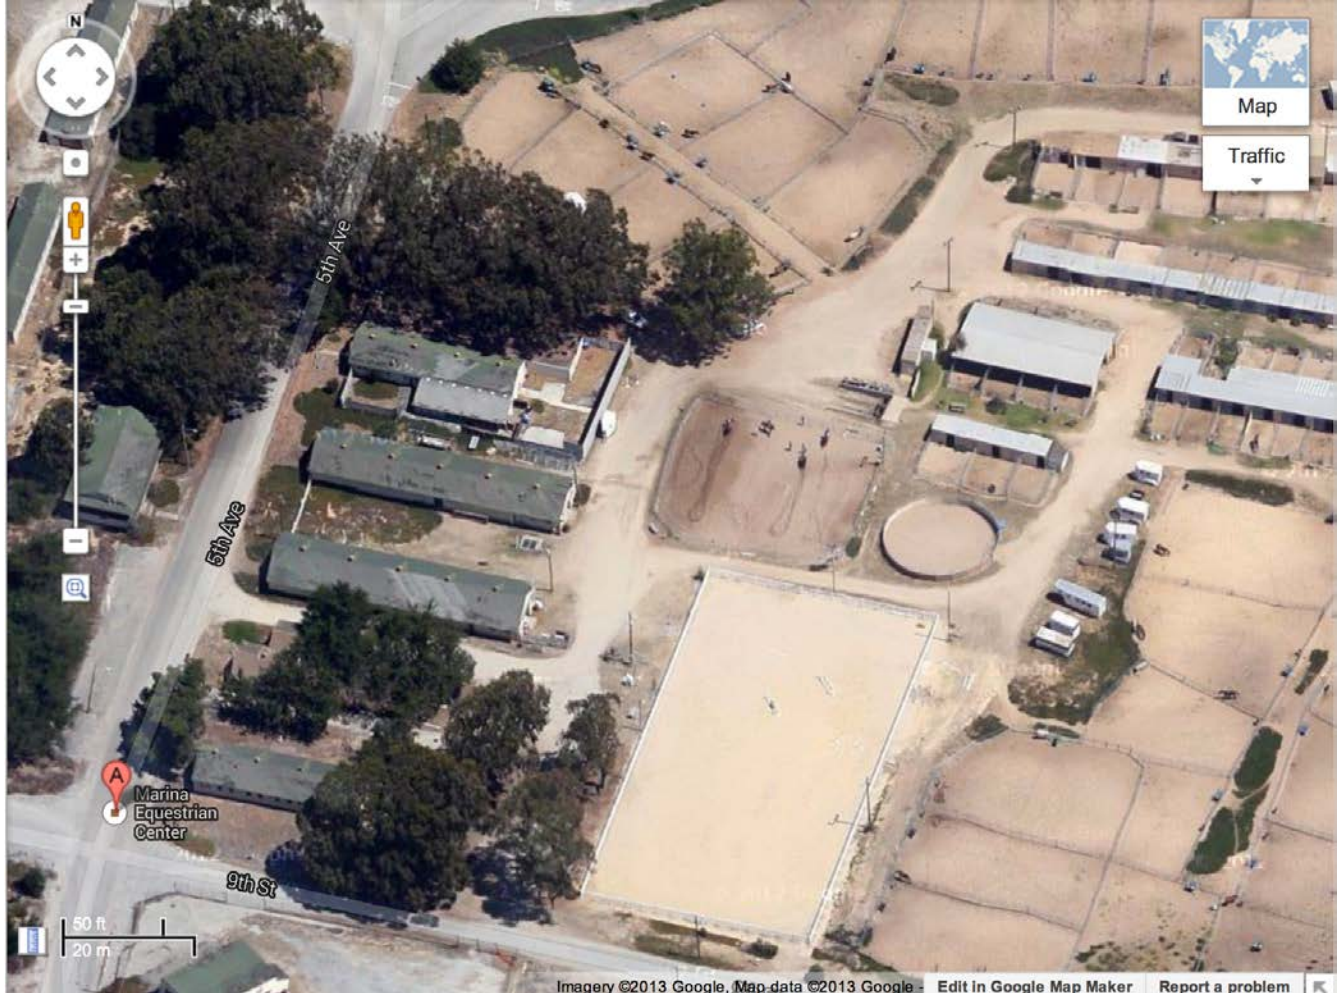
**Figure 3.** SVH and southern portion of MEC Park. Buildings counter-clockwise from Marker A at the corner of Fifth Avenue and Ninth Street: C-5, Colic, Wards A and B, C-6, and Barracks. Google Maps, 2013. From Davis.

Traveling north from the northeast corner of Fifth Avenue and Ninth Street before crossing Fifth Avenue to the barracks, the buildings of the SVH are as follows:

Building T-3140:	C-5 Veterinary Clinic
Building T-3141:	Colic Building
Building T-3142:	Veterinary Ward A
Building T-3143:	Veterinary Ward B
Building T-3144:	C-6 Surgical Veterinary Clinic
Building T-3132:	Veterinary Barracks

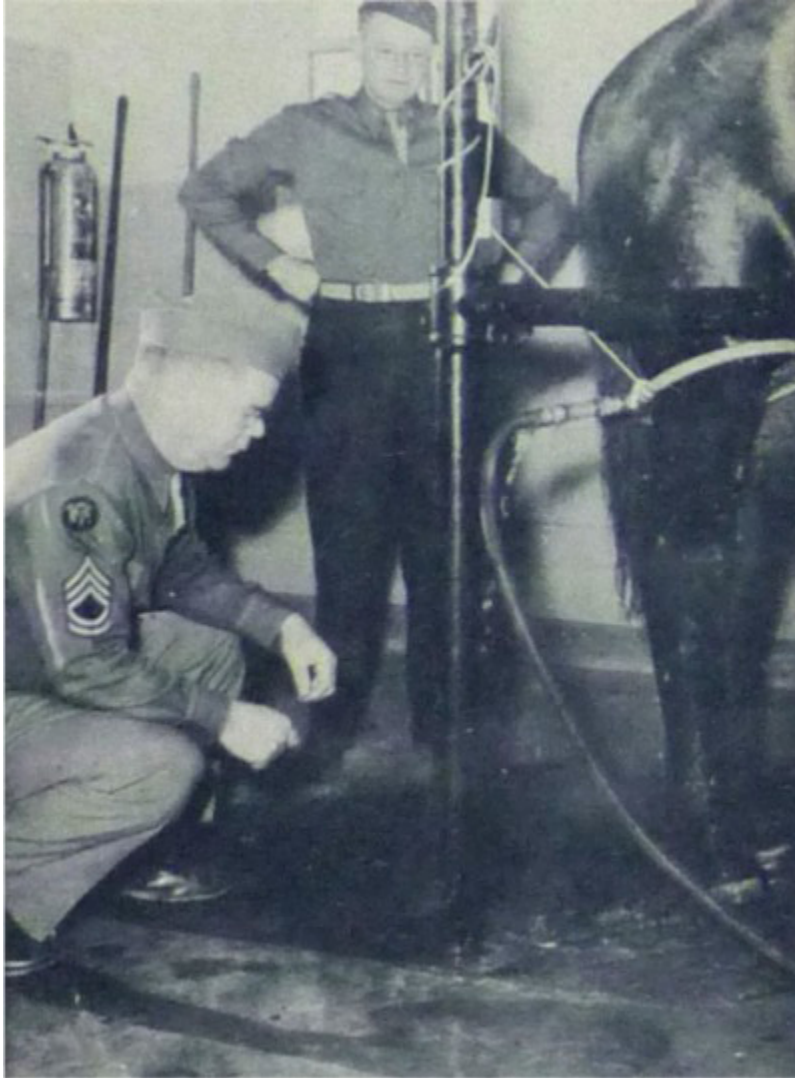
**Figure 12.** Horse in stocks in Fort Ord C-5 building. Source: *Fort Ord Panorama*, October 9, 1942. From Krenzelok,

Horses entered the dressing floor through the sliding door at the eastern end and were secured to a hitching rail along the southern wall. The sliding door is intact and functional, and the sawn-off stumps of the hitching rail are seen embedded in the concrete floor. The dressing floor contained two Ajax horse stocks for confining the animals during treatment. The stocks stood over drainage pits covered by wooden panels flush with the concrete floor; the pits and panels are intact and in good condition. One of the original Fort Ord stocks has been returned to the SVH and is placed over the northern pit.<sup>5</sup>

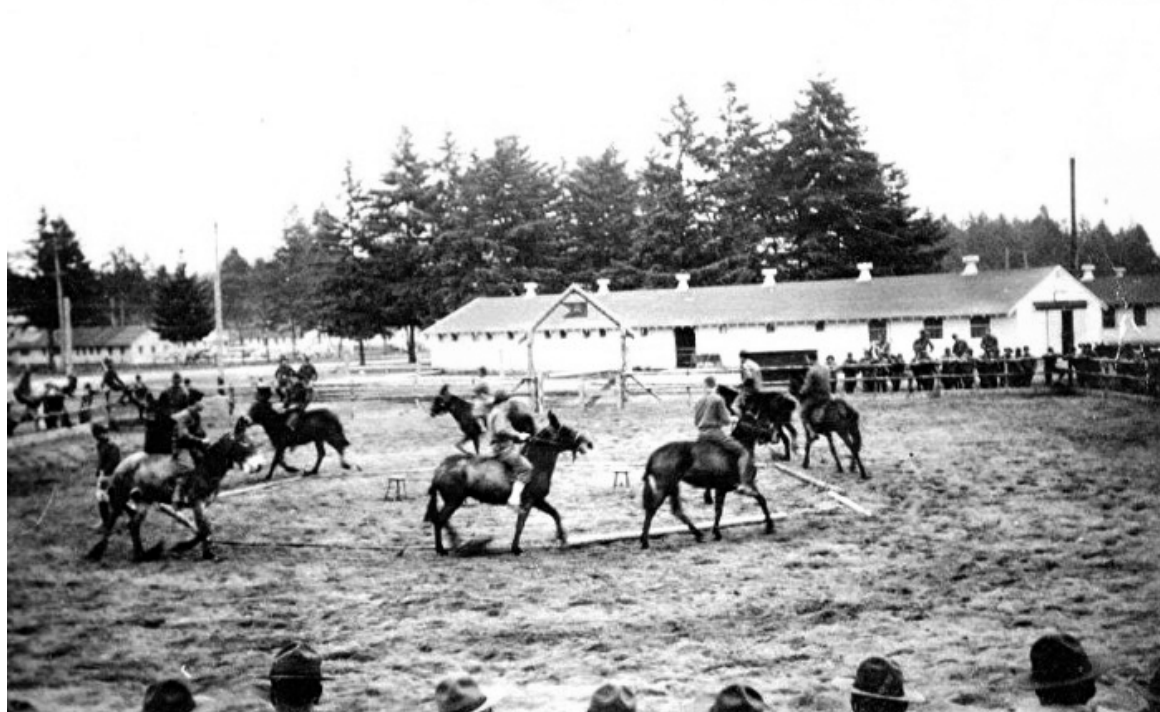
**Figure 15.** 98<sup>th</sup> Field Artillery musical chairs with mules, Fort Lewis, Washington, 1942. Series 700-486 ward in background identical to Fort Ord's Wards A and B. Number of roof ventilators could vary: six here, five at Fort Ord. Photo: R.B. Lawson Collection. From Krenzelo.

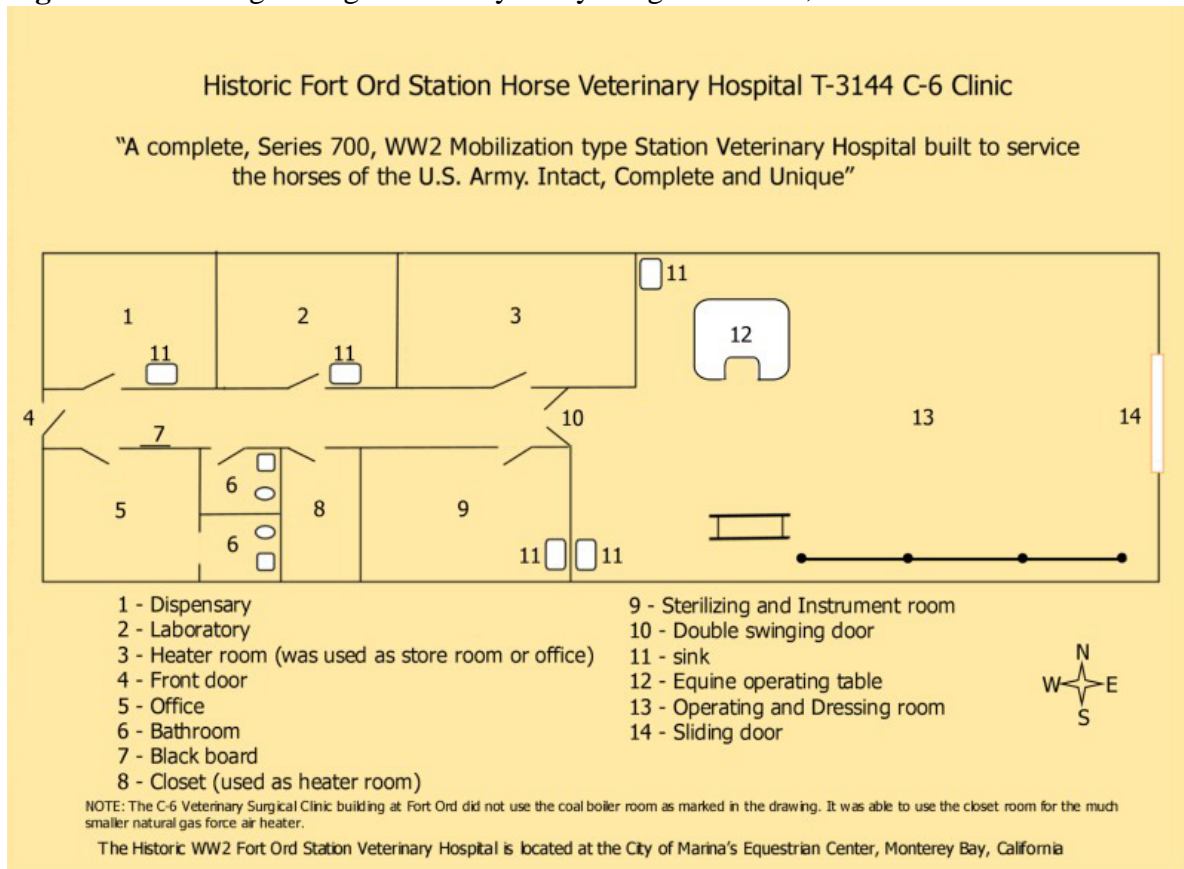
**Figure 16.** Drawing of original C-6 layout by Greg Krenzelo, 2010. From Krenzelo.

Horse surgery was performed in the C-6 veterinary surgical clinic, drawing series 700-272, Office of the Quartermaster General, May 1937. The original dimensions, 84.2 x 25.4 feet, are the same as the C-5's and the layout was originally very similar, including a sliding door at the eastern end.

C-6 clinics were authorized one per camp and included an office, latrine, rooms for supplies and heater, dispensary, laboratory, and room with operating table and hitching rails. Construction is concrete foundation and floors with wood frame walls and asphalt roofing. This building was converted in 1946-1948 into a small animal clinic. Its stocks, tilting operating table for horses, and hitching posts were removed and kennels were added to the north and south sides of the building, possibly by the 25<sup>th</sup> Infantry Scout Dog Platoon, which trained at Fort Ord in the 1950s.<sup>8</sup> Only slight modifications were made to the original building in adding the lean-to roofs that cover these kennels, and the original exterior walls and windows are intact and easily seen. The stonework at the street may be original; research has not been done on this feature. The shiplap of the original building is in very good condition.

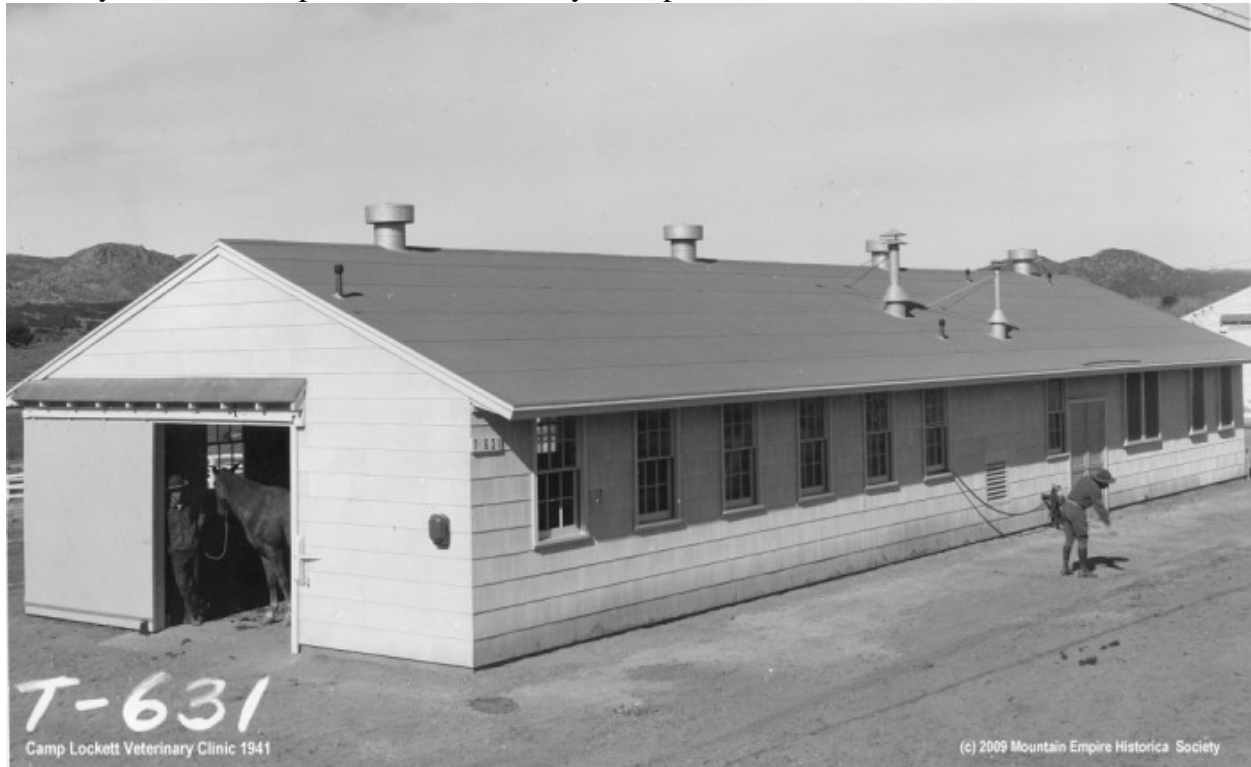
**Figure 20.** Type C-6 veterinary clinic, surgical, Series 700-272 drawing, Building T-631, Camp Lockett, San Diego County, California, 1941. This is the only other example of a Type C-6 building that Fort Ord SVH researcher Krenzelok was able to locate in the United States. Photo courtesy Mountain Empire Historical Society, Campo, California. From Krenzelok.
