National Register of Historic Places Registration Form

1. Name of Property	DRAFT			
<u>=</u>	Historic name: Headquarters Administration Building			
	Other names/site number: Big Basin Redwoods State Park Visitors Center Name of related multiple grant tiling at PRIMARY. National State Park Comparison			
Name of related multiple property listing: <u>PRIMARY—National-State Park Cooperative</u> <u>Program and the Civilian Conservation Corps in California State Parks 1933-1942, The:</u>				
SECONDARY—Historic Resources of Big Basin F				
SECONDINE INSTITUTE OF ENGLISHING	100110000000000000000000000000000000000

Headquarters Administration Building

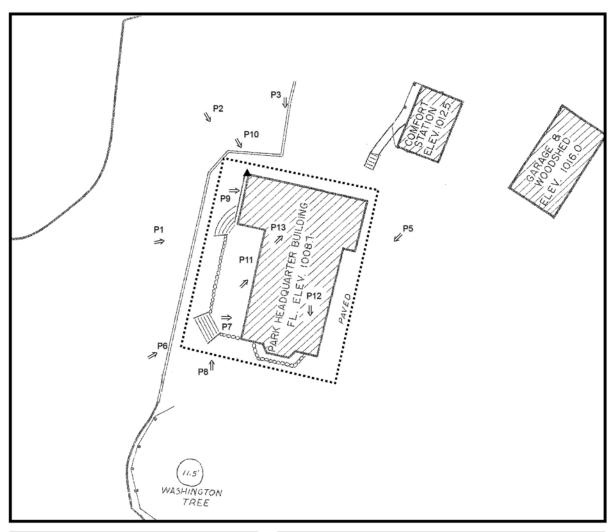
Photo Key/Location/Sketch Map: Portion of Big Basin Redwood SP – General Topography (CA Division of Beaches and Parks, 1957): sheet 9 of 26

- ▲ Latitude / Longitude Reference Point
- ↑ Photo Points

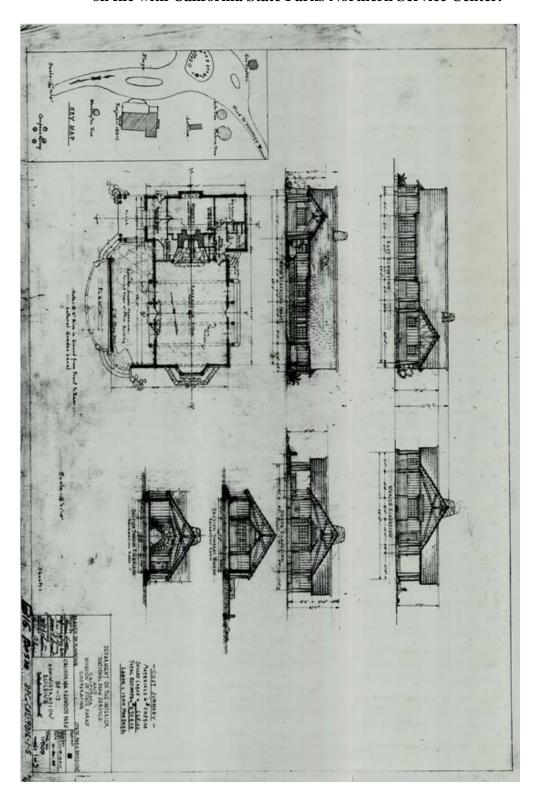
Figure 1. Original Plans for the Headquarters Administration Building, October 30, 1935, on file with California State Parks Northern Service Center.

NPS/California Division of State Parks. "California Redwood State Park: SP-15 Administration Building." [Floor plans, elevations, sections, and roof plan, two sheets] March 10, 1935. NPS.

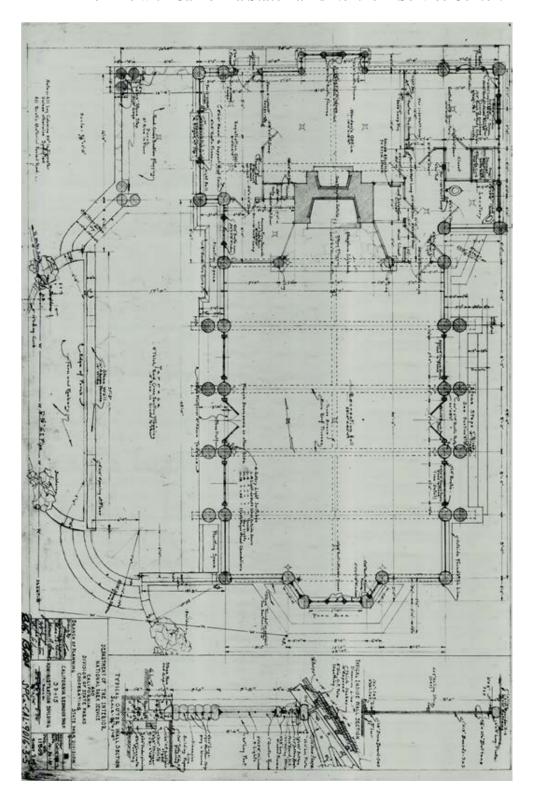
Figure 2. Original Plans for the Headquarters Administration Building, October 30, 1935, on file with California State Parks Northern Service Center.
