Potential Significance to Water Resources & Drainage Structure Condition Index

MITCHELL CANYON TO SUMMIT

Mount Diablo State Park Road and Trail Management Plan

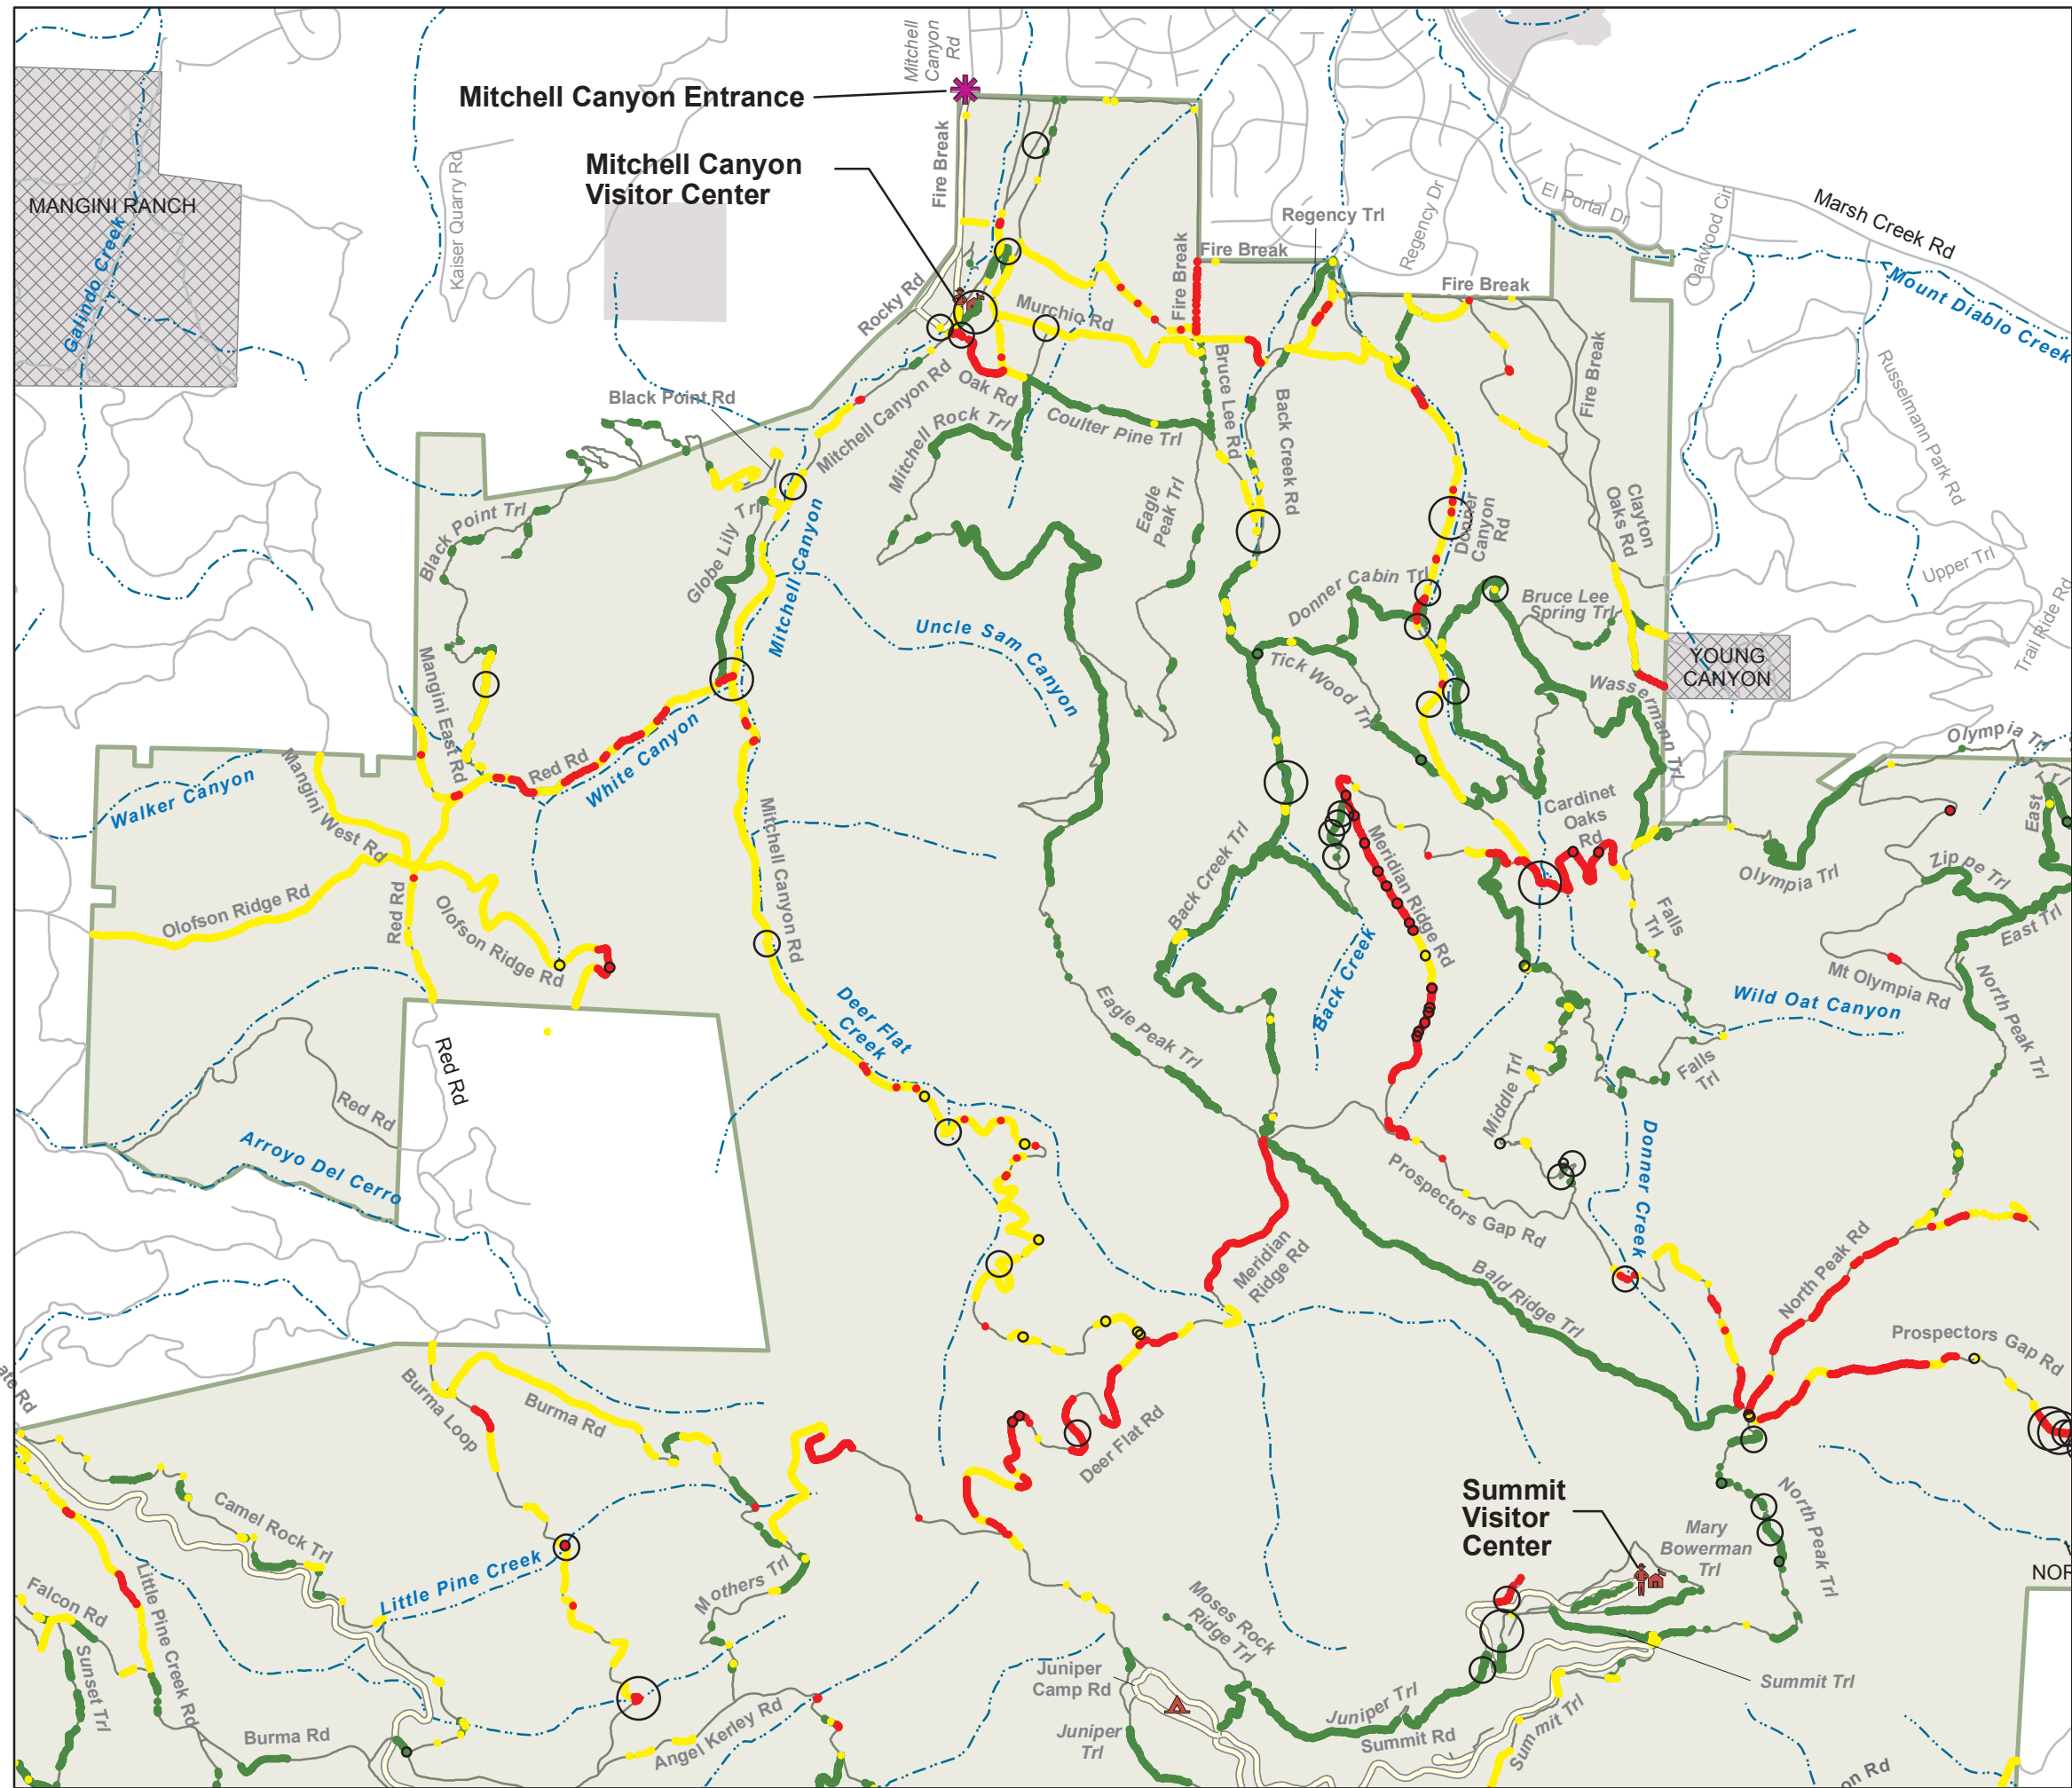
Potential Road and Trail Impacts To Water Resources

Drainage Structure Condition Index
Higher Score = poor condition of structure
