Potential Significance to Water Resources & Drainage Structure Condition Index

MORGAN TERRITORY TO SUMMIT

Mount Diablo State Park Road and Trail Management Plan

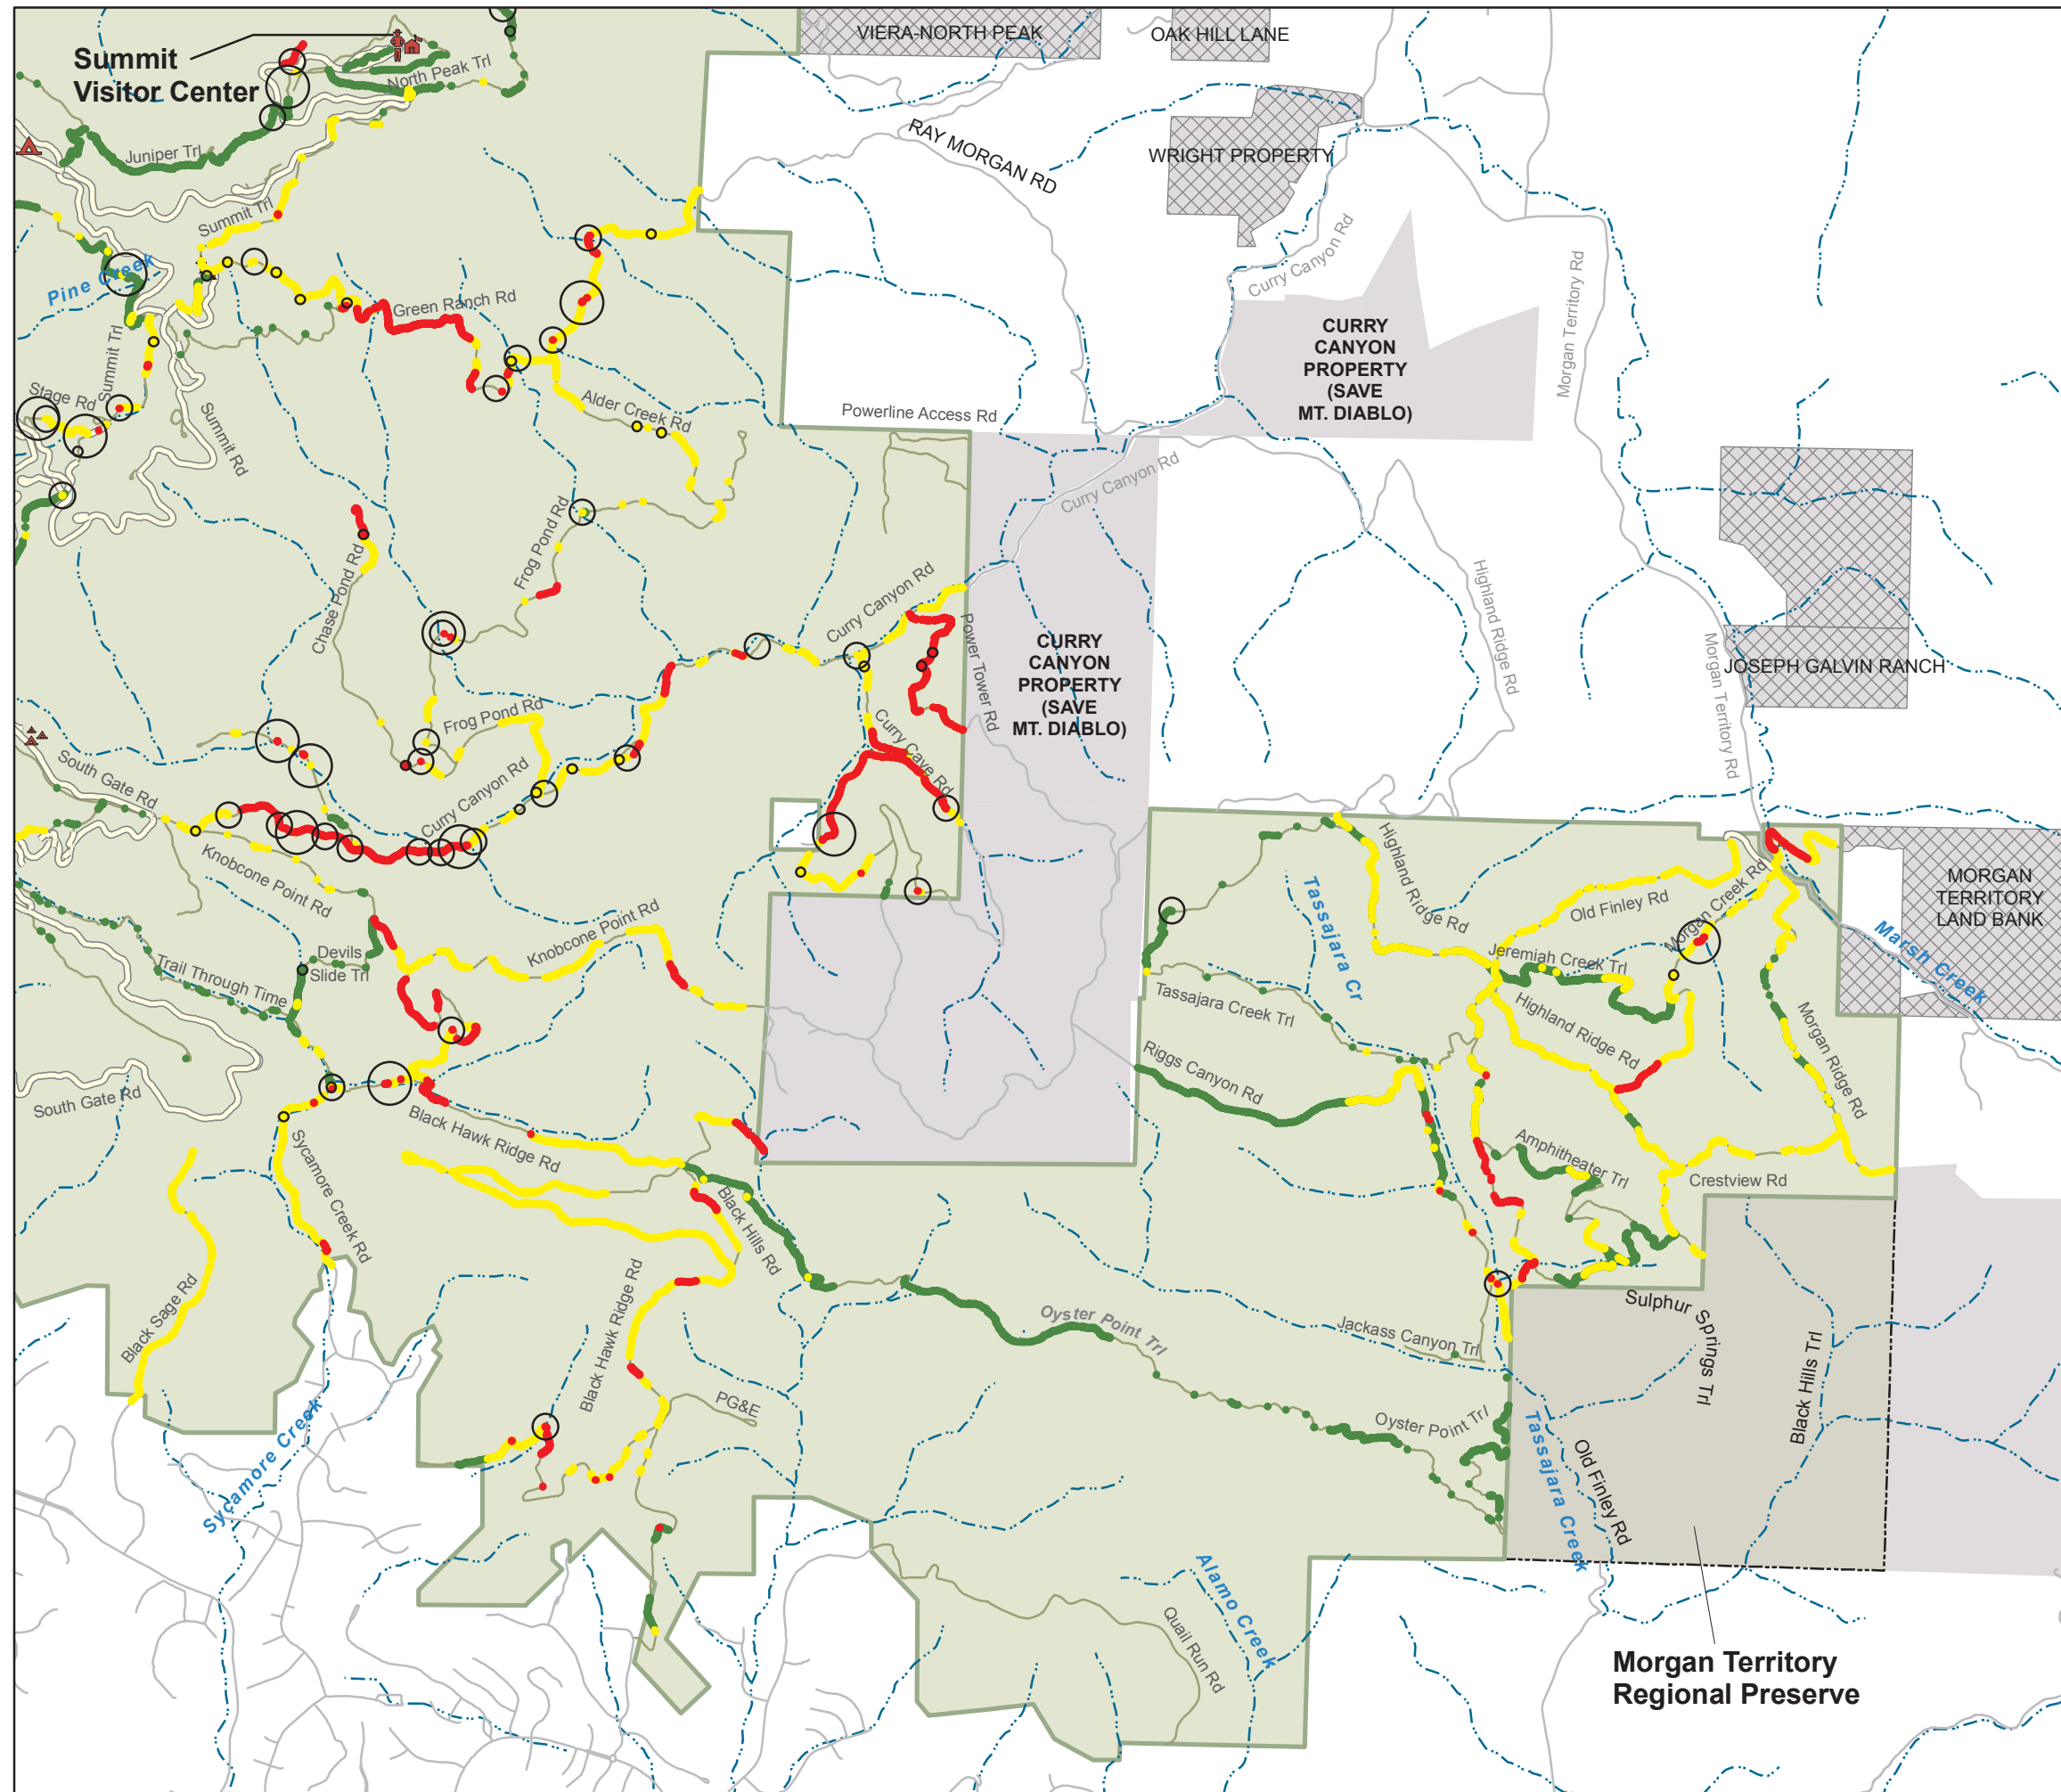
Potential Significance To Water Resources

- High (Red dot)
- Medium (Yellow dot)
- Low (Green dot)

Drainage Structure Condition Index
Higher Score = poor condition of structure

- Low (Small circle)
- Medium (Medium circle)
- High (Large circle)
