CROSS SECTION A-A'

EXISTING CROSSING BRIDGE ALTERNATIVE
COOL TO AUBURN TRAIL BRIDGE
ALTERNATIVE ANALYSIS
PLACER AND EL Dorado COUNTIES, CALIFORNIA

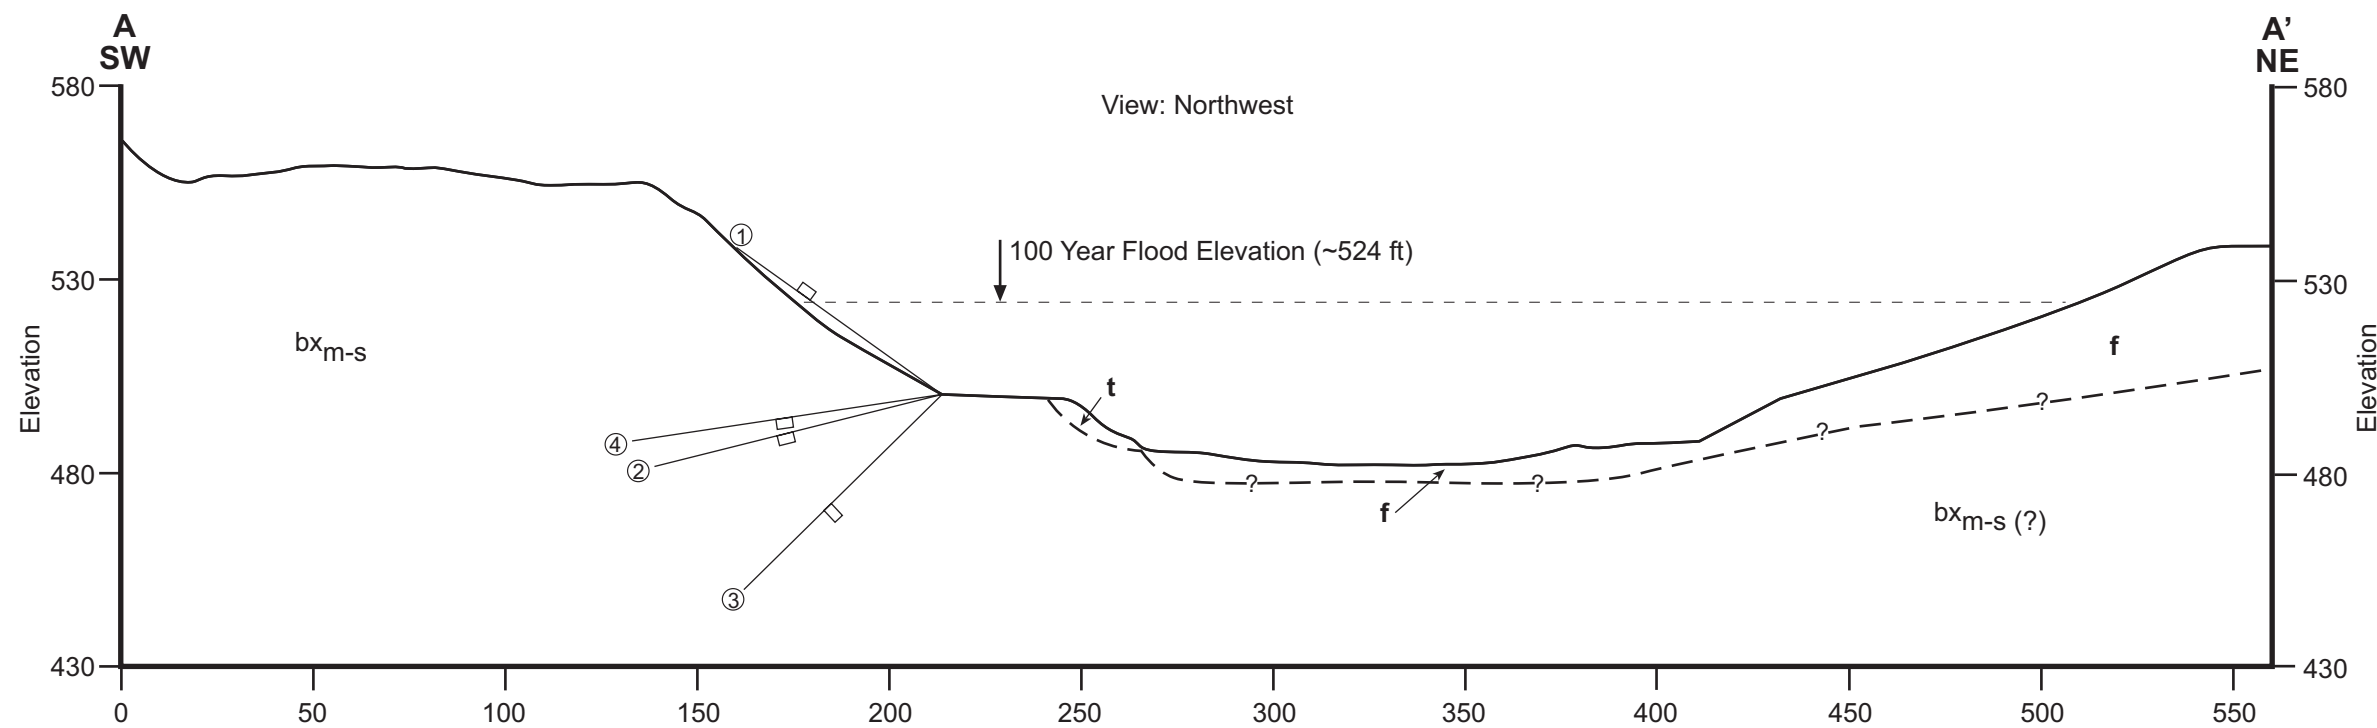
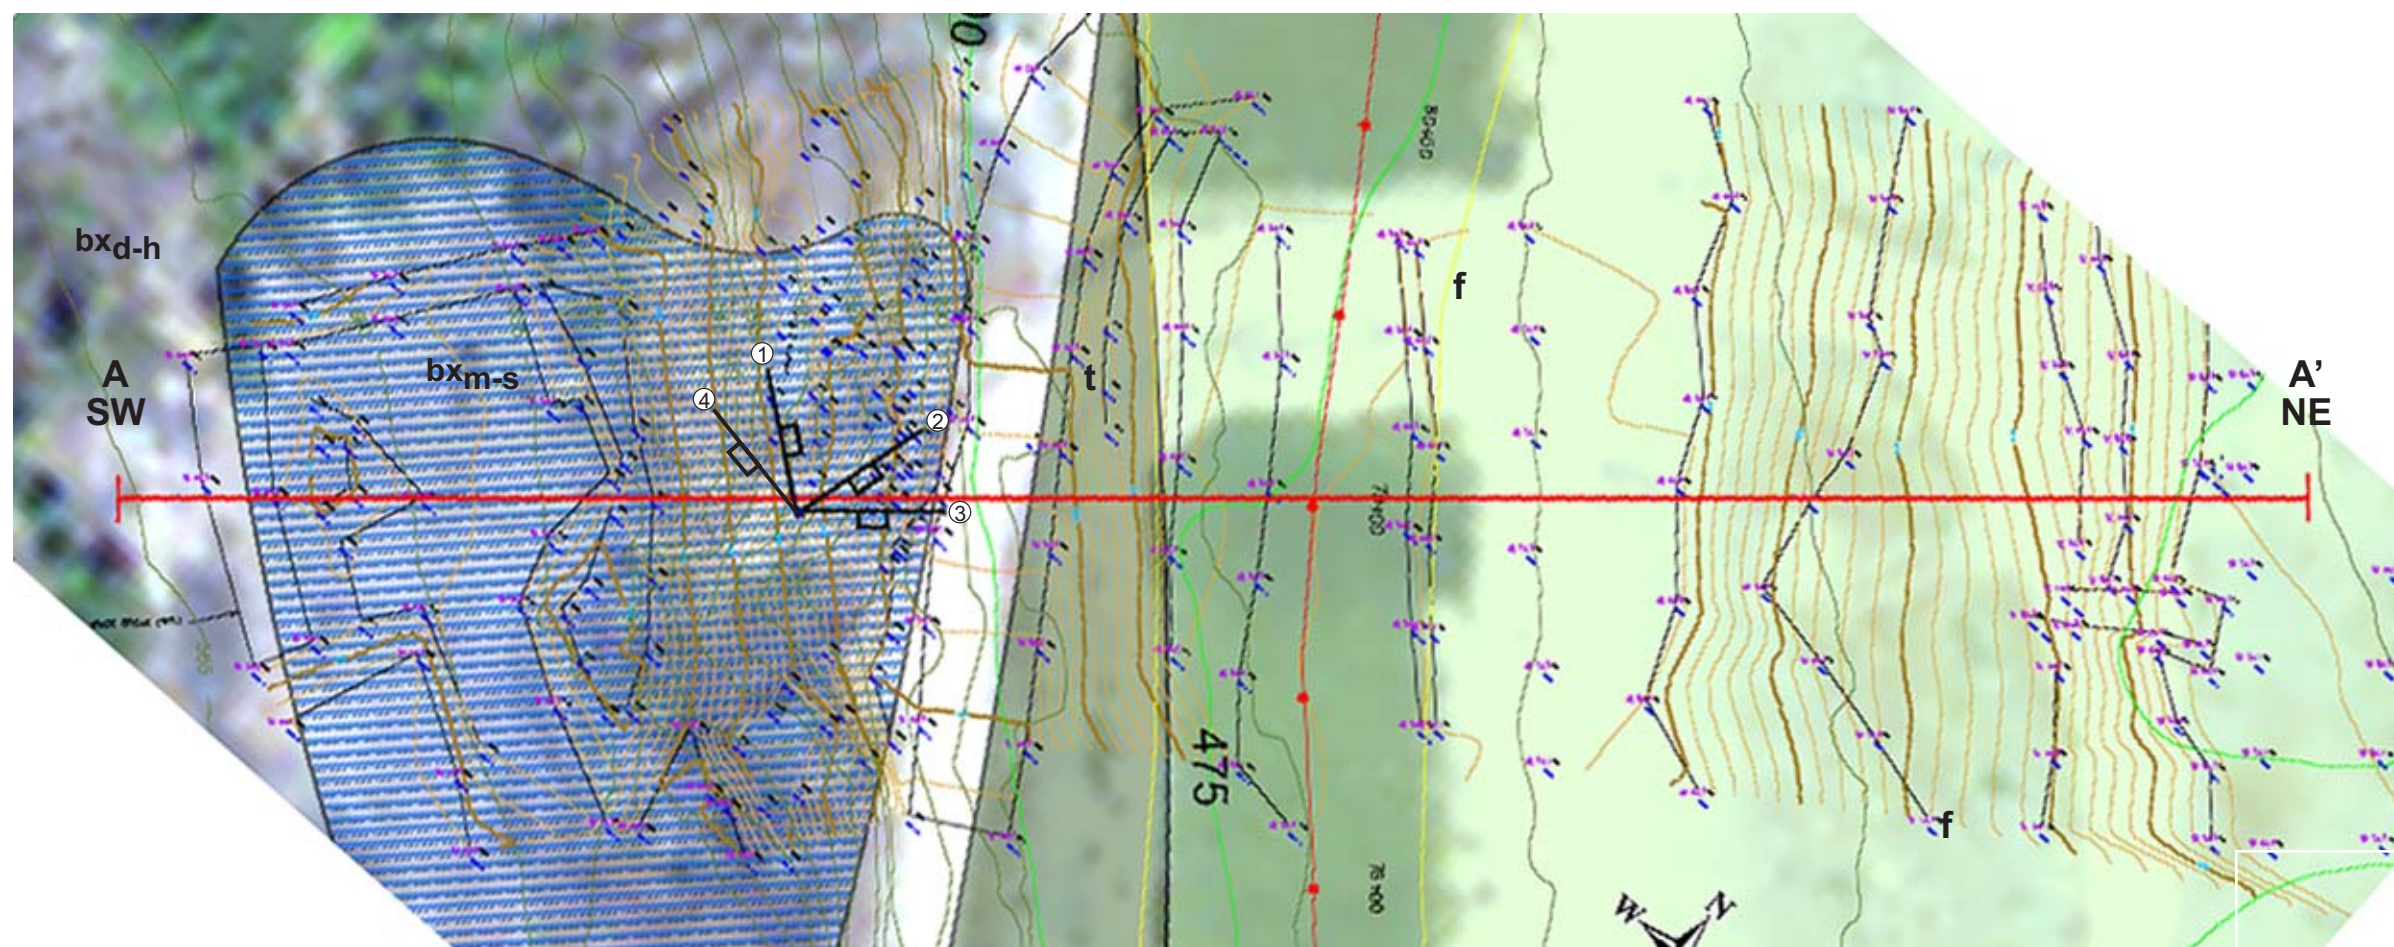
Figure 4
Existing Alternative
Crossing Geology

Note: Discontinuity lengths and locations shown schematically. Drawn showing apparent dip.
