Año Nuevo Island Light Station

*Documentation of the Light Station Complex
Año Nuevo Island,
Año Nuevo State Reserve, San Mateo County, California*

June 2005

Matt C. Bischoff
Historian II
California State Parks
Northern Service Center
Sacramento, CA

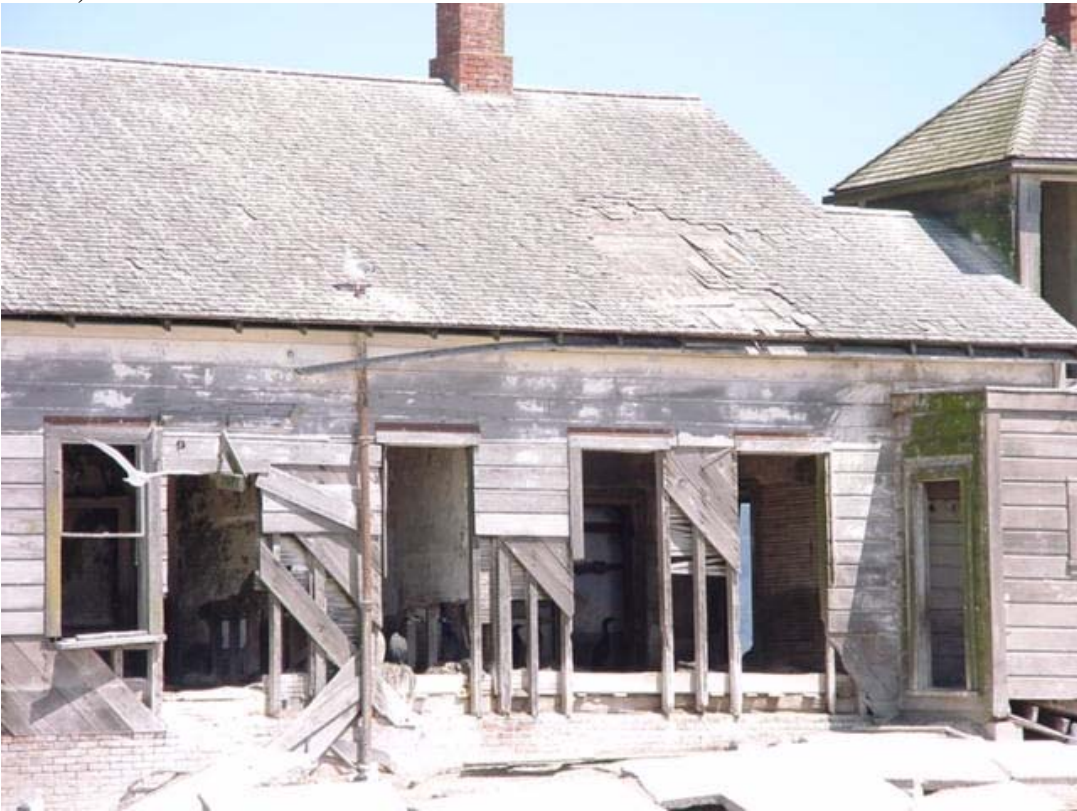
Figure 44. Keeper's dwelling, original portion, west side, 2005

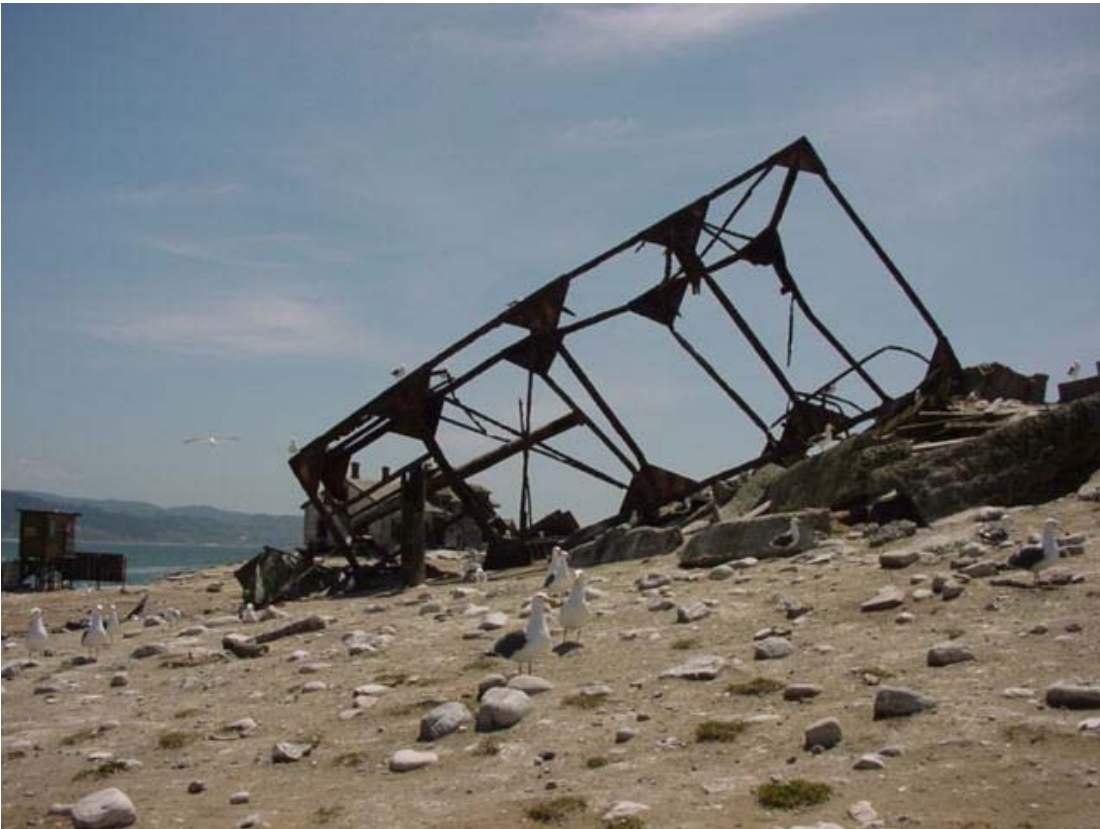
Figure 82. Steel light tower following dismantling by state, 1982. Catalog #24754 Catalog #24743, California State Parks, Archaeology Laboratory, West Sacramento.

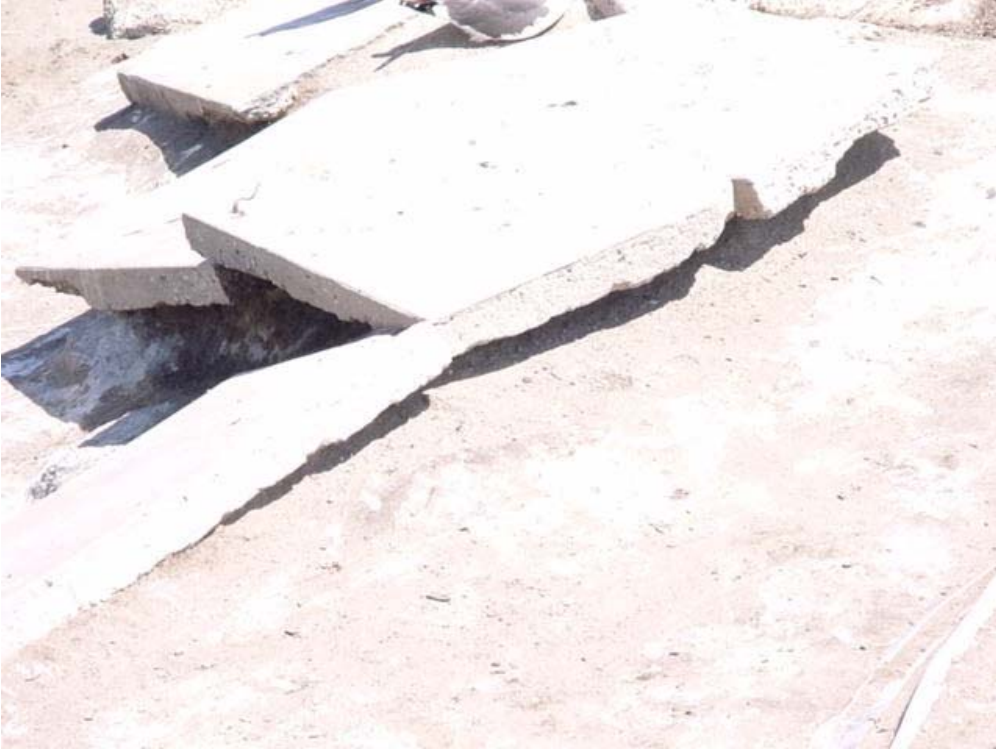
Concrete walkways were built around the fog signal building in 1900 and the dwelling sometime thereafter. Those around the keepers' dwelling have eroded significantly and are largely gone today. Concrete walkways remain around three sides of the fog signal building, however.

Figure 105. Remains of concrete walkway near keeper's dwelling, 2005.
